Project: **200-300 N.E. Leak Remediation
Design**

RE: **Addenda #1**
93 **(# of pages)**
Pages:

Re: 212 North End Avenue
Expansion Joint Investigation
WJE No.PC13.1965

Re: 212 North End Avenue
Leak and Probe Investigation
WJE No.PC13.1965

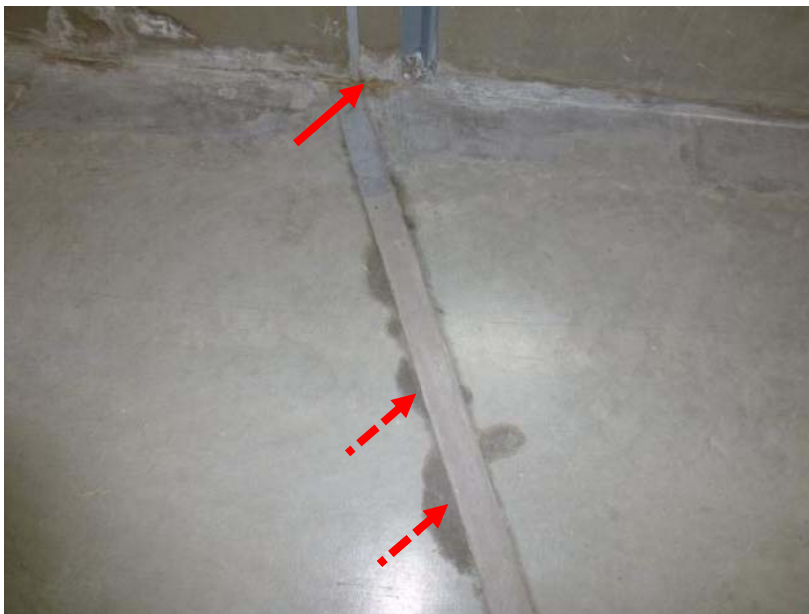
At main public corridor, a section of the expansion joint is visible [Figure 5]. Significant staining was observed at the bottom of the knee wall and at the floor [Figure 6]. Additionally, as previously noted in

Figure 6. Note significant staining at bottom of knee wall (solid line) and at slab (dashed arrows).

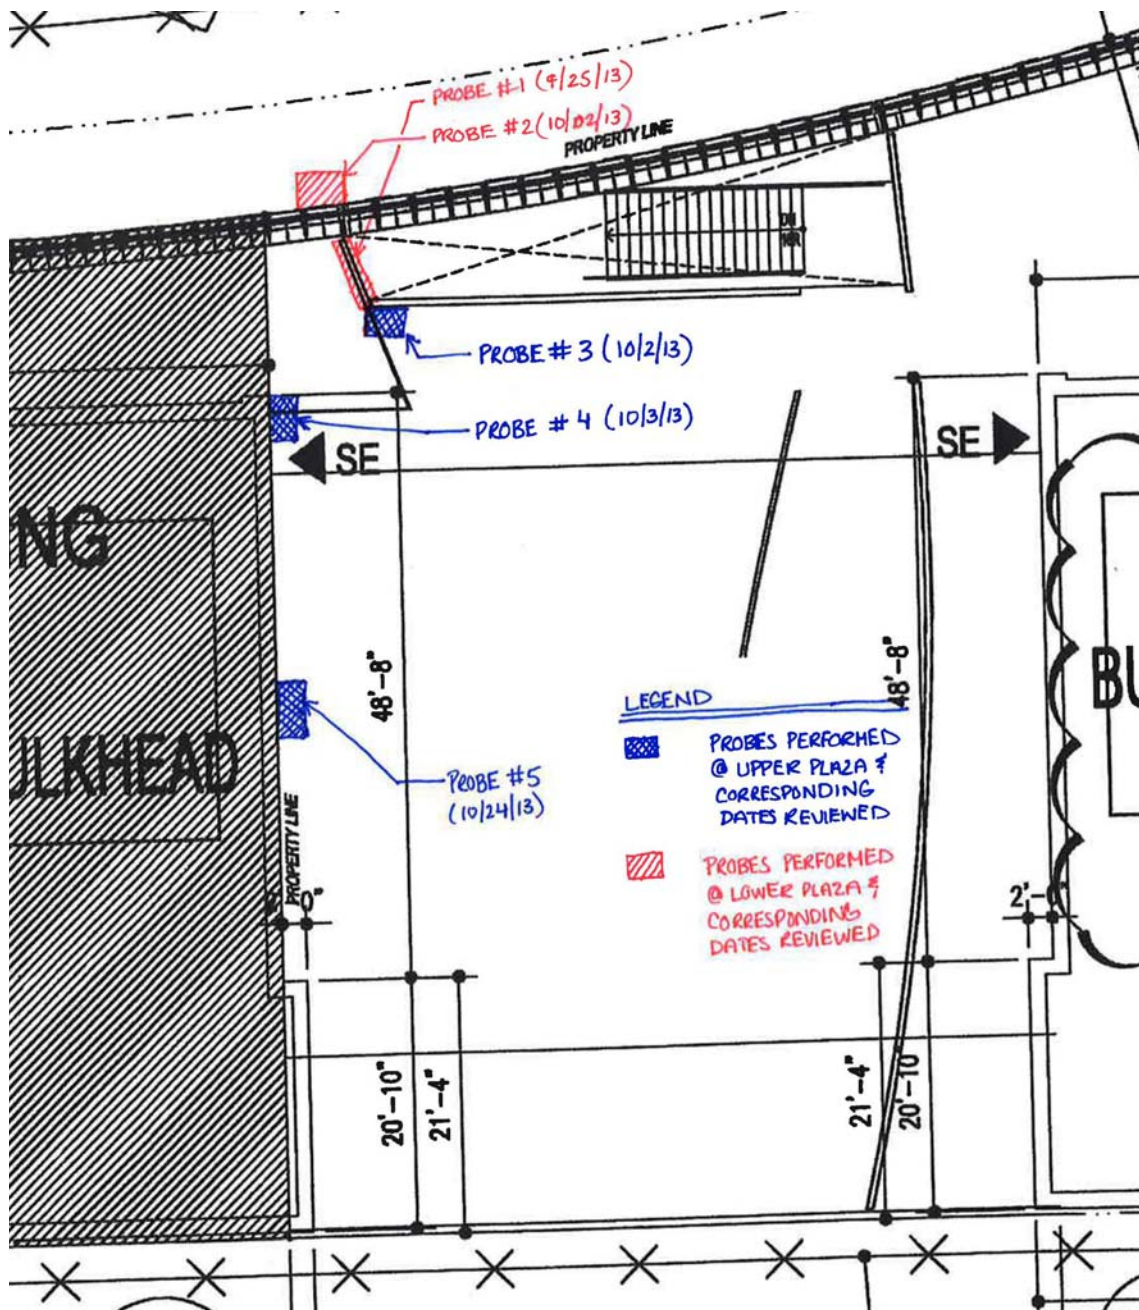
Figure 8. Location of exploratory probe openings performed between 9/25/2013 and 10/24/2013.

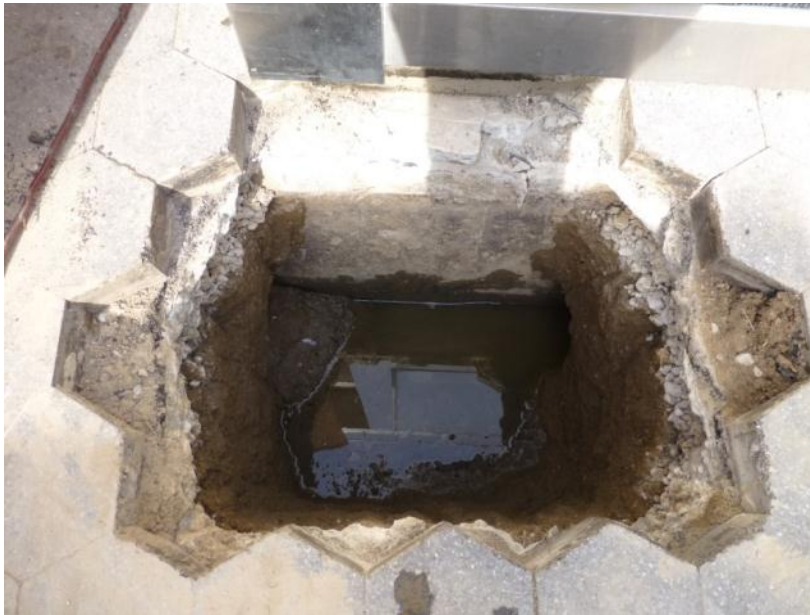
In addition to the above observations, approximately 5" of standing water was noted in the opening [Figure 13]. Based on our conversations with BPCA and observations over several days, it is our understanding that the opening maintains the standing water and does not drain. Unfortunately, this made it impossible for us to observe the entire height of the foundation wall or the junction of the wall with the slab.

Figure 13. Note standing water at probe opening #2.

- Since the water does not drain properly at the area directly outside of the north entrance of the Center Courtyard, there is built-up hydrostatic pressure against the foundation wall. A provision should be made for draining the water at this area, thus relieving/alleviating the current pressure caused by the water. This will likely require consultation with the MEP designer.

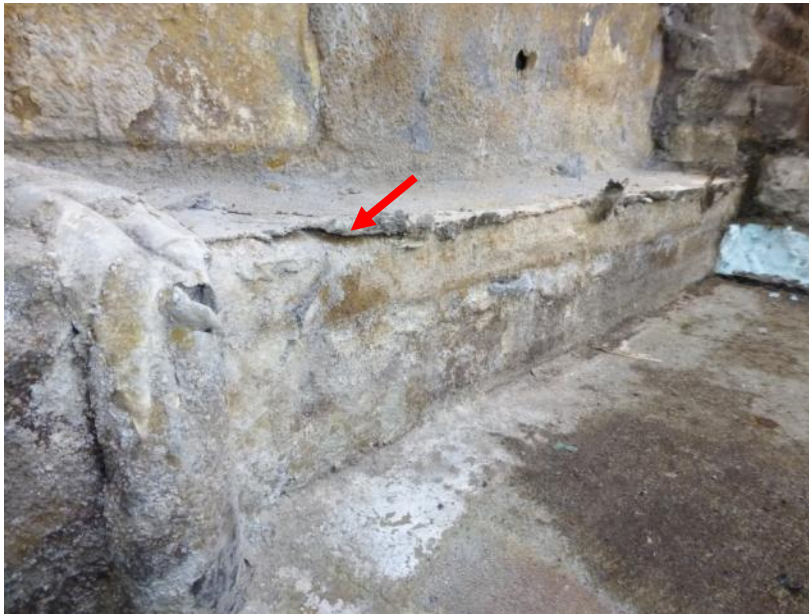
brittle and delaminating from the substrate [Figure 15]. The material at the curb, which appears to be a slurry coat, was noted to be delaminated from the base Kemper installation [Figure 16]. There was an opening in the expansion joint, however it was likely caused by demo work during the probe opening.

Figure 16. Material at curb, which appears to be a slurry coat, noted to be delaminated from base Kemper installation (arrow).

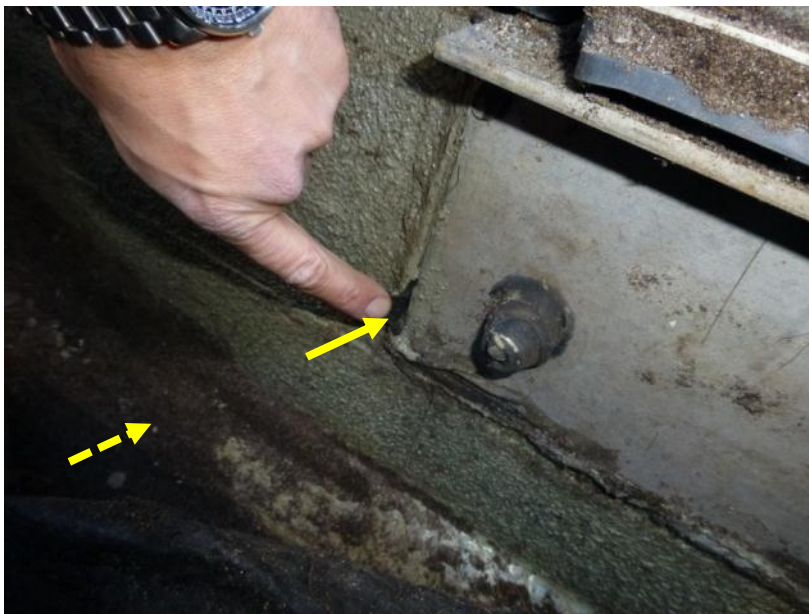
- Probe No. 5 - The expansion joint directly above the leak in room C24C could not be probed because it coincides with the emergency exit of Building 23. Therefore, a probe was taken at the planter area approximately 5' west of the leak. Removal consisted of a section of soil and sand down to the concrete deck [Figure 24]. At this location, there is a change in slab elevation and the configuration of the expansion joint varies in that it is a horizontal to vertical transition. The waterproofing installation at this probe appeared to be in good condition [Figure 25]. The only deficient condition identified was at the perimeter of a steel angle where the membrane was open [Figure 26]. Additionally, some soil/sand was noted behind the felt and on the membrane.

Figure 26. Note opening observed around perimeter of steel plate (solid arrow). Also, note soil behind felt (dashed arrow).

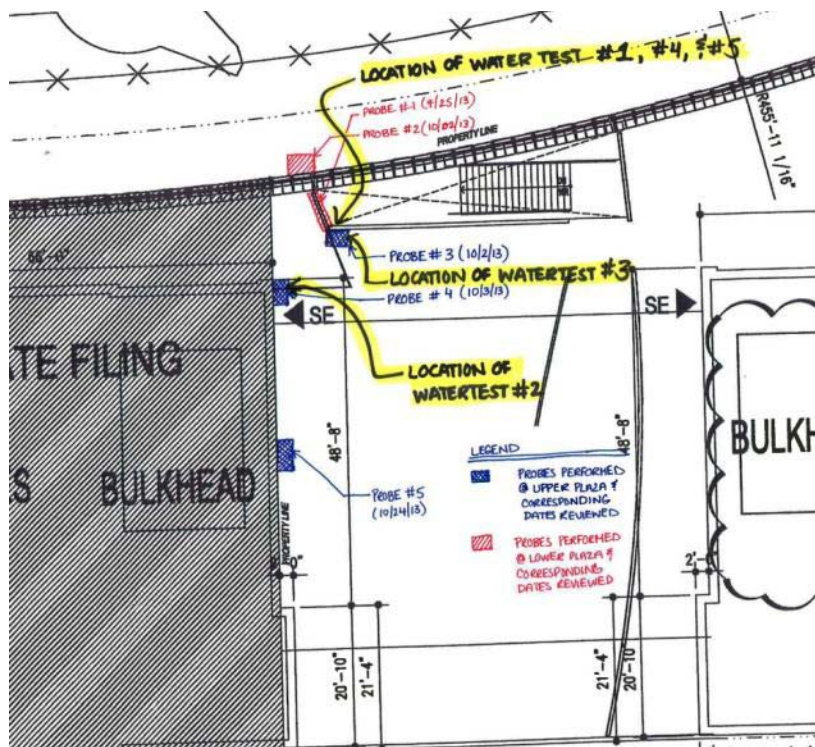
Figure 27. Location of water tests performed. Note locations coincide with probe locations.

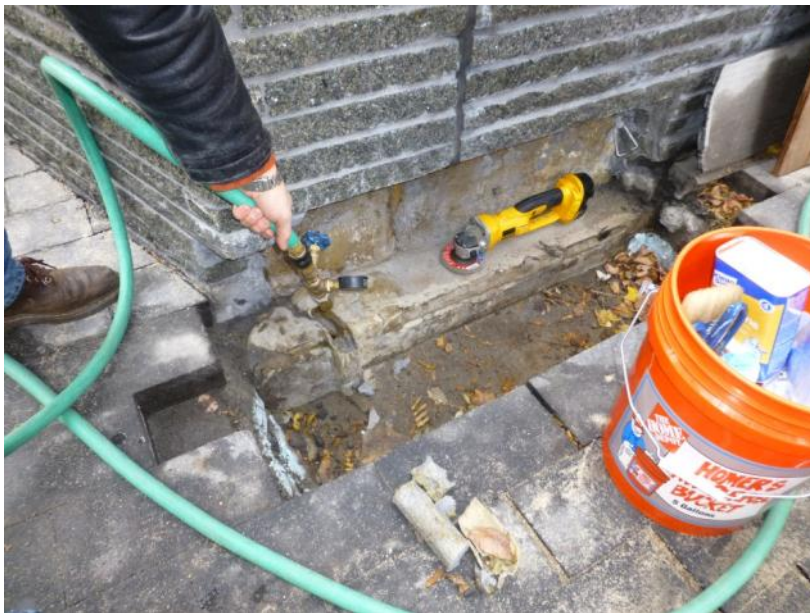
Figure 34. Water test 3 - sprayed AAMA nozzle at very low pressure directing water into expansion joint system.

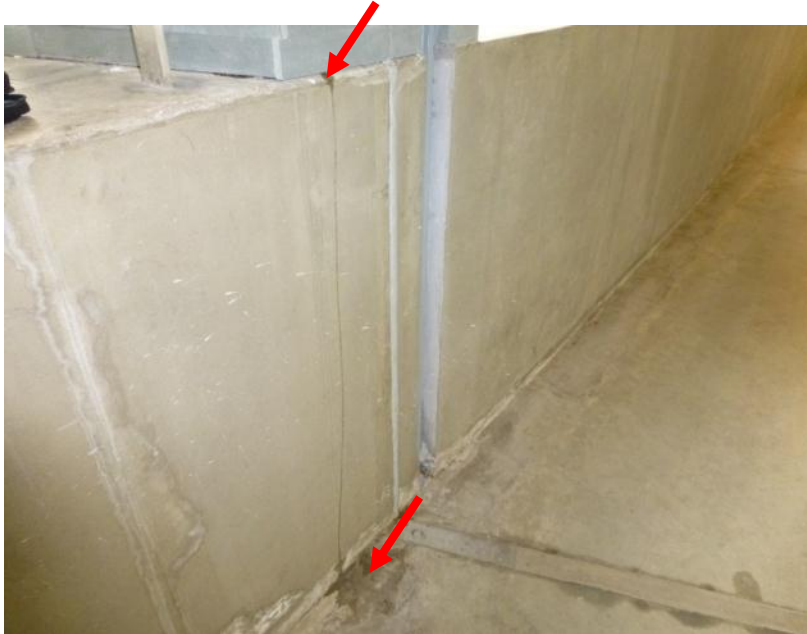
3	2 min.	Sprayed AAMA nozzle at a very low pressure at opening made at expansion joint [Figure 34].	Water infiltration occurred 2 minutes after applying a small amount of water to the expansion joint, recreating the current leaks [Figure 35].
4	15 min.	Sprayed AAMA nozzle at jamb of storefront window and door [Figure 36].	The staining at the north corner of the storefront window appeared to grow [Figure 37].
5	15 min.	Sprayed AAMA nozzle at corner of parapet above north door and storefront window [Figure 38].	No changes to the staining patterns were observed.

Figure 35. Water infiltration occurred 2 minutes after applying a small amount of water to the expansion joint.

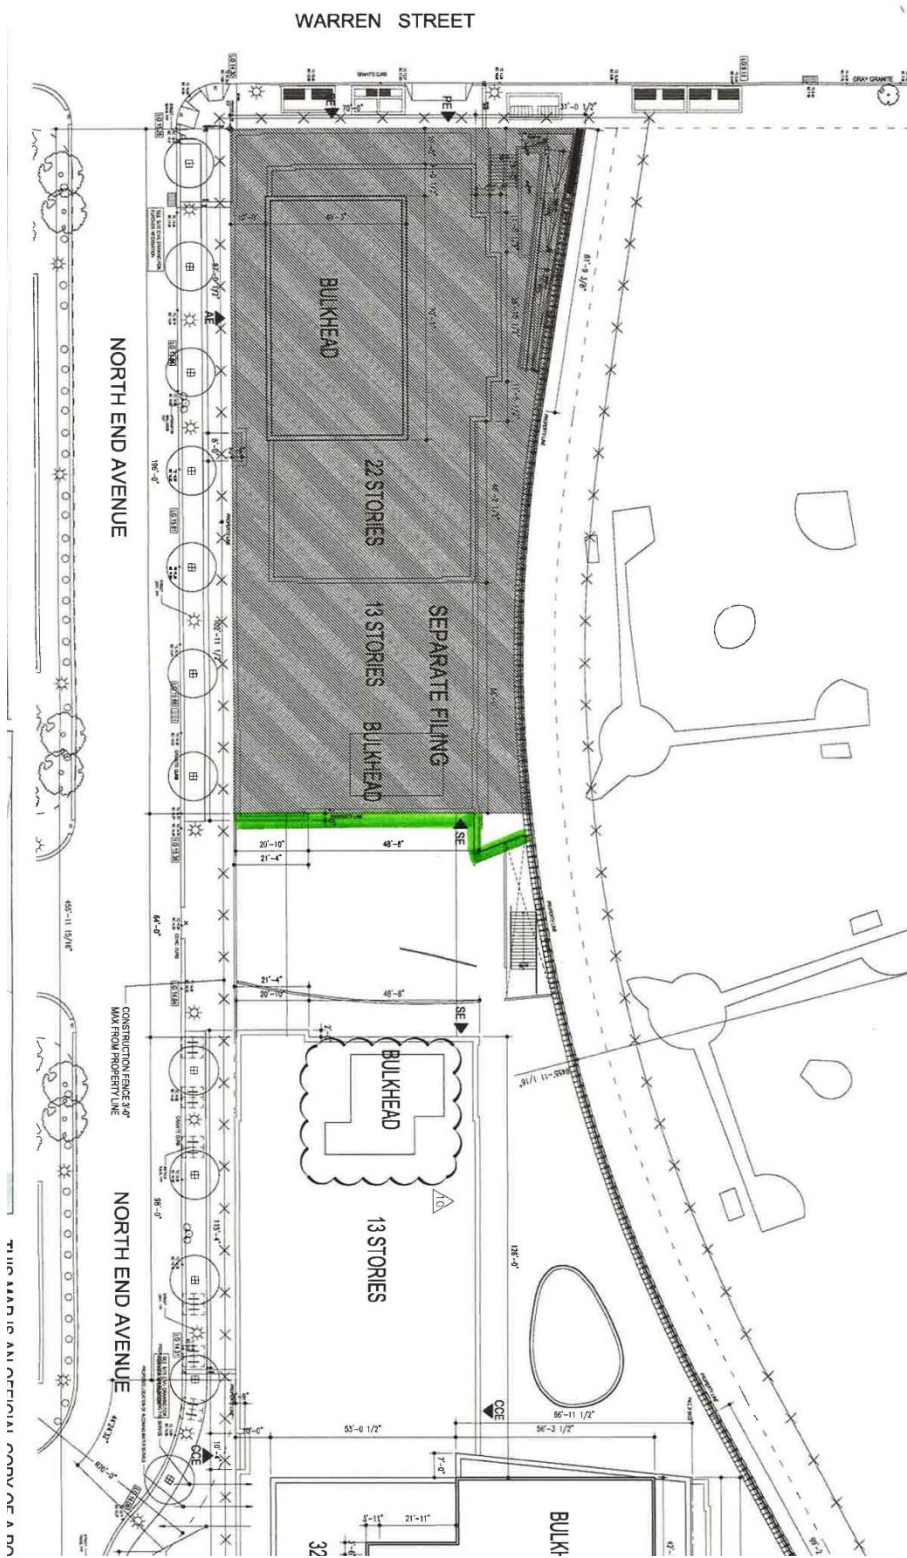
Figure 41. Recommended extent of removal and replacement of expansion joint highlighted in green.

Given our observations and understanding of the current conditions via our probe observations and water testing, we recommend the removal and replacement of the full length of the expansion joint that traverses the building in the east-west direction [Figure 41]. The scope of recommended repairs is described below:

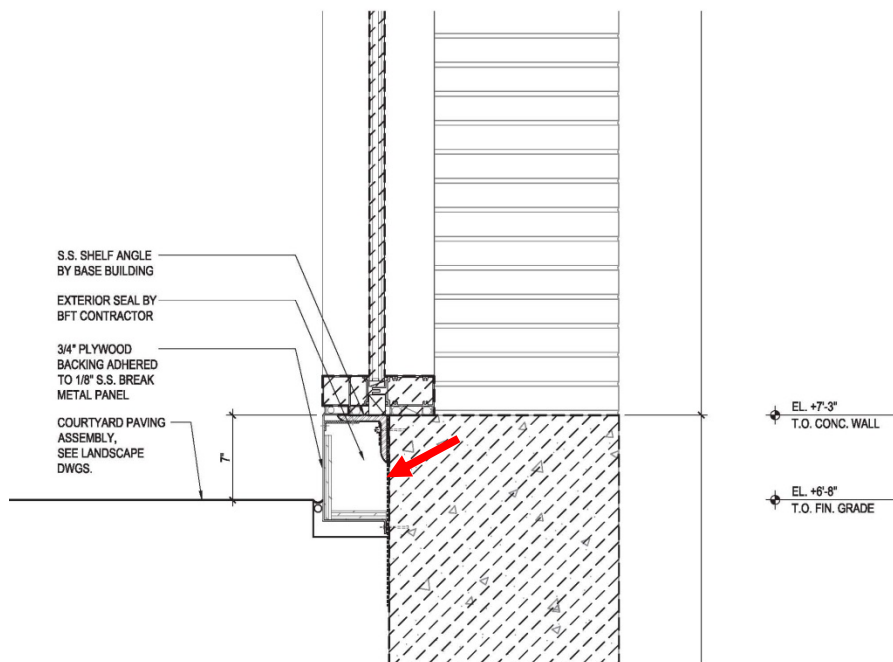
Figure 7. Detail D1, sheet A-713. Note waterproofing on the outside of the foundation wall shown to terminate at the outside face of the wall without extending into the return surface of the opening (arrow). Also note no presence of sill pan flashing.

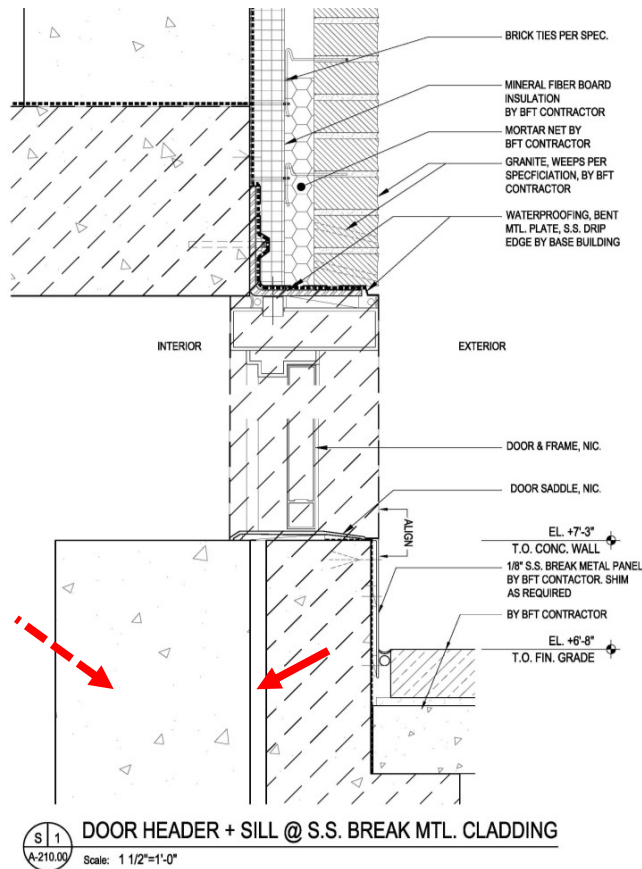
Figure 8. Shown above, detail S1, sheet A-210.00. Note expansion joint below door saddle (arrow). Foundation wall shown by dashed arrow.

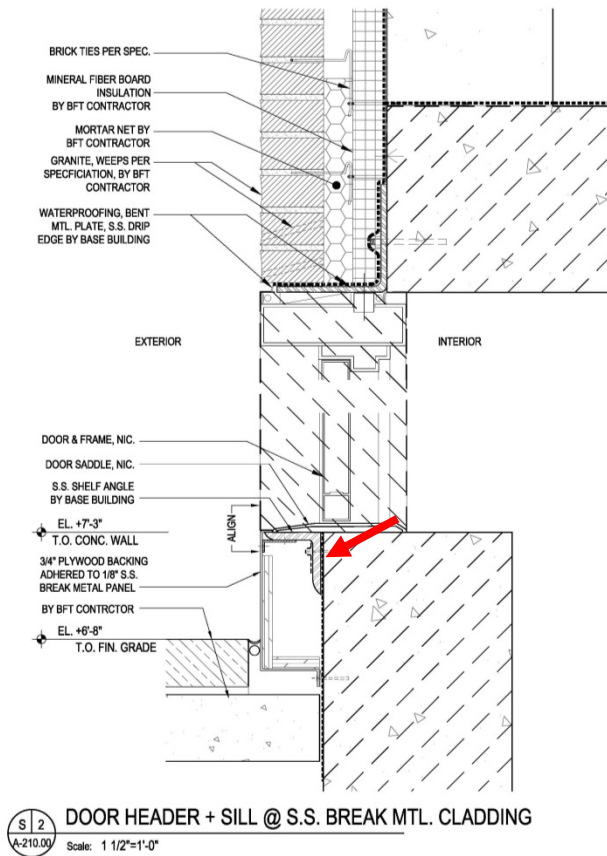
Figure 9. Shown above, detail S2, sheet A-210.00. Note waterproofing shown to terminate at the outside face without extending into the return of the opening.

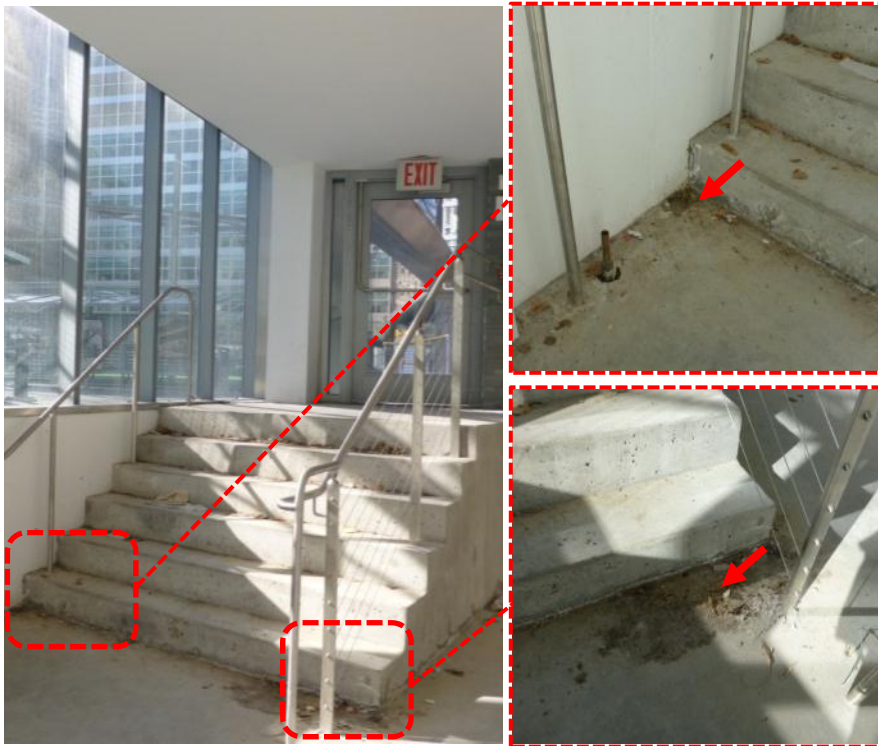
Figure 11. North stair of Center Courtyard depicted above. Note staining at bottom of stair on each end (arrows).

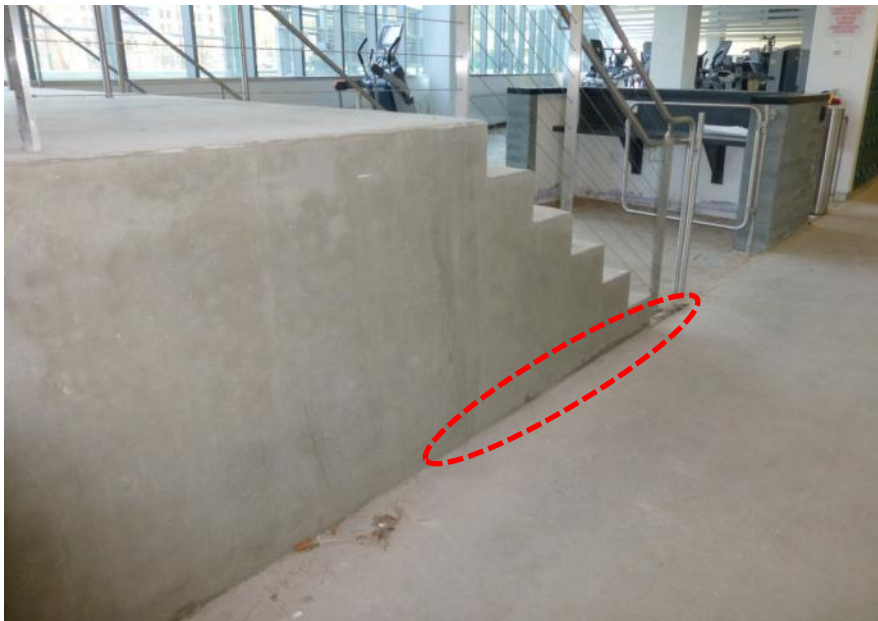
Figure 12. Staining at slab-to-wall interface at the gym floor. South stair shown above.

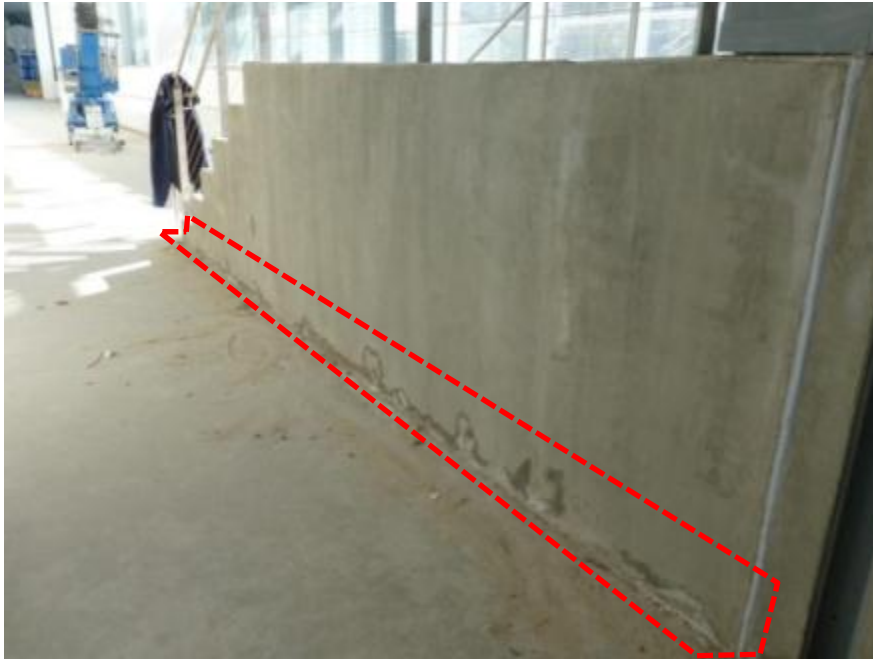
Figure 13. Staining noted at the slab-to-wall interface at the north stair of the Center Courtyard.

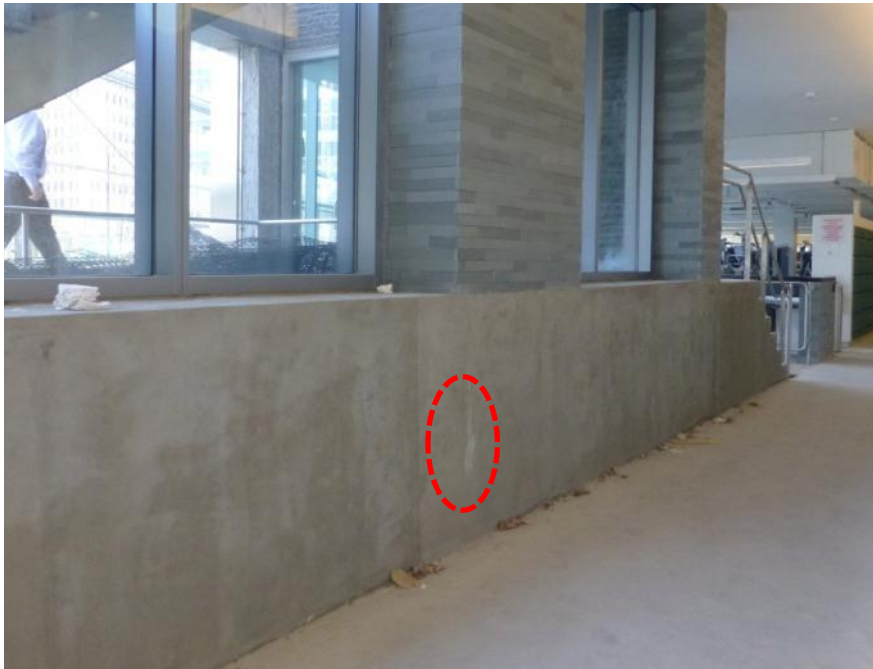
Figure 14. Staining observed at localized areas of the knee wall.

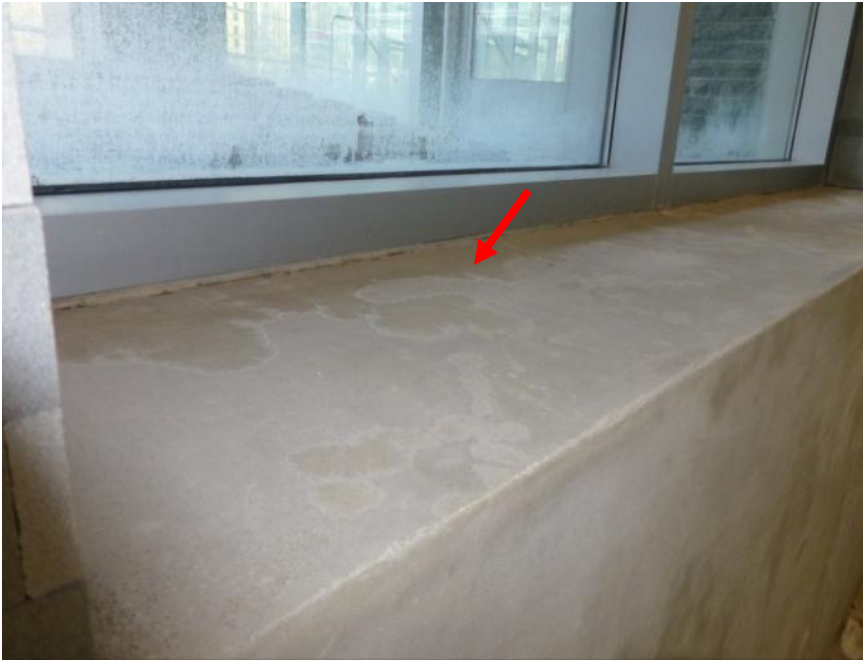
Figure 15. Water staining noted below storefront window. Noted at three east facing storefront windows of Center Courtyard location (arrow).

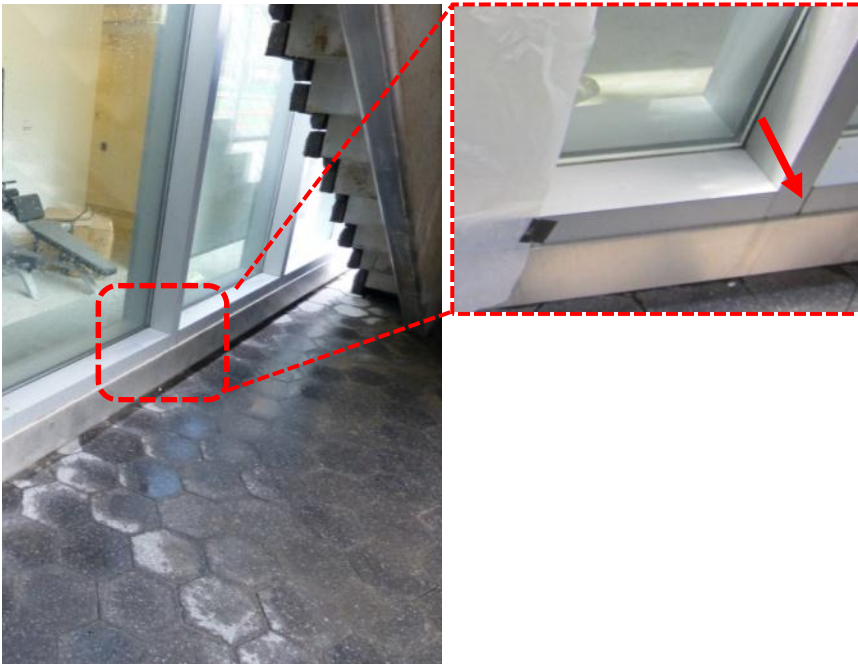
Figure 16. Large gaps observed between the horizontal and vertical frame members.

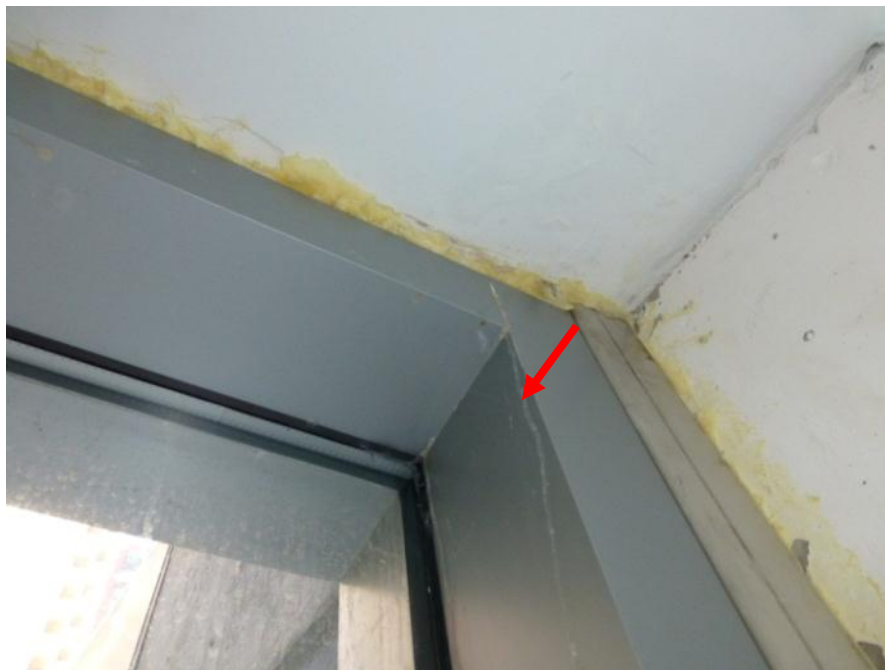
Figure 18. Water stains observed emanating from the storefront window framing joint at the window head and extending down the vertical mullion (arrow).

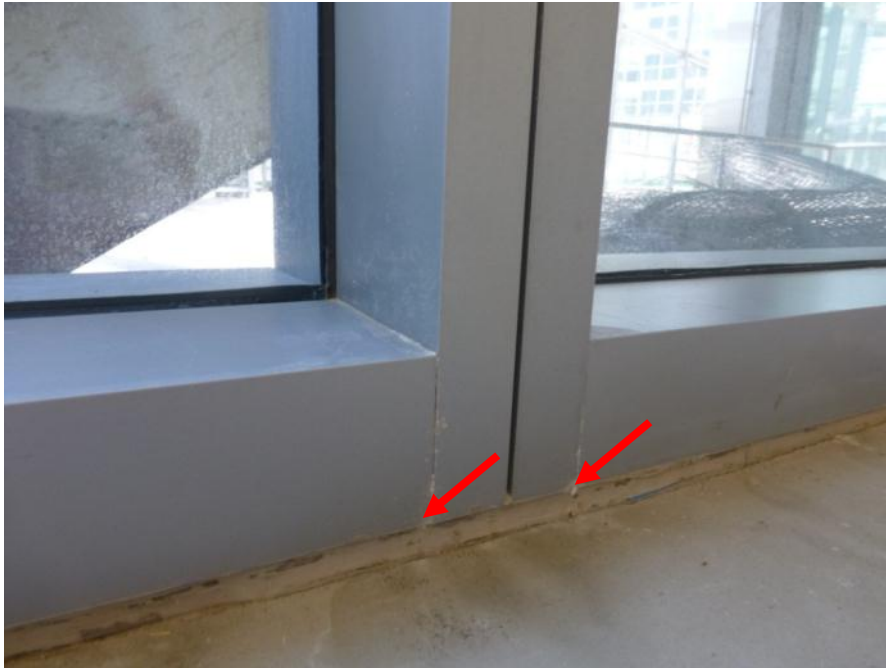
Figure 19. Note evidence of efflorescence leeching out of framing joints of storefront window (arrows).

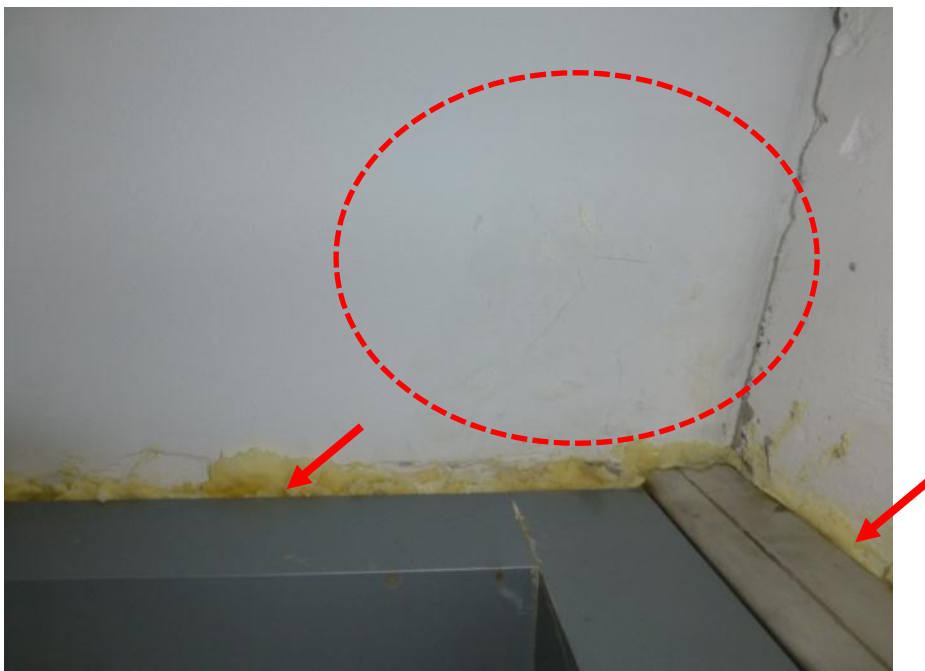
- Spray foam insulation was observed to be installed at select window perimeter locations [Figure 20].

Figure 20. Damages at existing plaster finish at ceiling. Note the use of spray foam insulation at window perimeter (arrows).

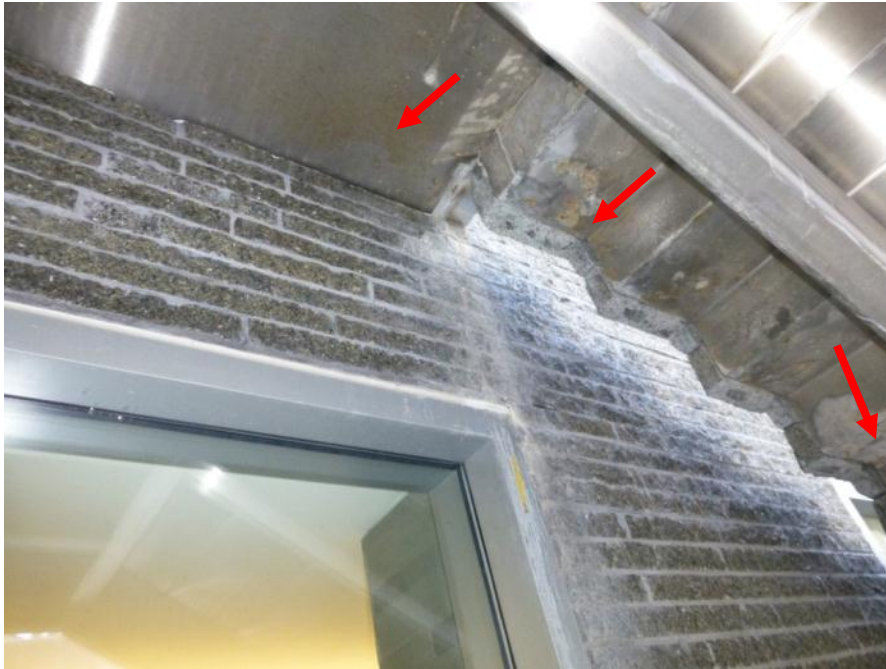
Figure 27. Staining (ferrous and efflorescence) observed at stainless steel armature of stair (arrows).

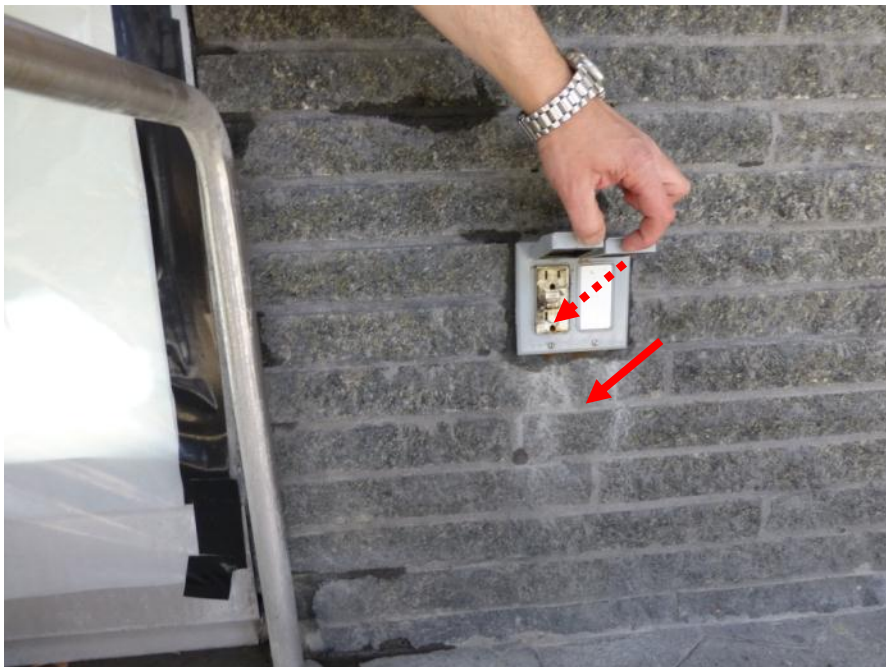
Figure 28. Note corrosion at electrical box (dashed arrow) and evidence of efflorescence (solid arrow).

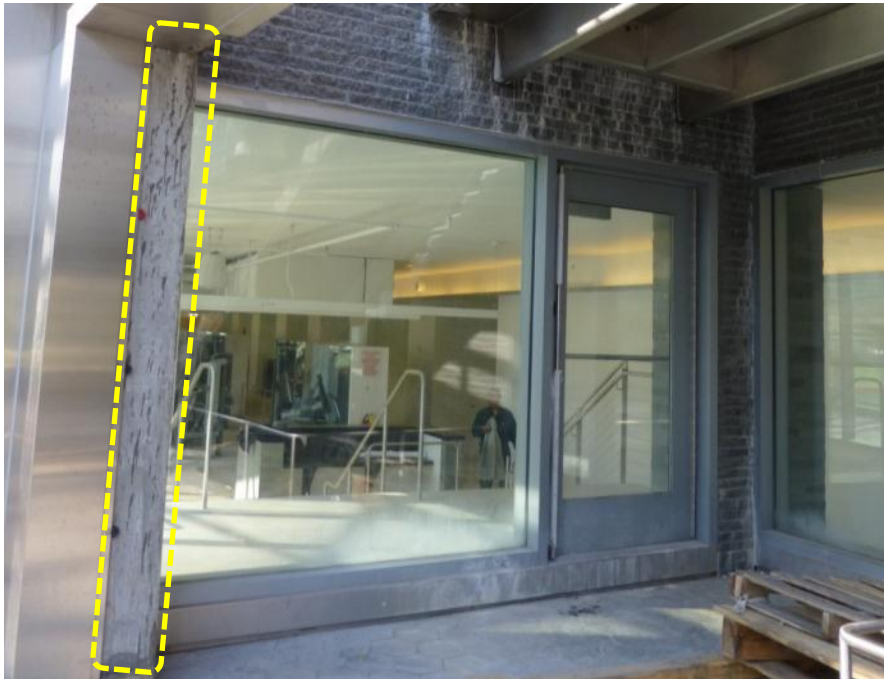
Figure 29. Note missing metal panel at south column of Center Courtyard.

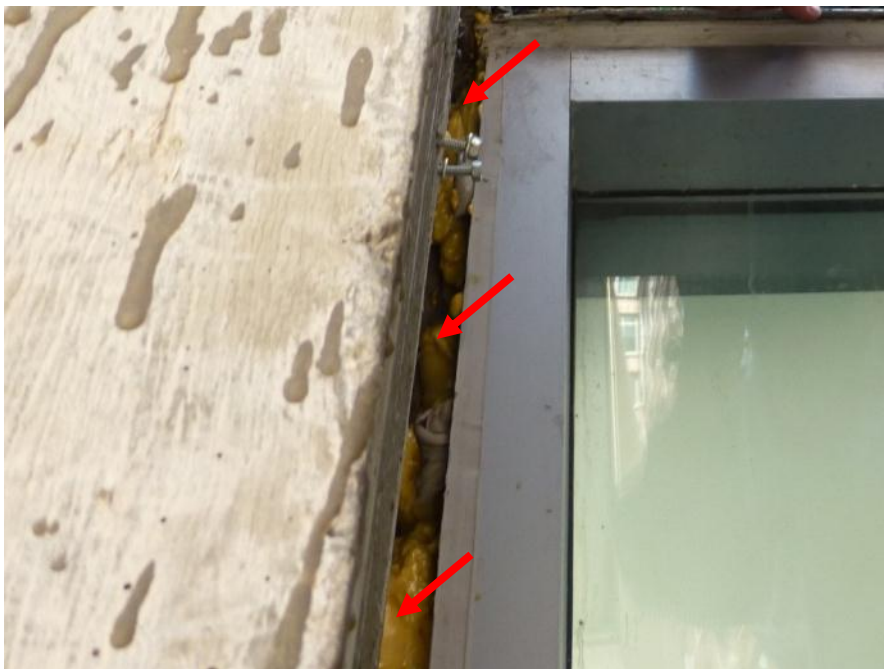
Figure 30. Spray foam insulation filling a large void was observed at the window jamb (arrows).

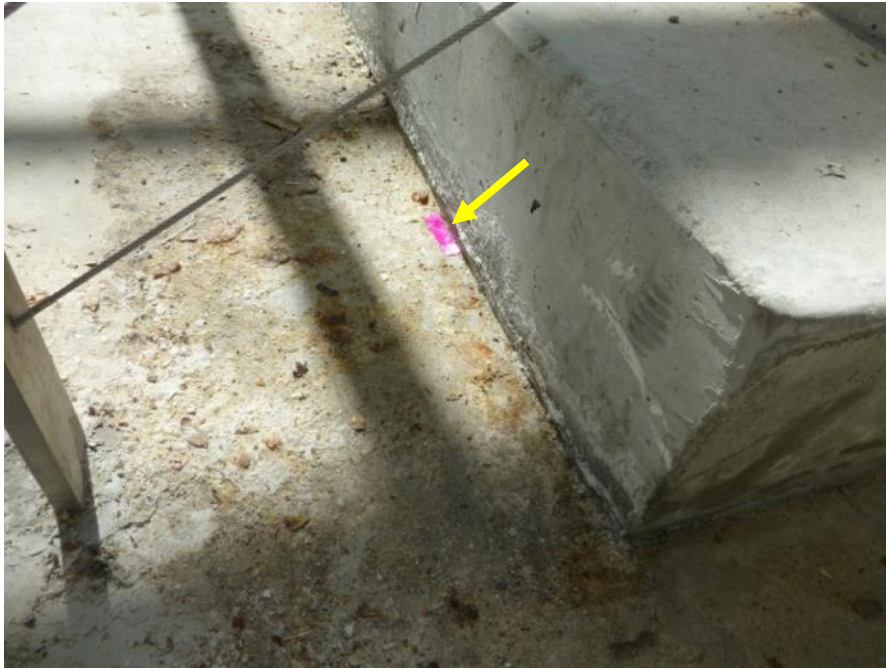
Figure 35. Leak detected at bottom of step within 30 minutes of running test apparatus (arrow).

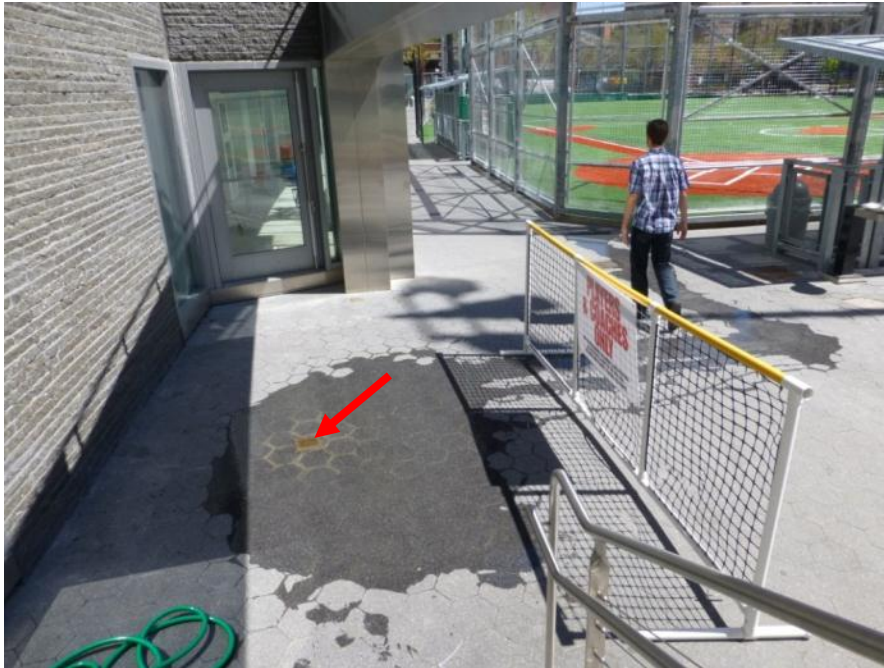
Figure 37. Drain observed to be discharging water during Test No. 2. Testing in progress was located at opposite end of drain.

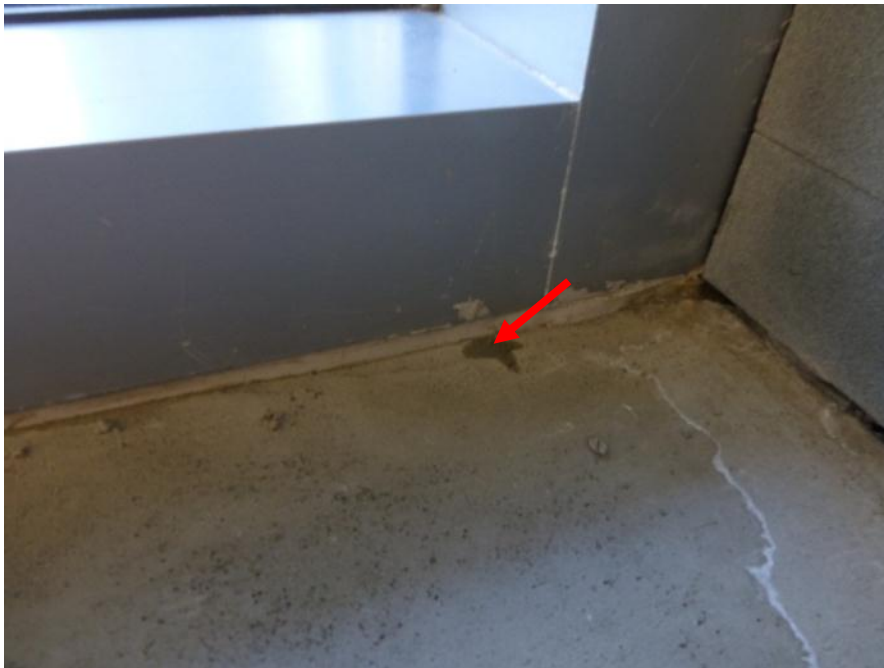
Figure 38. Leak detected at south corner of sill, while spraying at center mullion (arrow) during test no. 3.

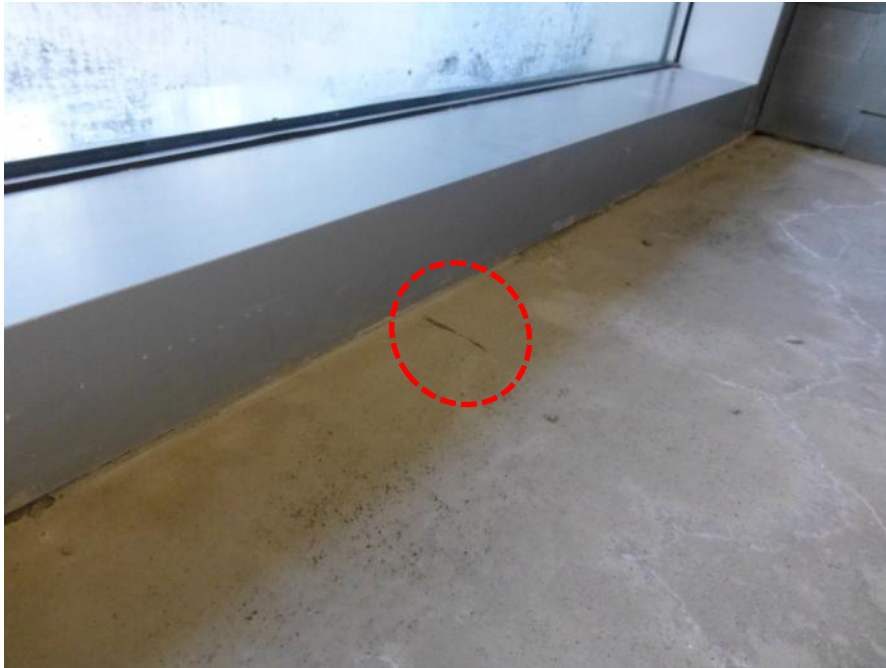
Figure 39. Leak detected at sill, midpoint between south window jamb and center mullion while spraying at north jamb during test no. 3.

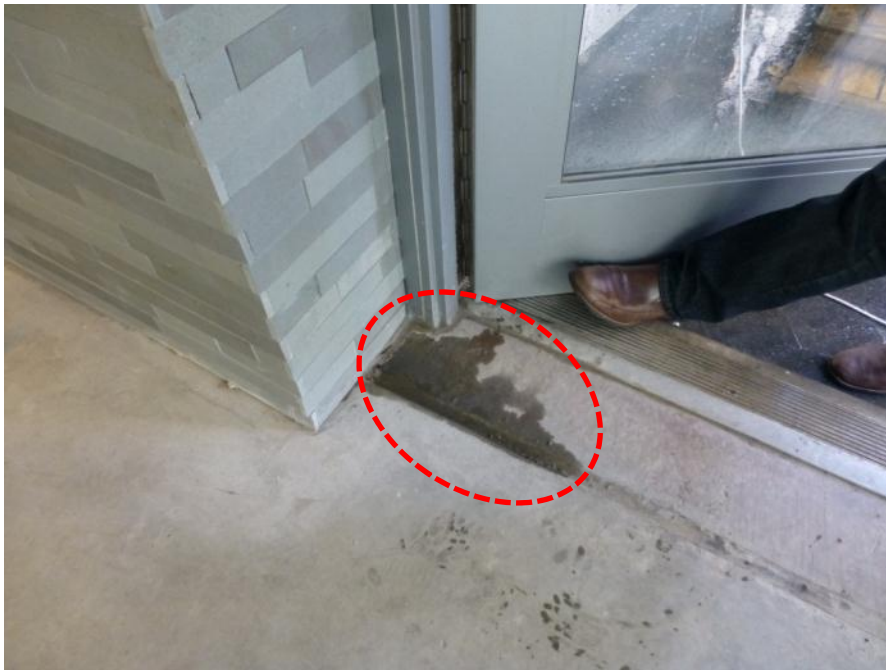
Figure 40. Water intrusion occurred through door threshold while running test no. 4.

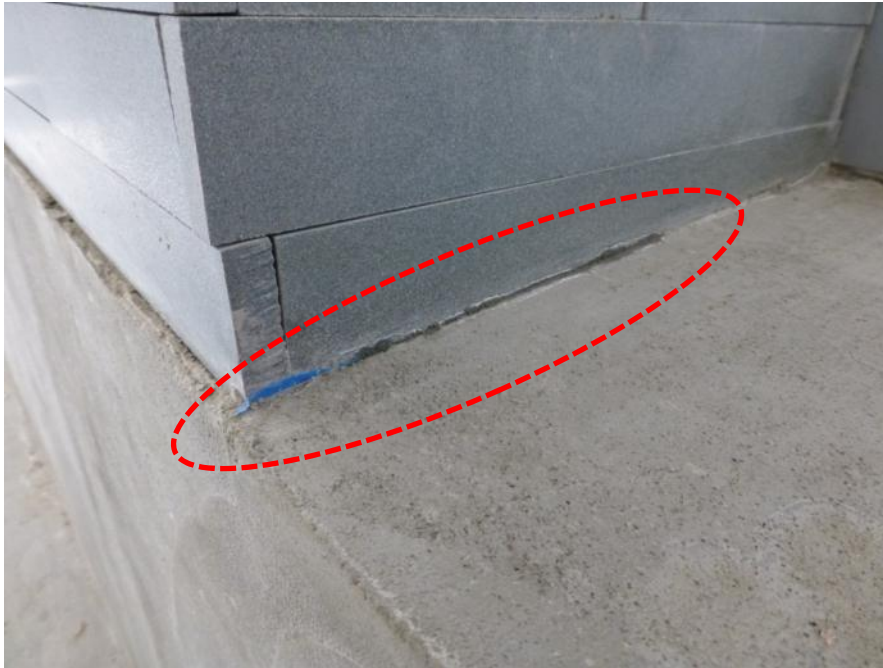
Figure 43. Leak detected at bottom of north column of Storefront No. 2.

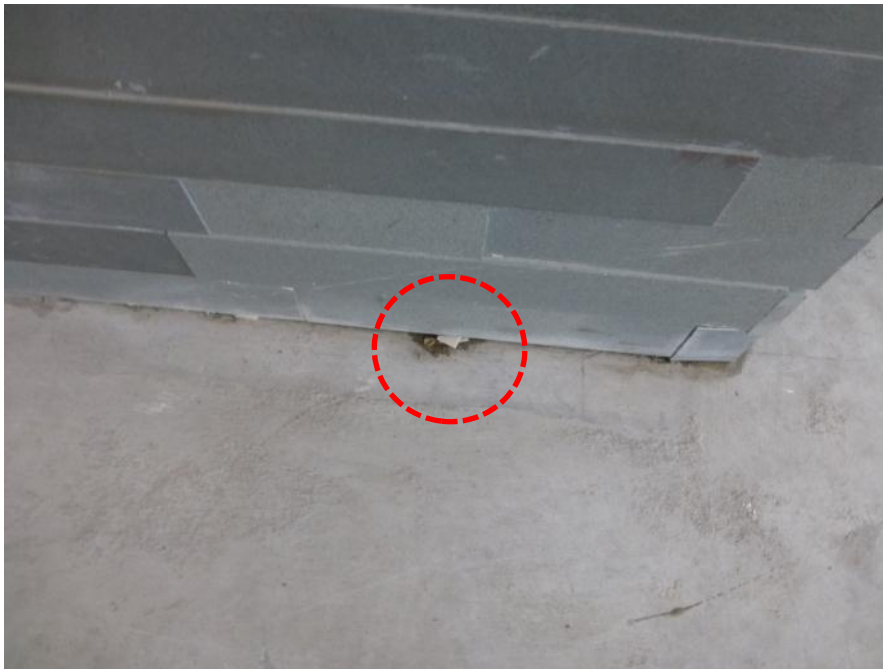
Figure 44. Moisture at the bottom of south column adjacent to south door noted after 75 minutes of into test no. 6.

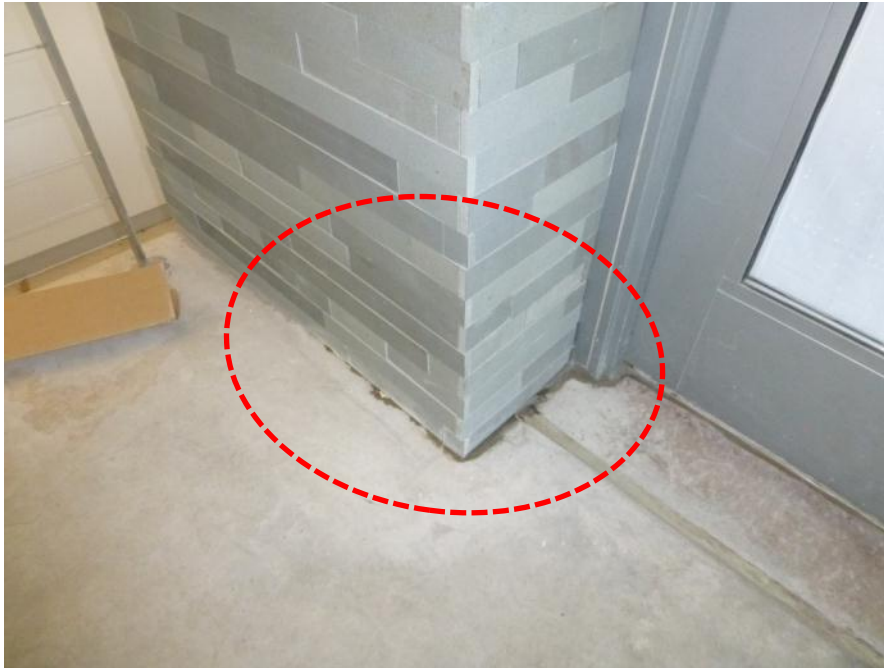
Figure 45. Leak at bottom of south column continued to grow during test no. 7.

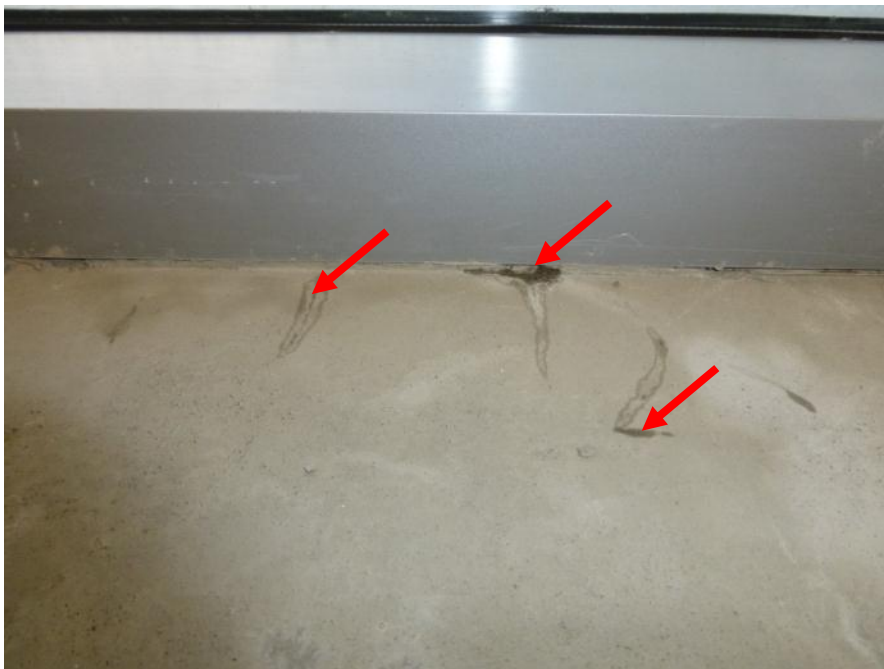
Figure 46. Moisture observed at the center of window sill of Storefront no. 2 during test no. 7 (arrows).
