Project: **200-300 N.E. Leak Remediation
Design**

RE: **Addenda #1**
93 **(# of pages)**
Pages:

Re: 212 North End Avenue
Expansion Joint Investigation
WJE No.PC13.1965

Re: 212 North End Avenue
Leak and Probe Investigation
WJE No.PC13.1965

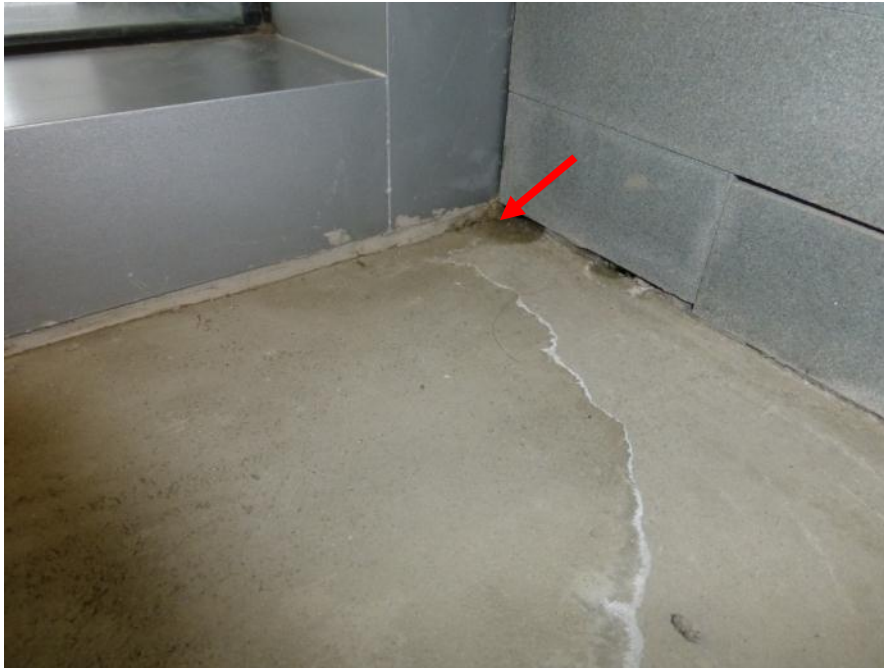
Figure 47. Moisture observed at the corner of window sill of Storefront no. 2 during test no. 7 (arrow).

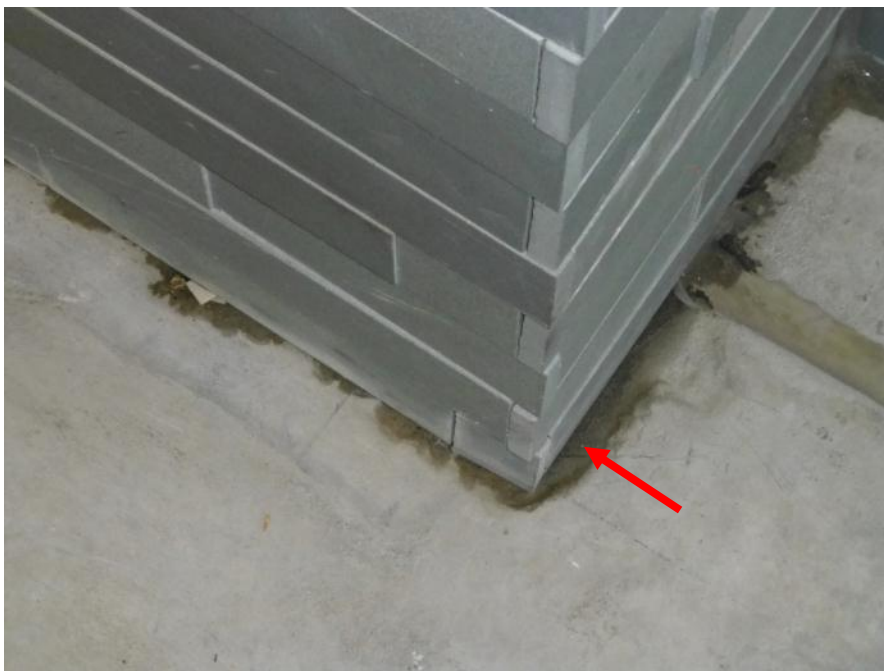
Figure 48. Leak at bottom of south column adjacent to south door grew while running test no. 8 (arrow).

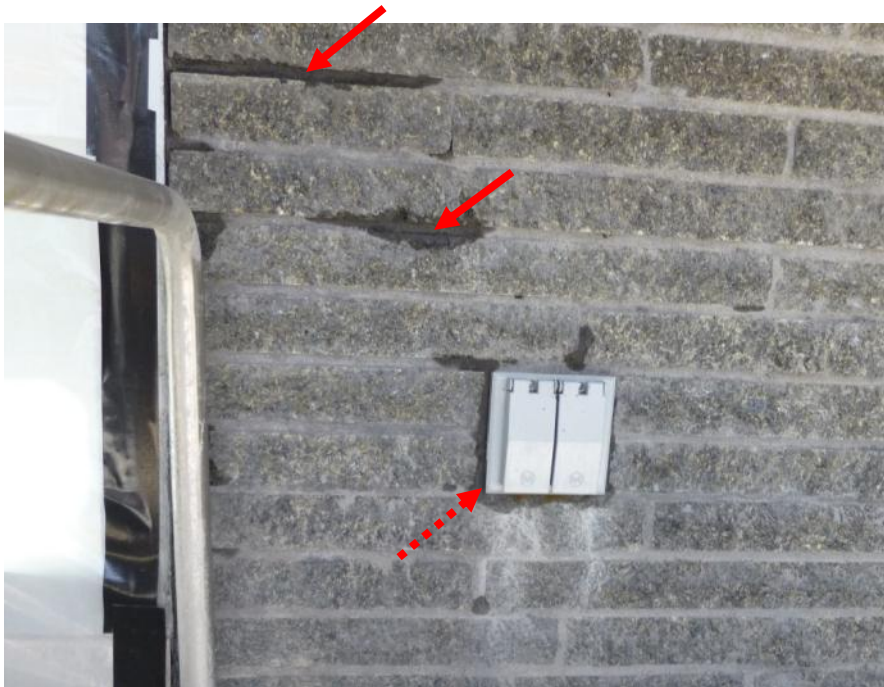
Figure 50. After approximately 15 minutes of running test no. 9, moisture was noted at the mortar joints of the brick cladding (arrows) and perimeter of electrical box (dashed arrow).

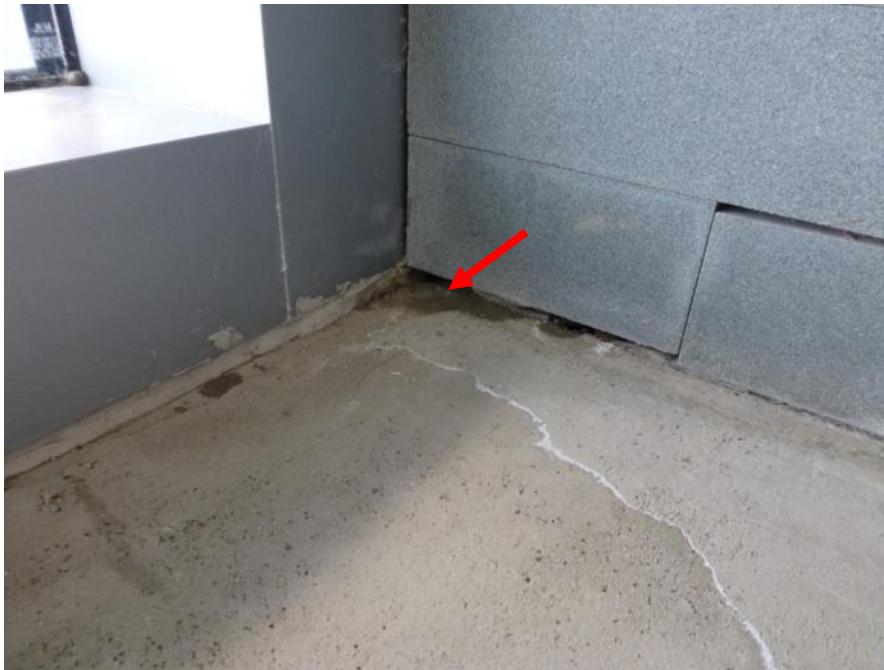
Figure 51. After approximately 90 minutes of running test no. 9, moisture was noted at the sill of Storefront no. 2 (arrow).

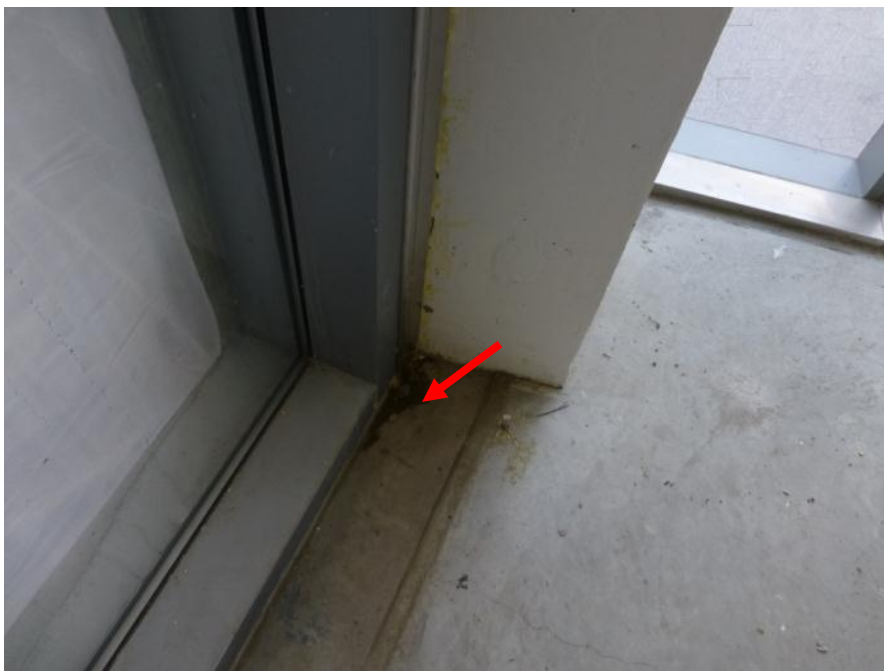
Figure 52. Leak noted after approximately 180 minutes after running test no. 10. East corner of Storefront no. 1 shown above.

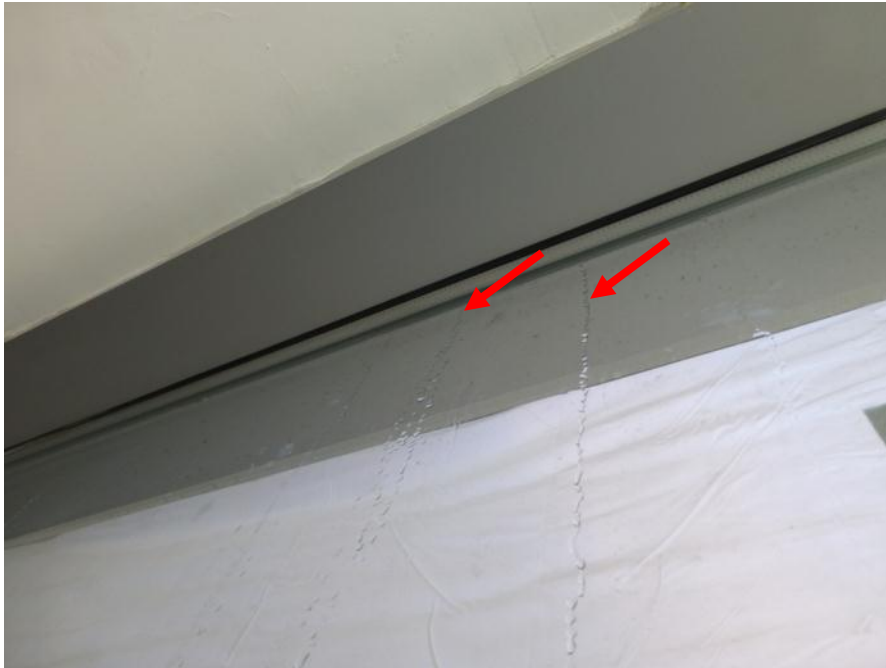
Figure 53. Note water emanating from glass-to-frame interface at approximately 140 minutes during test no. 10.

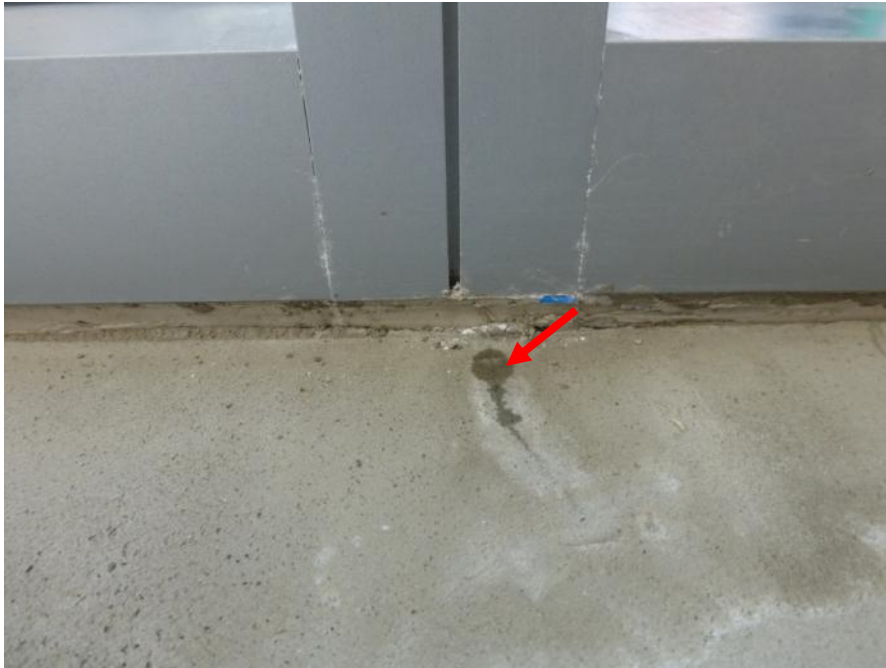
Figure 55. Moisture noted at jamb of Storefront no. 3 after approximately 18 minutes of running test no. 11 (arrow).

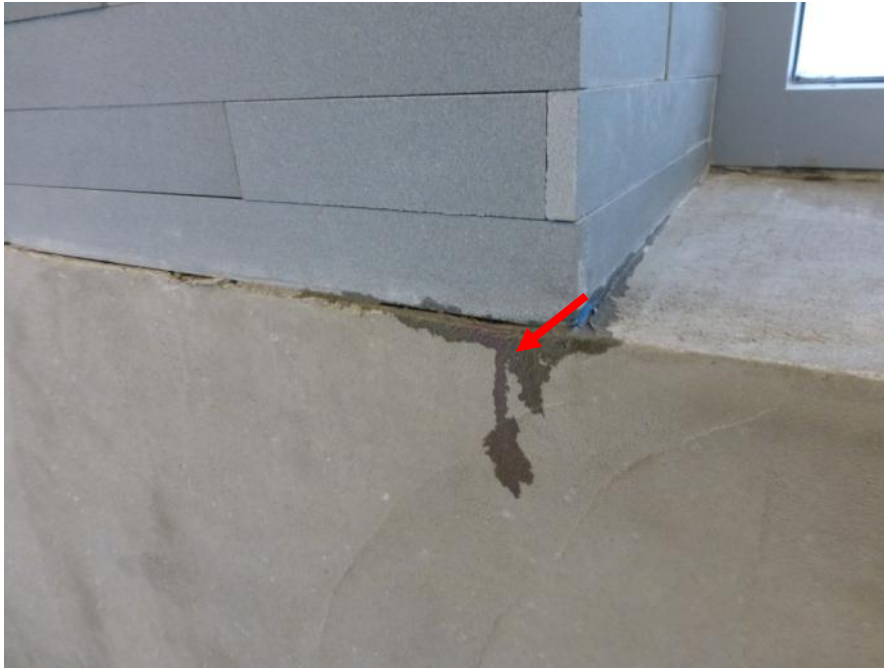
Figure 57. Moisture noted during test no. 13 at north column of Storefront no. 2 (arrow).

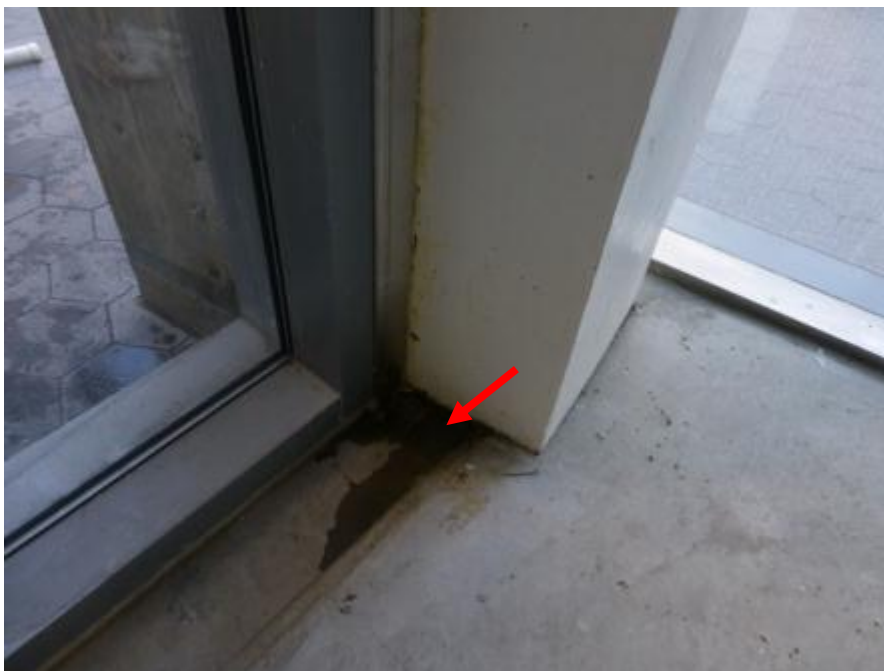
Figure 58. Leak at east of bottom corner of Storefront no. 1 continued to grow during test (arrow).

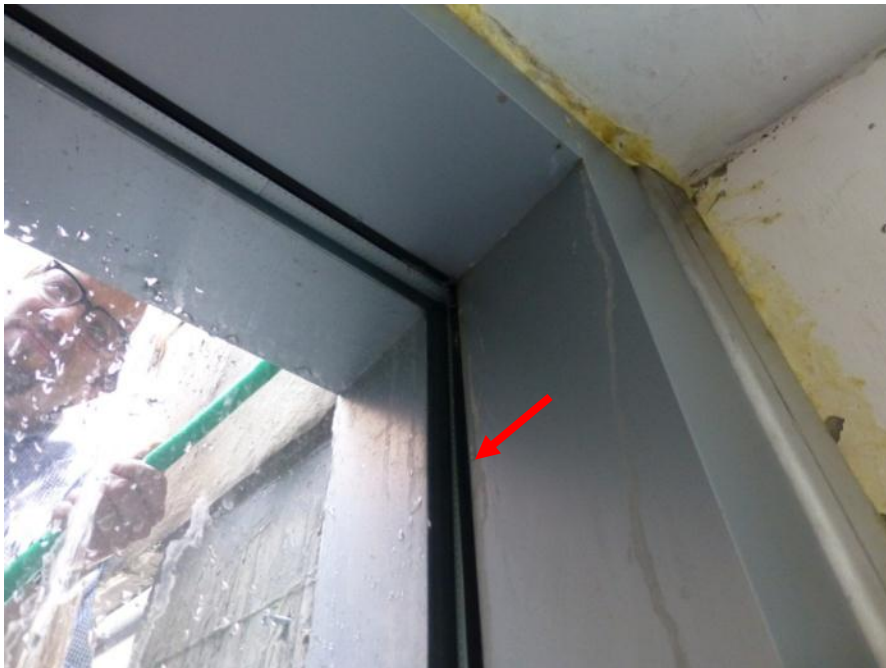
Figure 60. Note water running down aluminum frame (arrow).

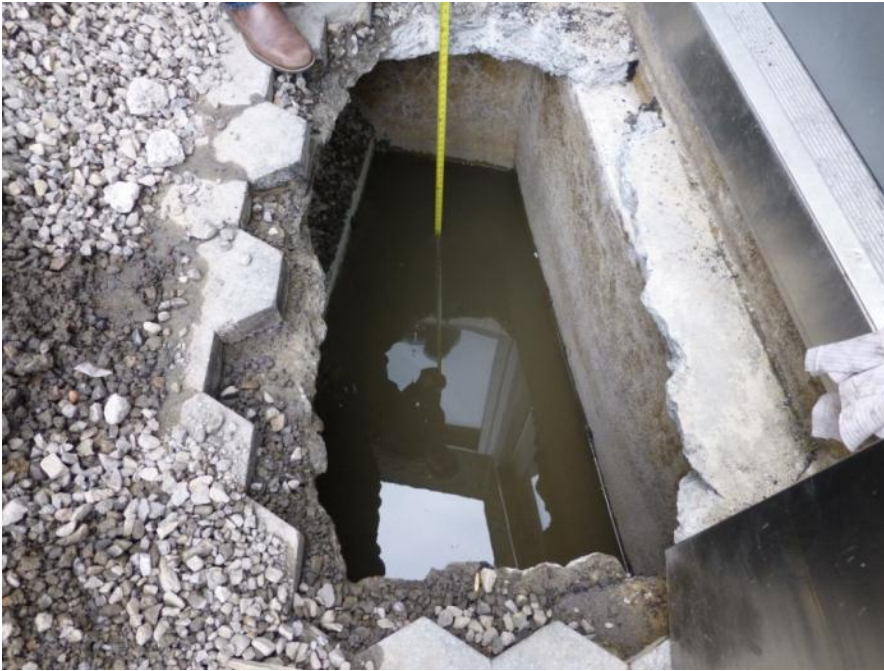
Figure 66. Standing water as observed on May 14, 2013.

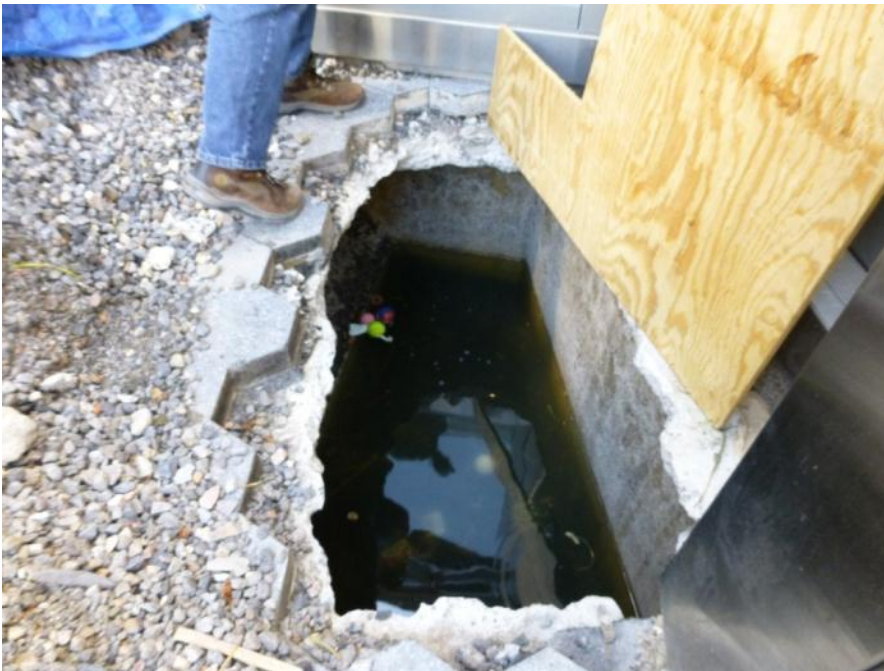
Figure 67. Standing water as observed on June 4, 2013.

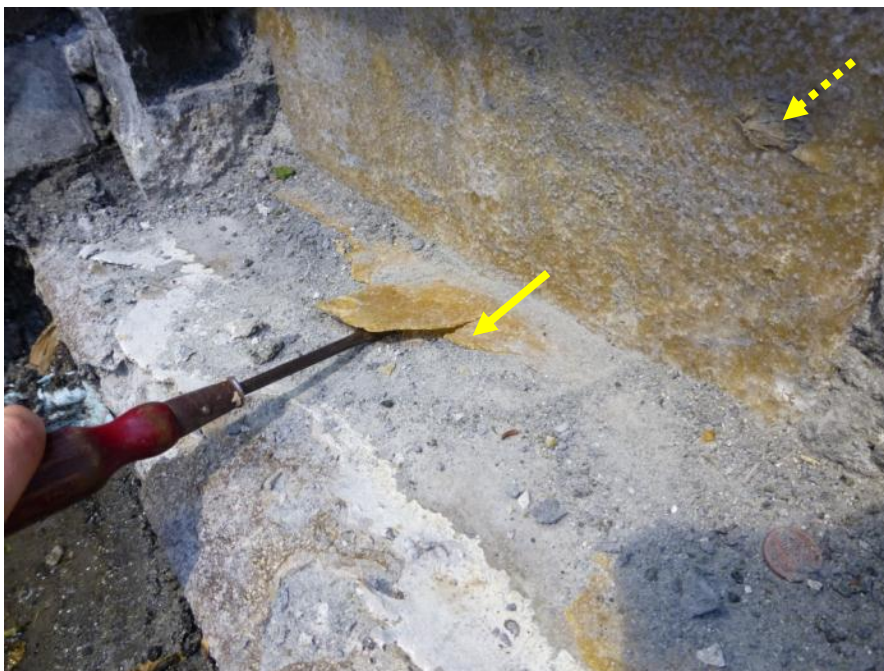
Figure 69. Kemper installed at CMU block wall was observed to be brittle and delaminating from the substrate (solid arrow). It also contained voids (dashed arrow).

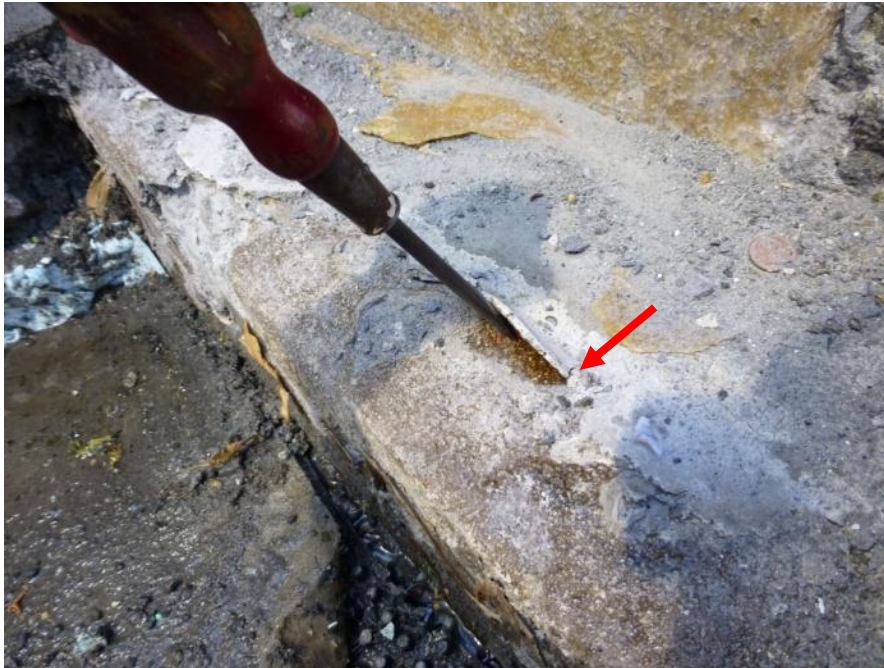
Figure 70. Slurry coat noted to not be bonded to base Kemper installation (arrow).

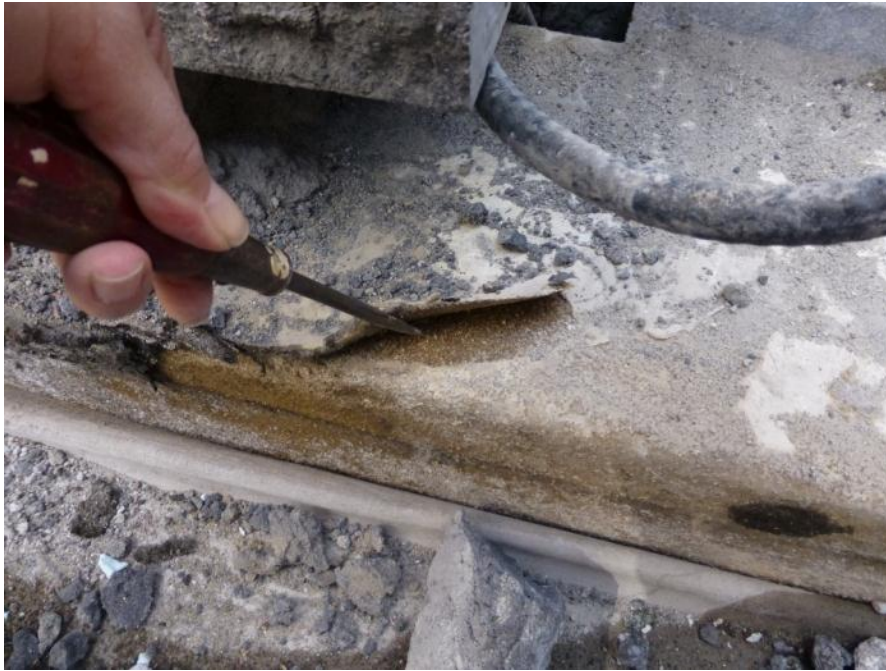
Figure 72. Slurry wall observed at probe location noted to be delaminated from the base Kemper installation.

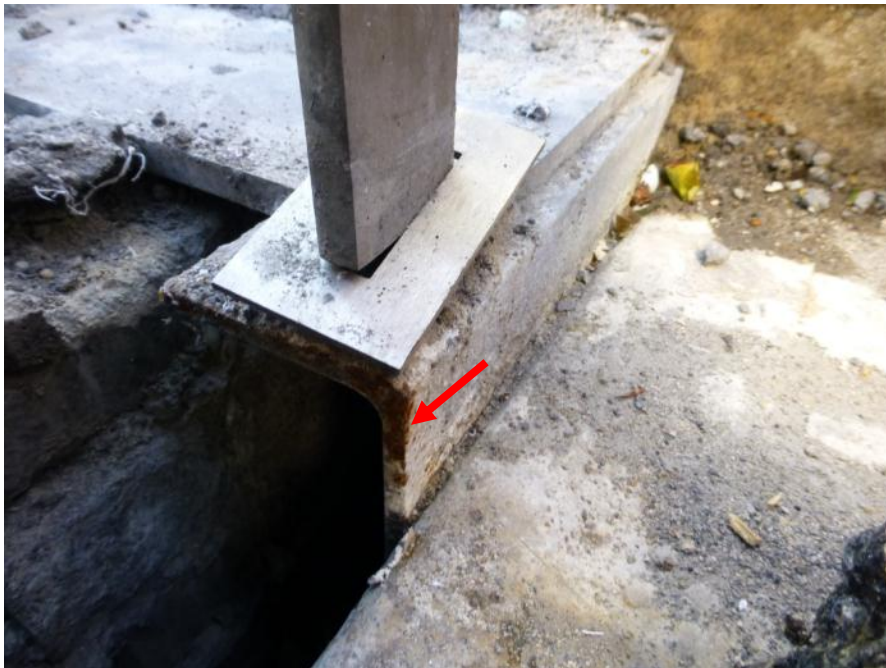
Figure 73. Corrosion noted at angle at stairway intersection (arrow).

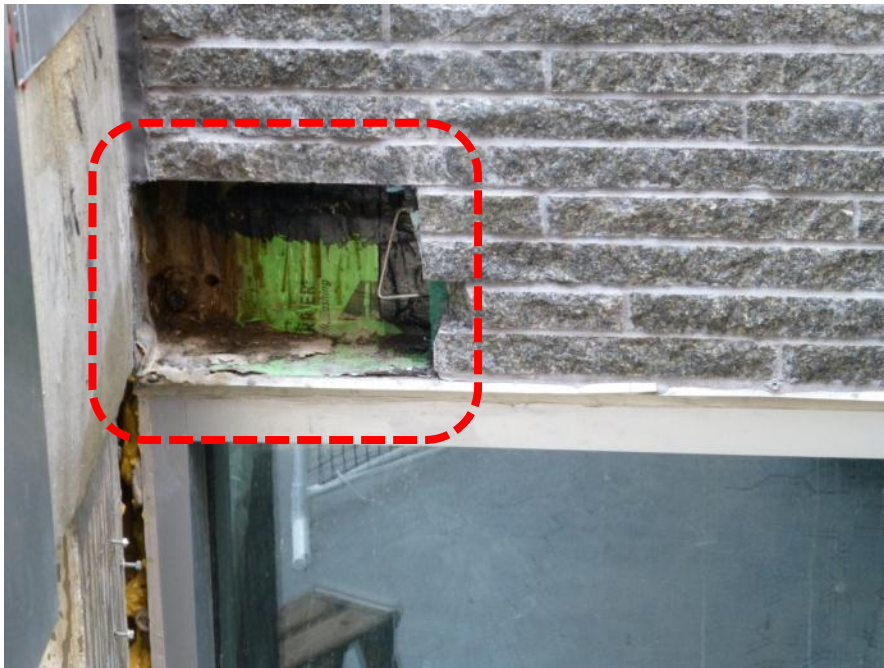
Figure 75. Probe #4 taken at window head condition and at window-wall condition above.

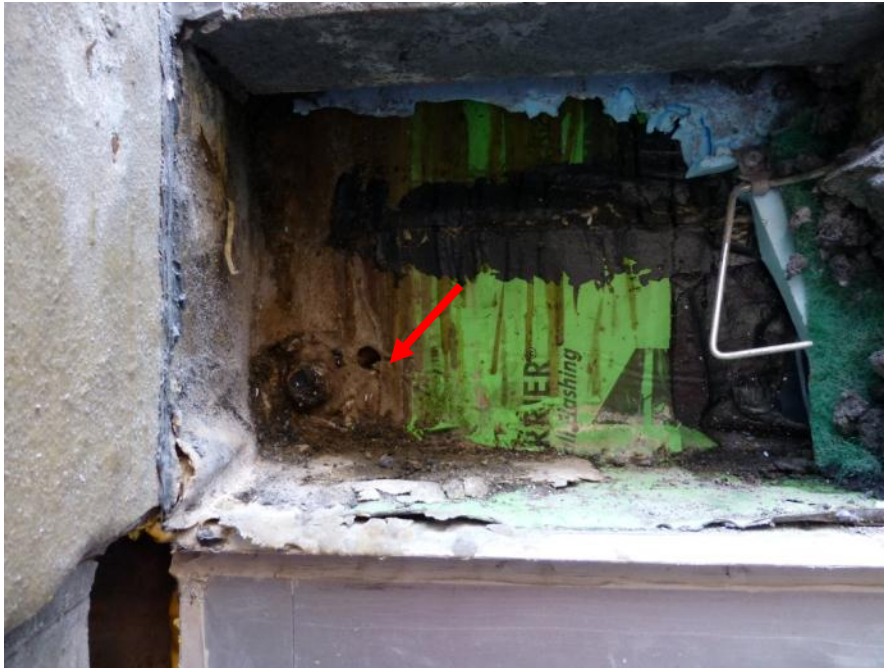
Figure 76. Hole noted in the Grace Perma Barrier membrane (arrow). It appeared that the void at the location was also at the lintel.

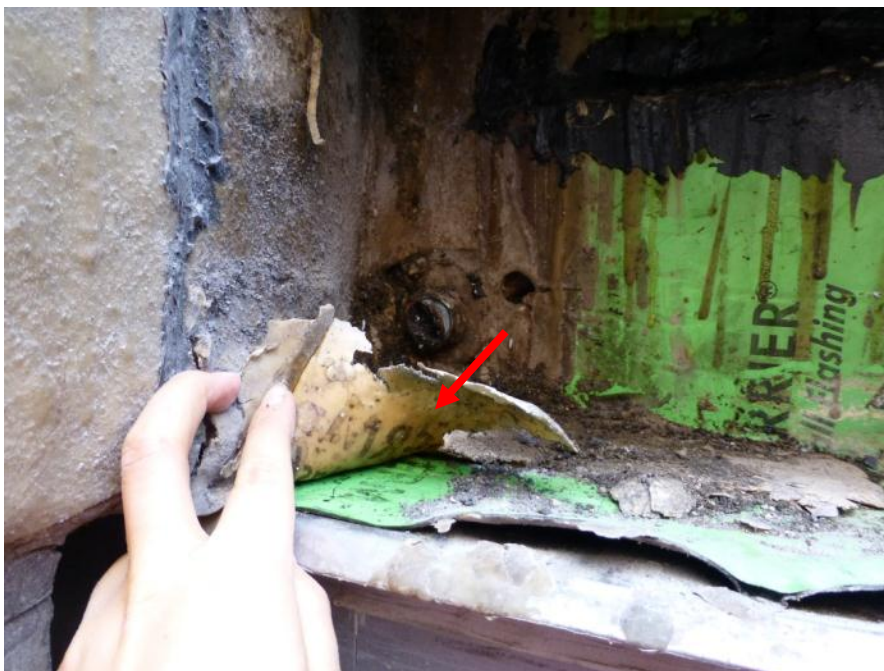
Figure 77. Delaminated Kemper membrane at tie-in location (arrow).

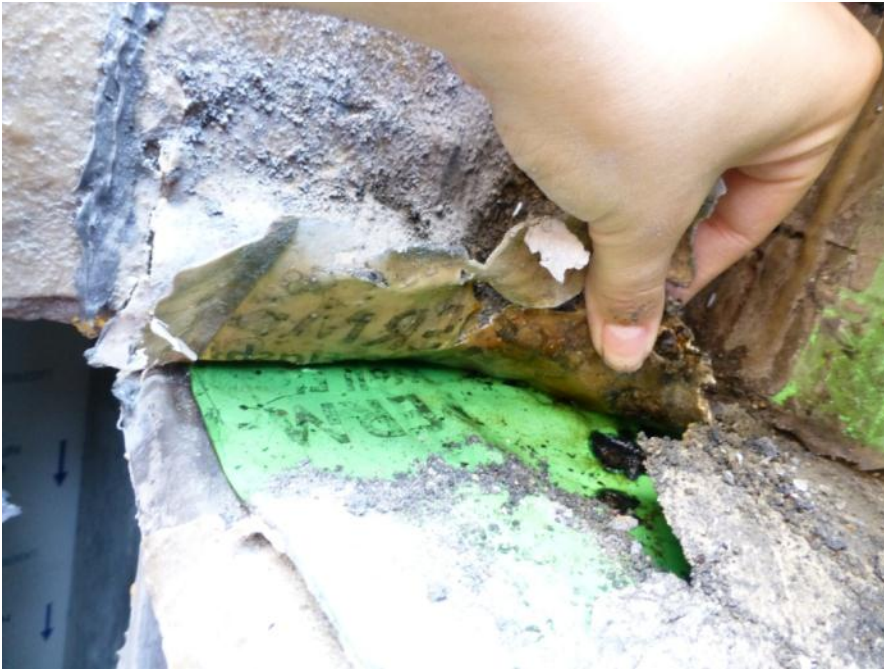
Figure 78. Moisture noted underneath the Kemper.

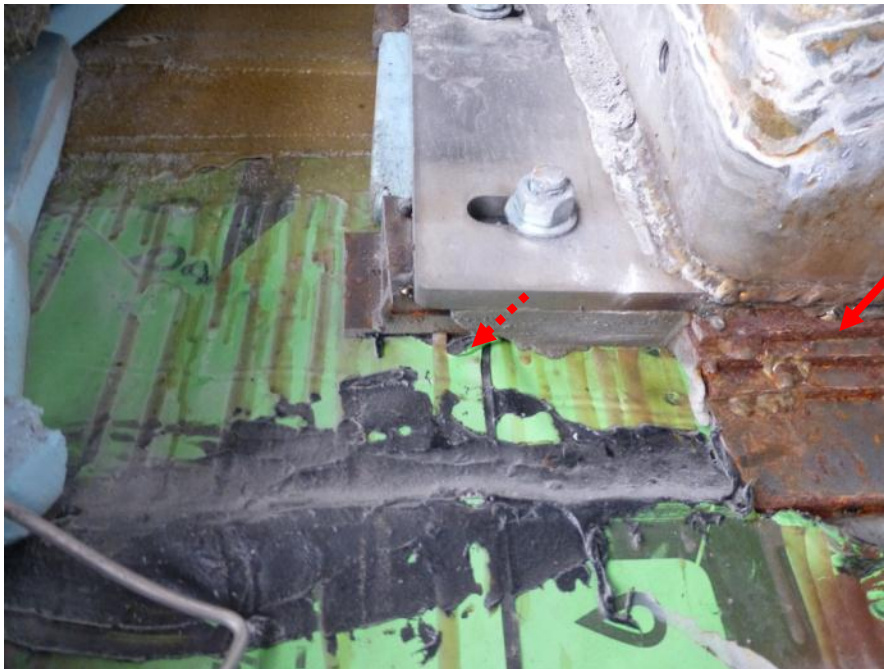
Figure 81. Corroded shims and fasteners at stair beam / wall intersection (solid arrow) and breach in the waterproofing at a shim (dashed arrow).

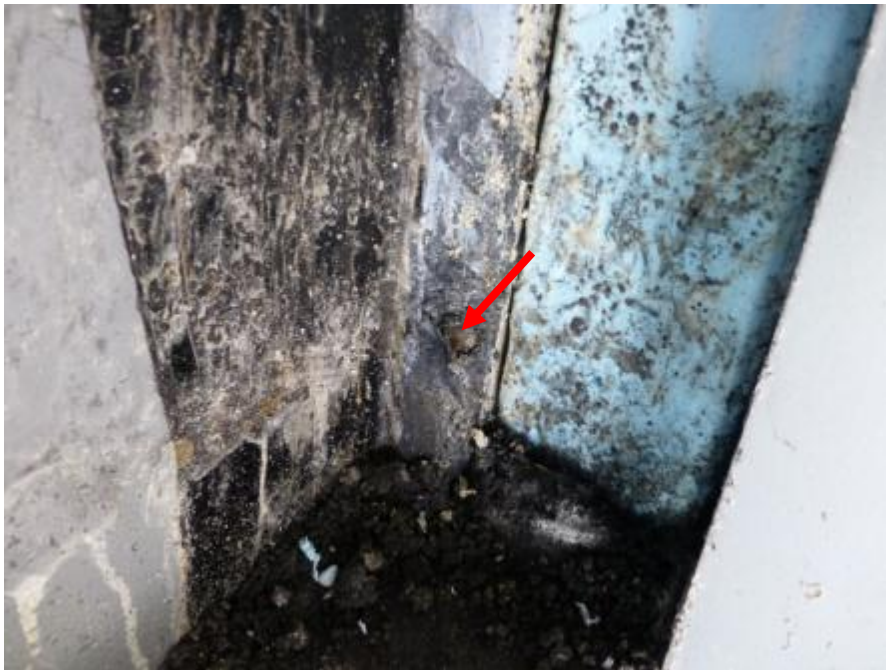
Figure 83. Openings noted in the flashing membrane that exhibited moisture underneath.

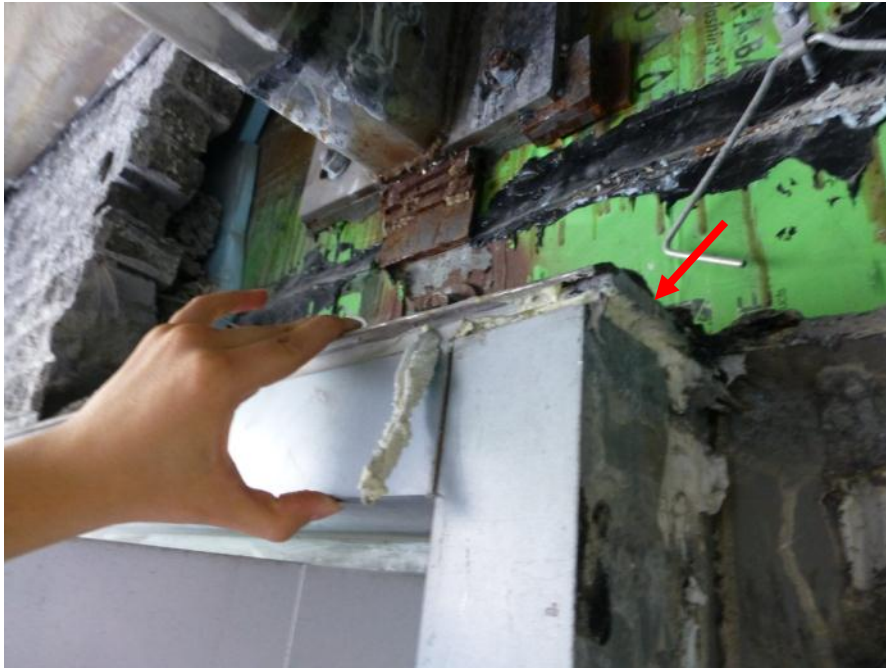
Figure 84. The metal flashing above the south door at probe location #5 did not have any end dams (arrow).

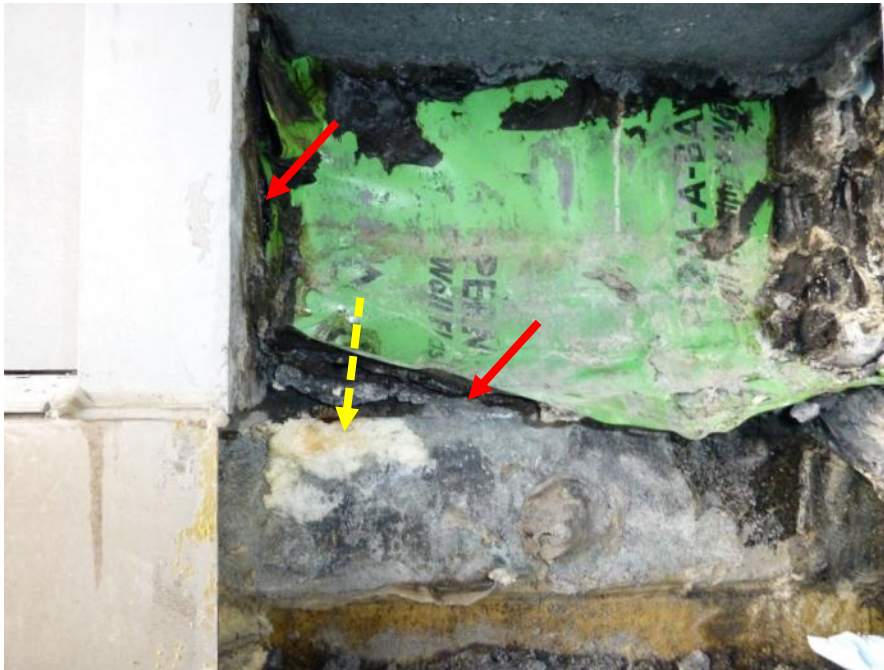
Figure 86. Perm-A-Barrier noted to be delaminated at door jamb and base of wall at Probe #6 location (solid red arrows). Note corrosion at angle (yellow dashed arrow)

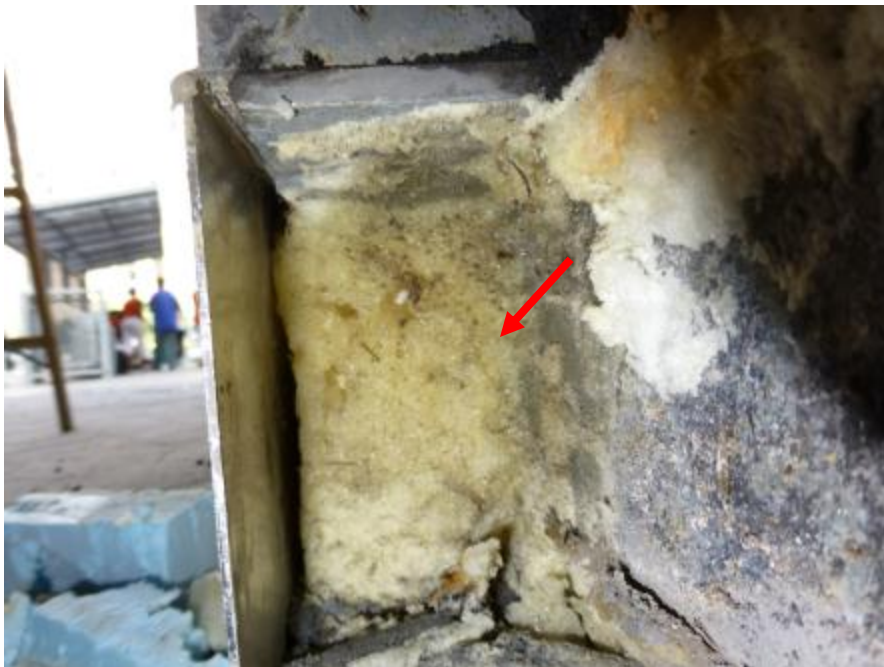
Figure 87. Note spray foam insulation behind metal panel.
