Project:	Phase 4 Pile Remediation North Cove Marina	Date:	May 22, 2015
Engineer:	McLaren Engineering Group	RE:	Addendum #1
		# of Pages:	16

Caisson Repair Scope of Work

Re: Area 2 Repair Condition Inspection
Battery Park City, New York
MEG File No. 130870
Phase 10

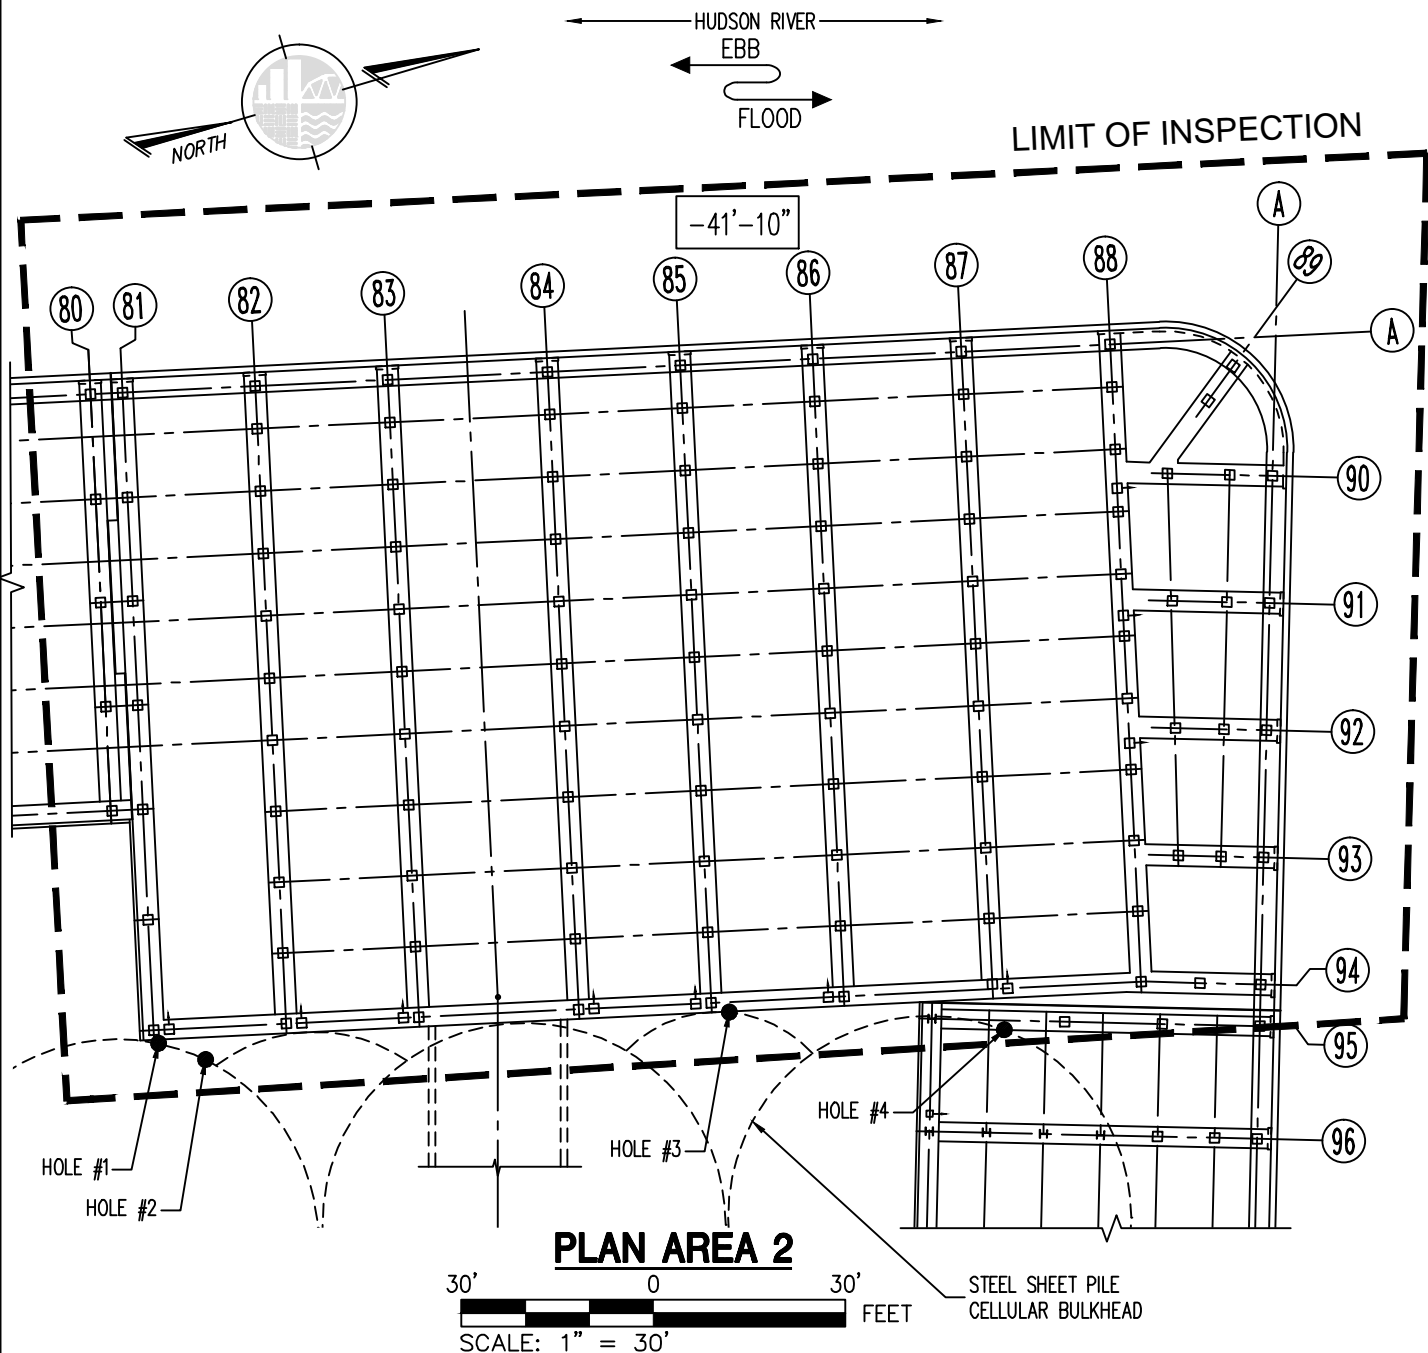
SHEET TITLE
**BACKWALL INSPECTION PLAN
AREA-2**

1. Bent 81 – Hole in sheeting 2.4' above the riprap, 8"H x 3"W located directly behind the pile bent at the first sheet north of the concrete bulkhead. (see Photo 3)
2. Bent 81 – Hole in sheeting 2.8' above the riprap, 1'H x 8"W located at 3rd sheet north of the concrete bulkhead.

3. Bent 85 – Hole in the sheeting approximately 3' above the riprap, 3"H x 1"W located directly behind the pile bent.
4. Bent 87 – Hole in sheeting approximately 2' above the riprap 9"H x 5"W with a void 2' +/- deep caused by active fill loss. This hole is located roughly 5' north of the bent centerline. (see Photo 4)

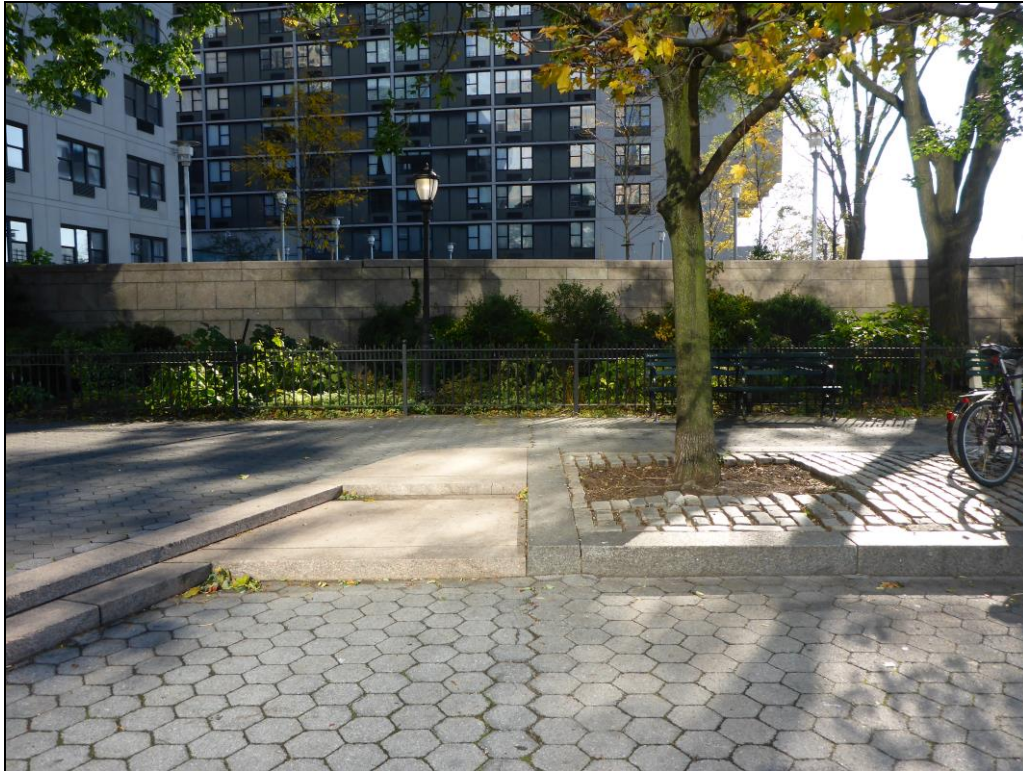
Though the inspection of the bulkhead was not explicitly part of the scope, MEG performed a brief visual inspection in an attempt to determine the source of the observed sinkholes. The area of concern was identified by BPCA as two sinkholes and an area of masonry retaining wall exhibiting settlement at the southeast corner of the esplanade near the bottom of the steps south of the volleyball court (see Photos 1 and 2). Typically, the steel sheet pile exhibits moderate to heavy corrosion within the tidal zone. Severe corrosion resulting in holes penetrating the sheeting was noted in the following four (4) locations:

Photo 1 - Esplanade above Bents 80-81. Area of concern identified by BPCA.

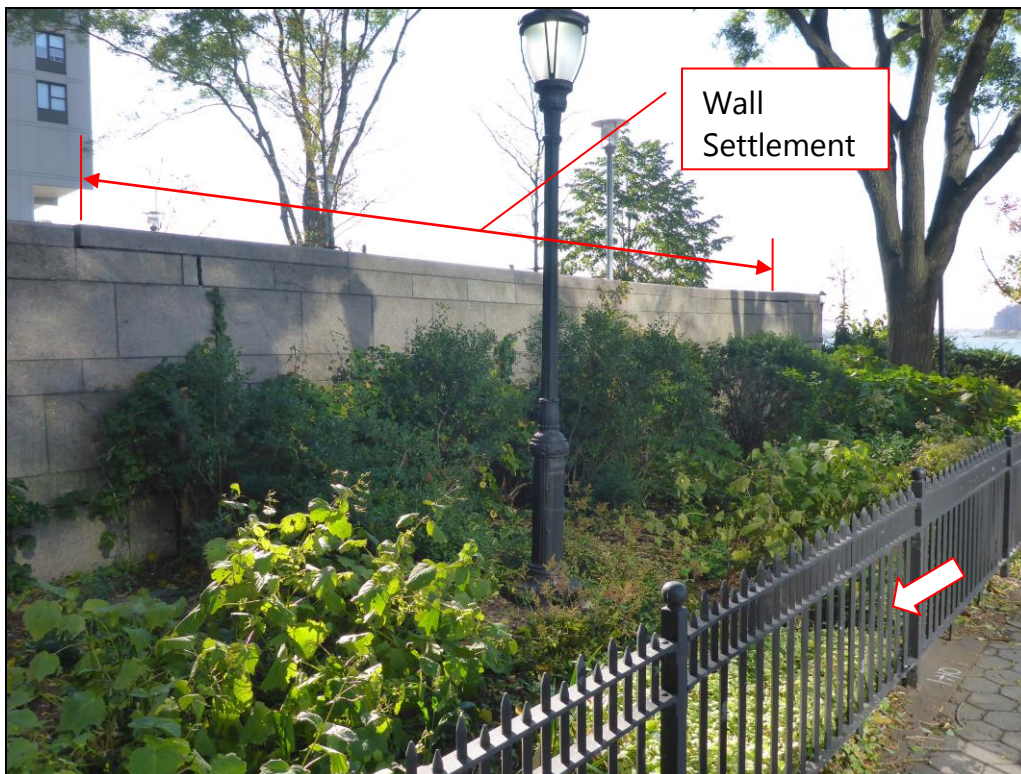
Photo 2 - Esplanade above Bents 80-81. Note settlement of wall and sinkhole (see arrow).

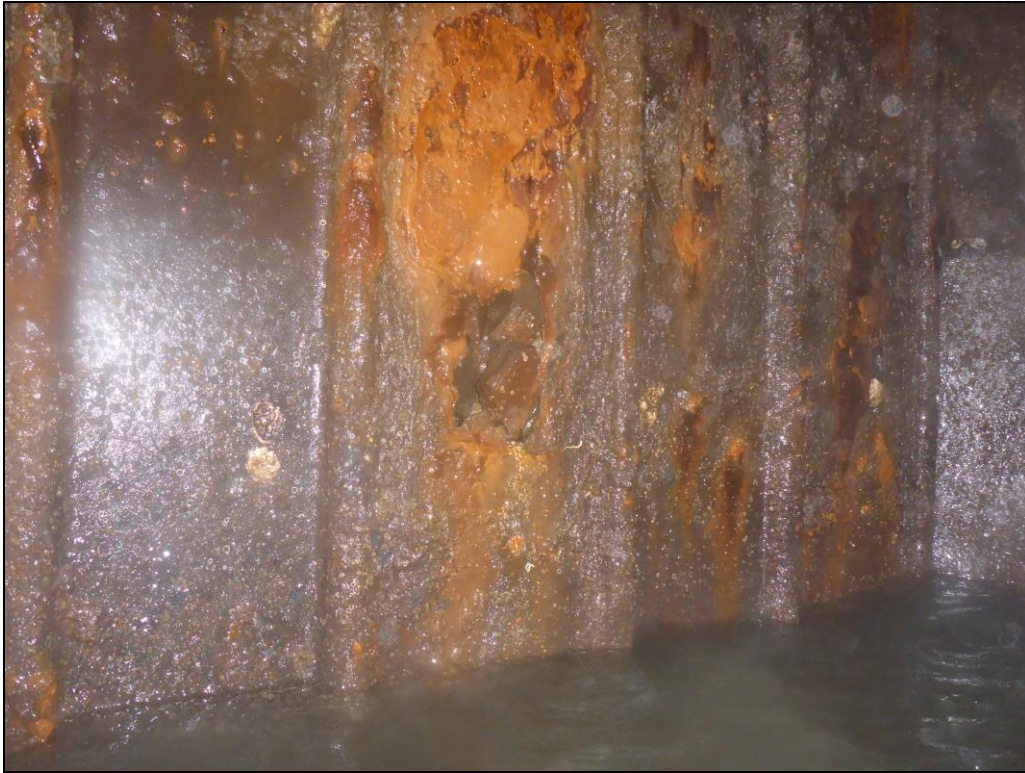
Photo 3 – Holes #1 & 2 in sheeting at Bent 81. Note additional corrosion of steel above hole.

MEG recommends contacting a marine contractor to patch the observed holes in the steel sheeting. The holes may be patched with plate steel of equivalent thickness to the nominal section of the steel sheet pile (currently unknown; the available as-built drawings do not specify). The plates would be welded to the exterior face of the sheeting and then coated with a marine grade epoxy (Splash zone) to protect the weld. Additionally, grout should be pumped under pressure into the voids to prevent or mitigate additional or future subsidence.

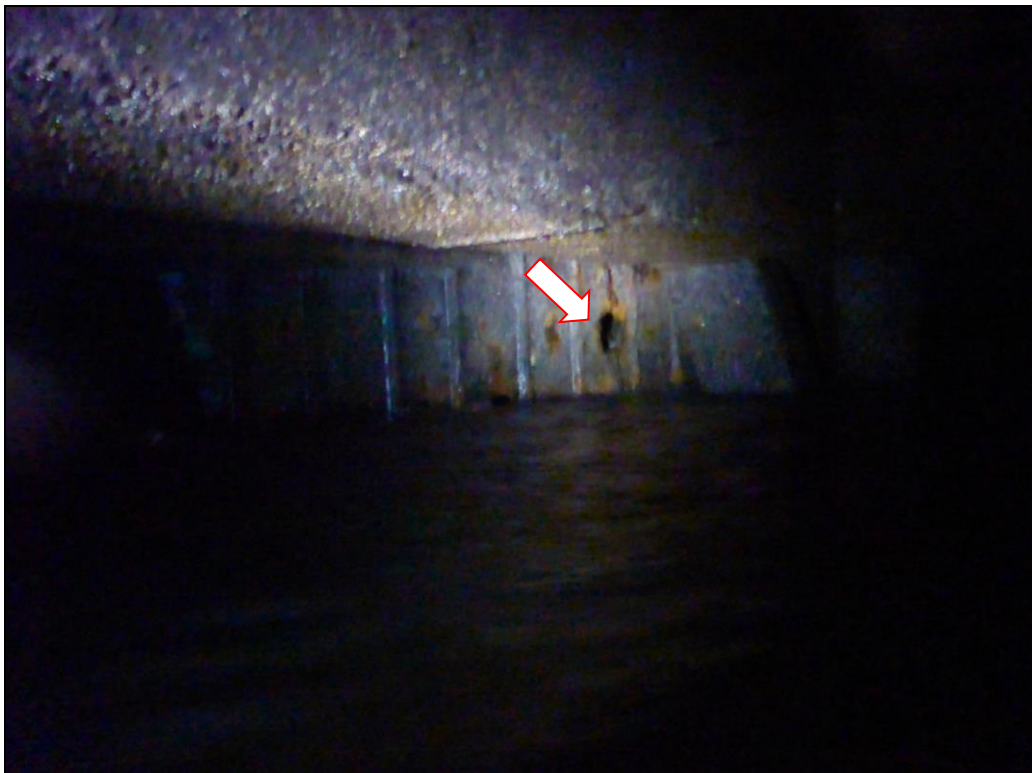
85	Backwall	Hole in sheeting 3' above riprap. 3"H x 1"W located directly behind the pile bent.
87	Backwall	Hole in sheeting 2' above riprap. 9"H x 5"W with a void 2' ± deep caused by active fill loss. Hole is roughly 5' north of the bent line.

Photo 4 - Hole #4 in sheeting at Bent 87, void with fill loss visible during inspection.

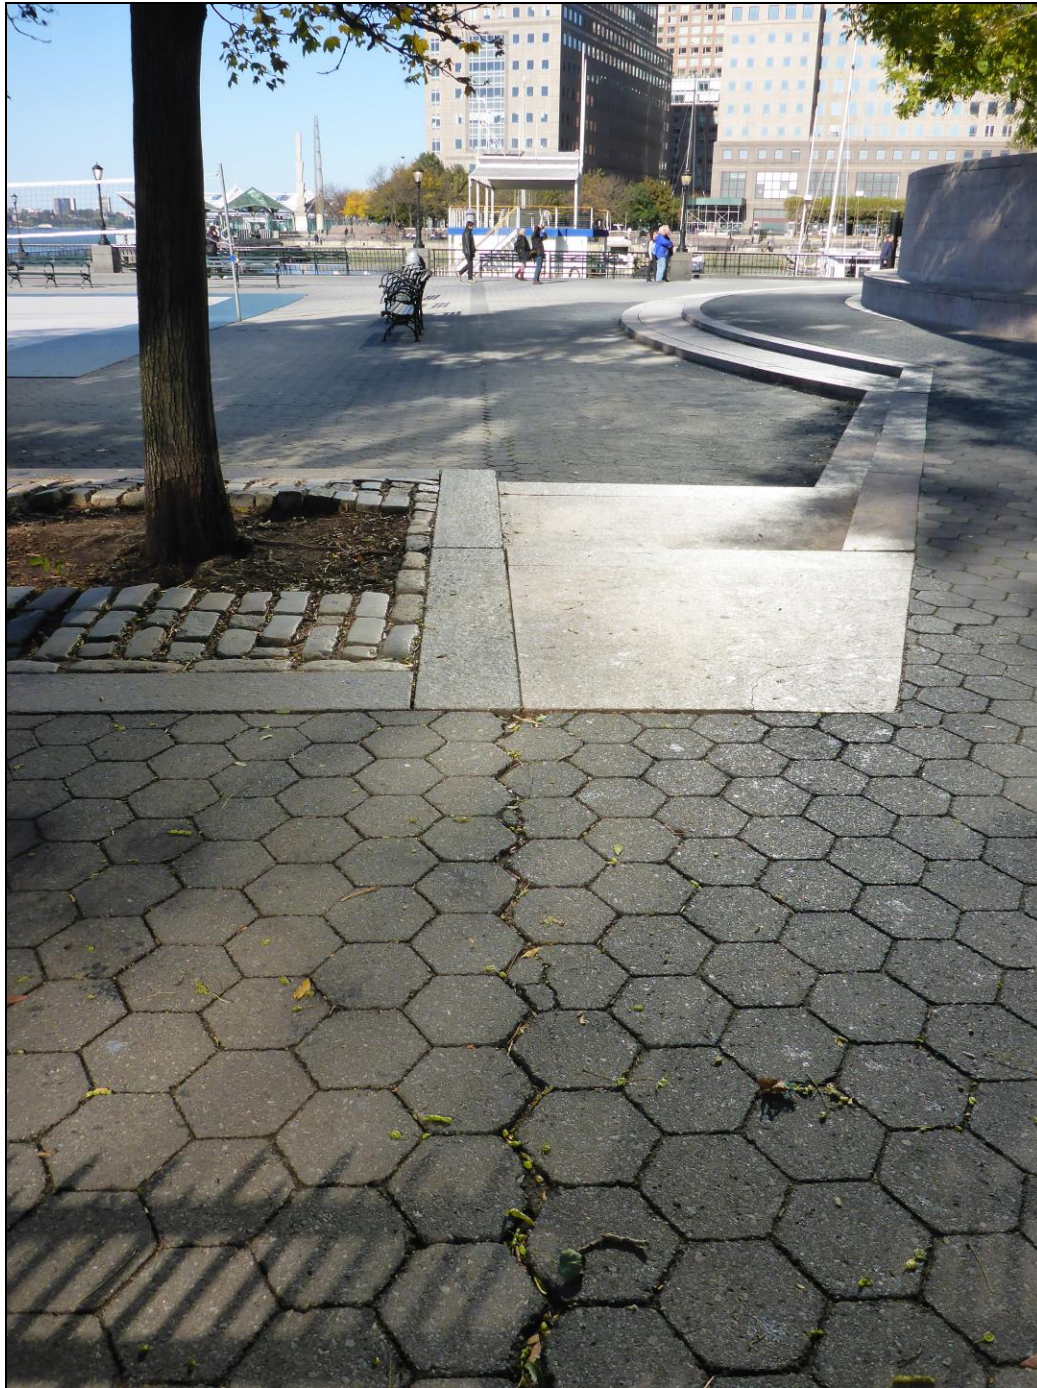
Of the four observed holes, subsidence was observed in the plantings in the immediate vicinity of holes 1 and 2. There was no visible subsidence evident in the vicinity of holes 3 or 4; however, these areas are paved above the bulkhead and it is possible that the slabs and pavers are bridging over any voids that are present. (see Photo 5)

Photo 5 - View of paved esplanade above the joint between the platform and bulkhead.
Note: Minor separation of pavers, no visible subsidence. Photo taken from Bent 81 looking north.
