Project: **200-300 N.E. Leak Remediation
Design**

RE: **Addenda #1**
93 **(# of pages)**
Pages:

Re: 212 North End Avenue
Expansion Joint Investigation
WJE No.PC13.1965

Re: 212 North End Avenue
Leak and Probe Investigation
WJE No.PC13.1965

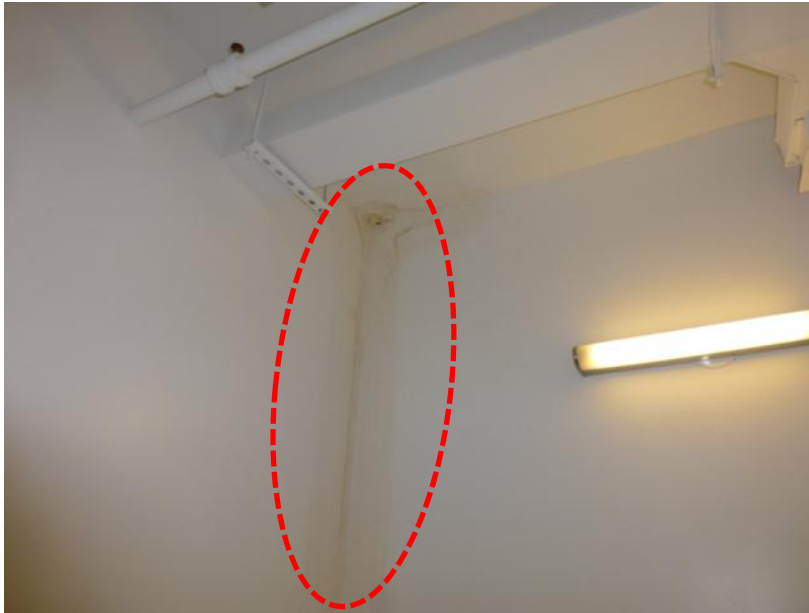
Figure 3. Note damage noted at west corner of room C34C of Family Changing Room (as noted on 9/25/2013).

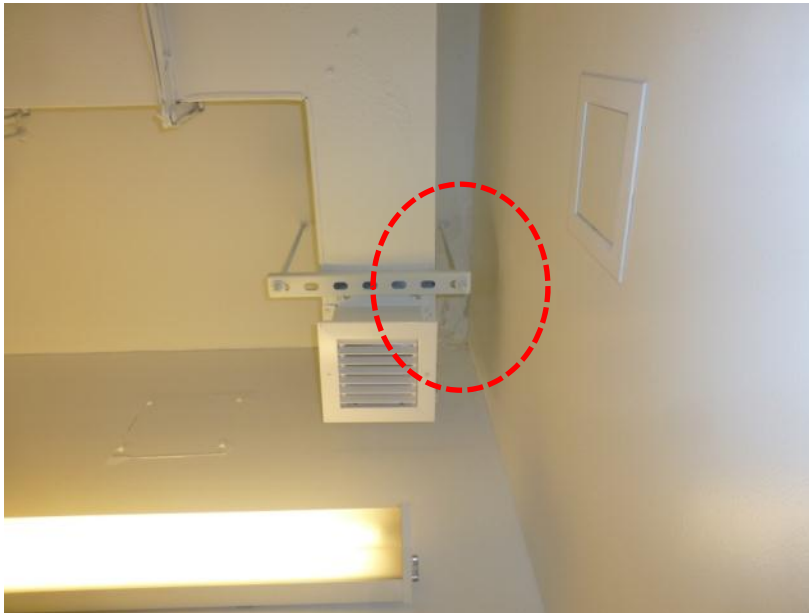
Figure 4. Note damage noted at northeast corner of entry corridor of Family Changing Room (as noted on 9/25/2013).

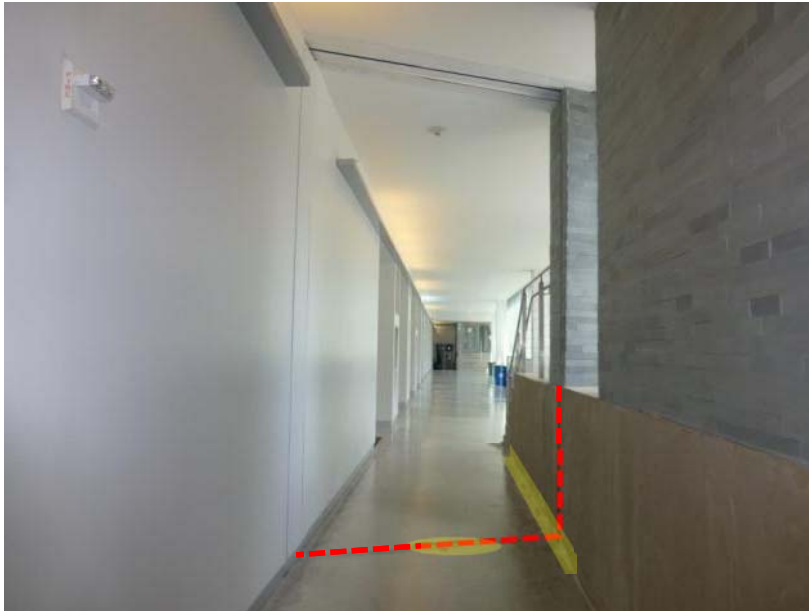
Figure 5. Section of expansion joint visible from the main public corridor (dashed line). Yellow highlights indicate sections where staining is readily visible.

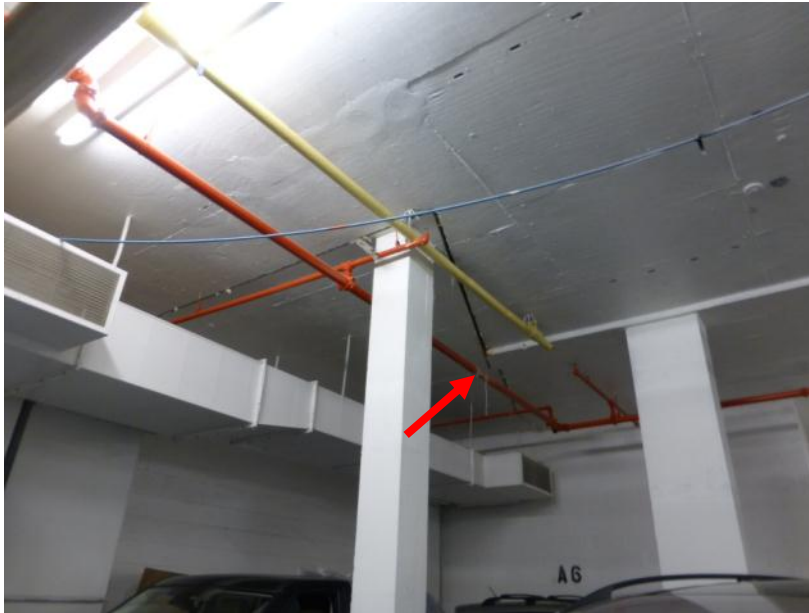
Figure 7. Evidence of water infiltration in the form of stalactites noted at the parking garage (arrow).

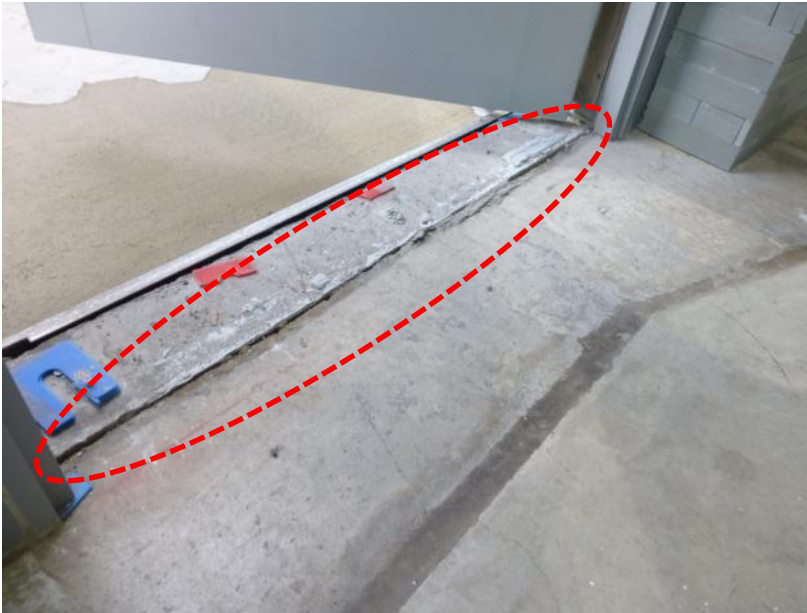
Figure 9. Probe #1 - removal of door saddle of north entrance of Center Courtyard.

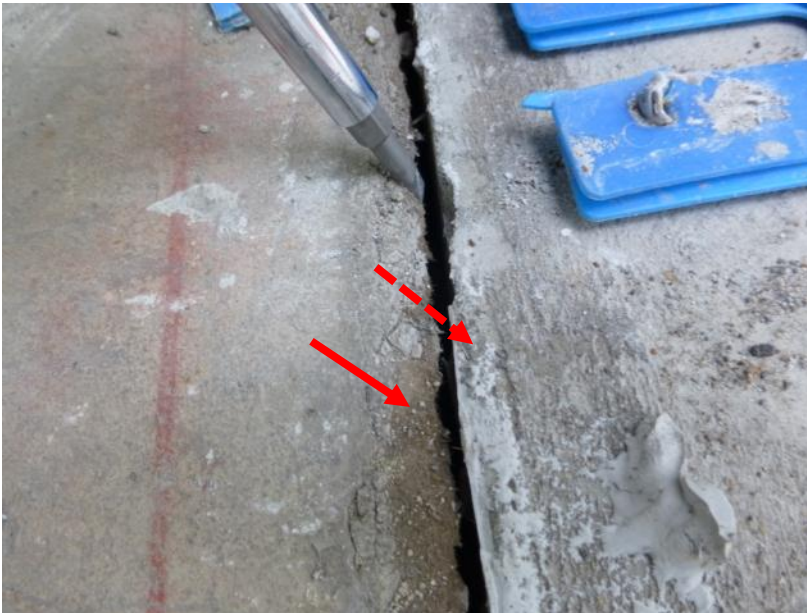
Figure 10. Note evidence of sealant (dashed arrow) and a compressible filler material (solid arrow).

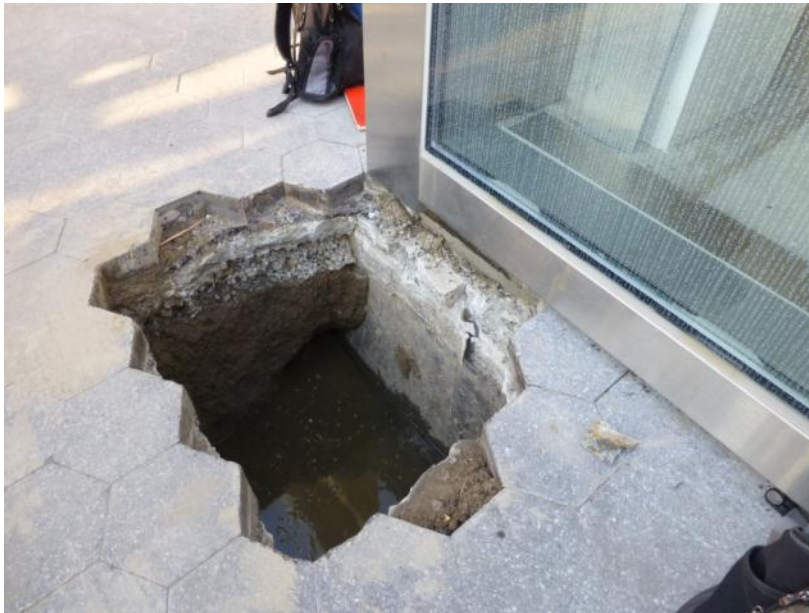
Figure 11. Probe #2 - Lower Plaza at foundation wall. Water noted to pond at probe location.

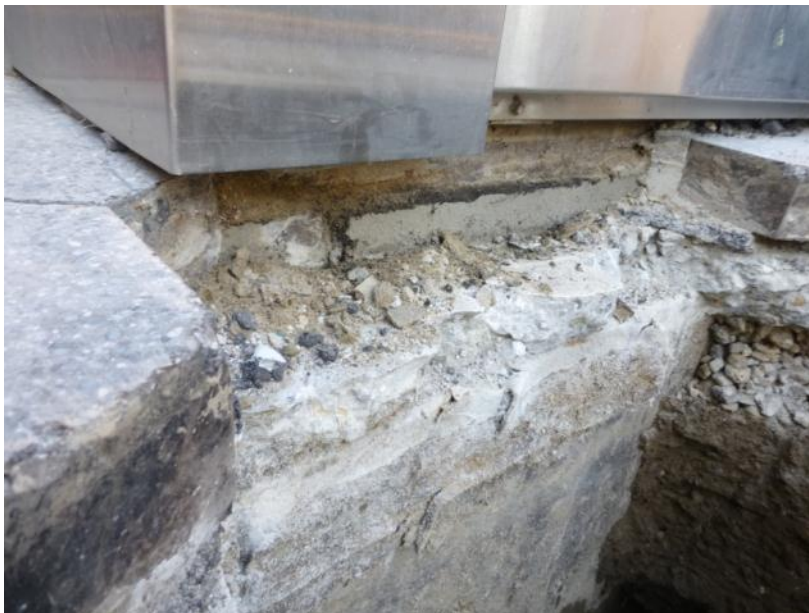
Figure 12. No expansion joint observed to not go through the foundation wall. Waterproofing on wall appeared to be in good condition.

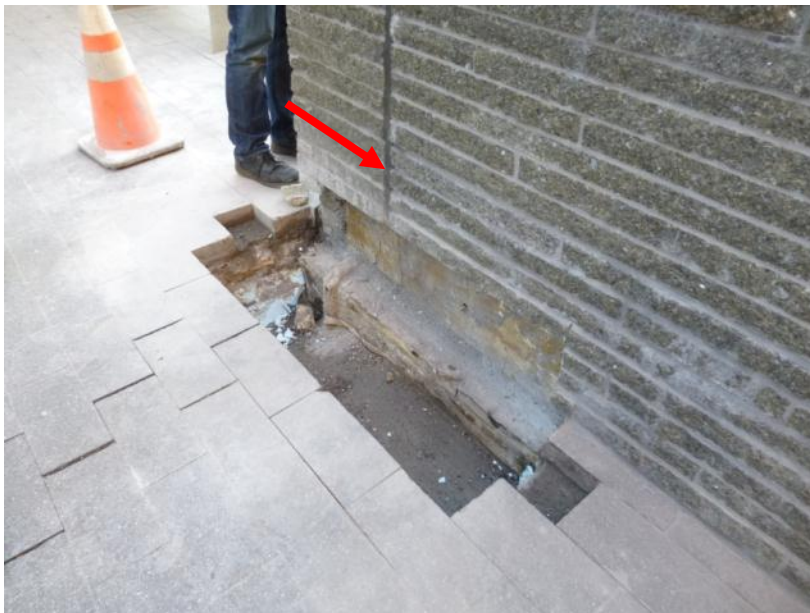
Figure 14. Probe #3 - opening performed at parapet-plaza interface in the vicinity of the expansion joint (arrow).

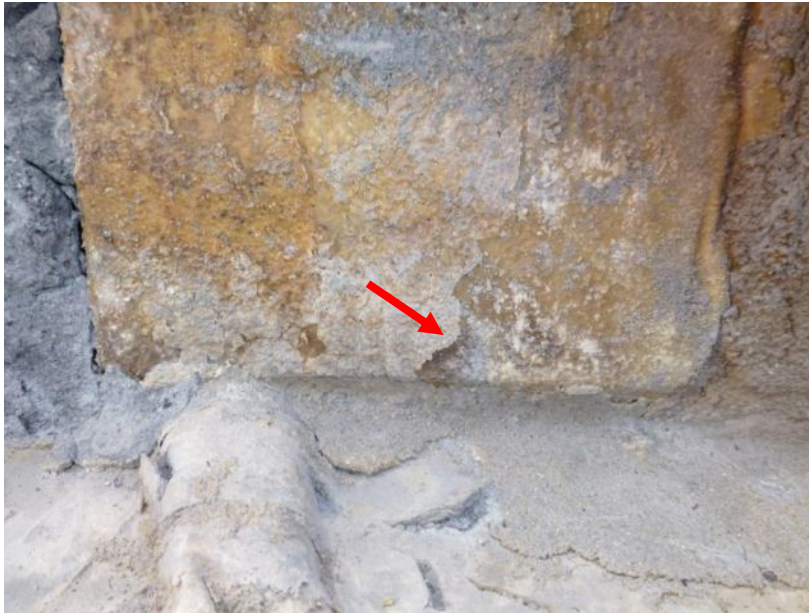
Figure 15. Kemper at the face of the CMU block within the parapet wall was noted to be brittle and delaminating from the substrate (arrow).

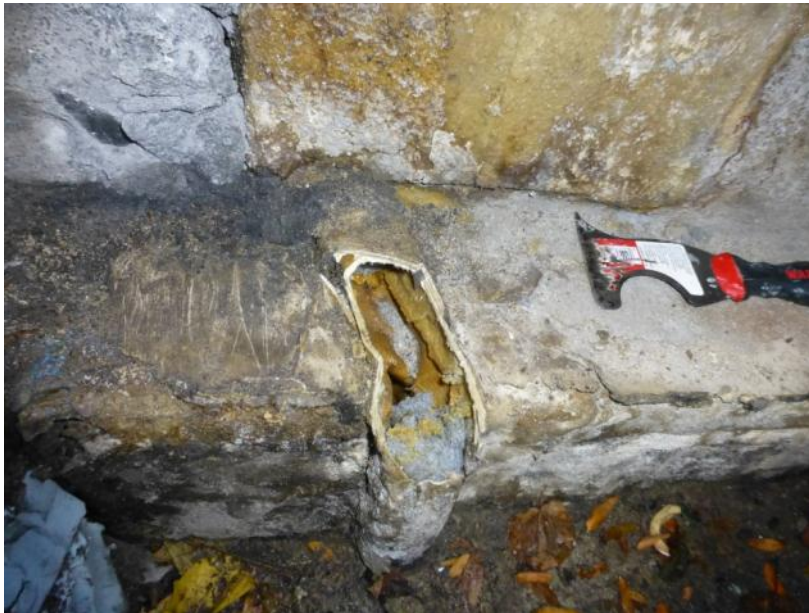
Figure 17. Probe taken at expansion joint to confirm detailing. Removal consisted of two layers of fabric reinforced liquid membrane and a section of closed cell backer rod.

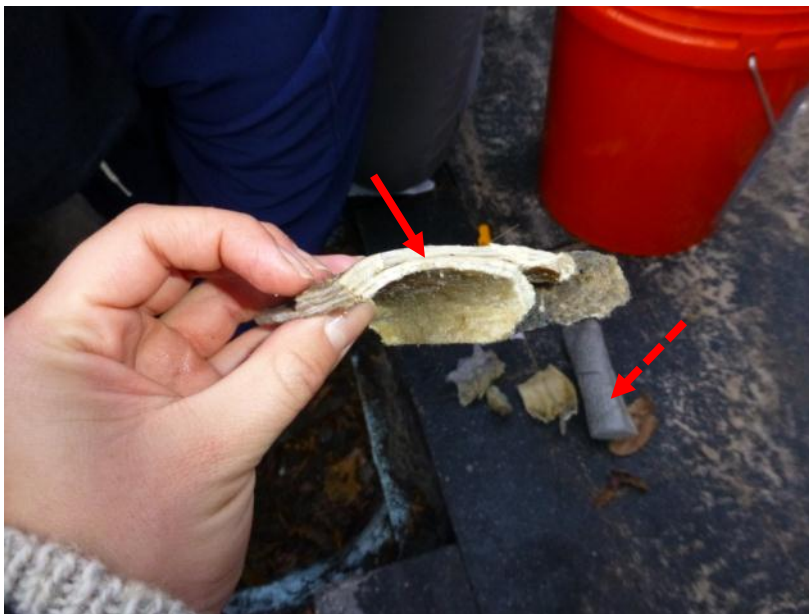
Figure 18. Two layers of fabric reinforced membrane (solid arrow) and a section of closed cell backer rod (dashed arrow) shown above.

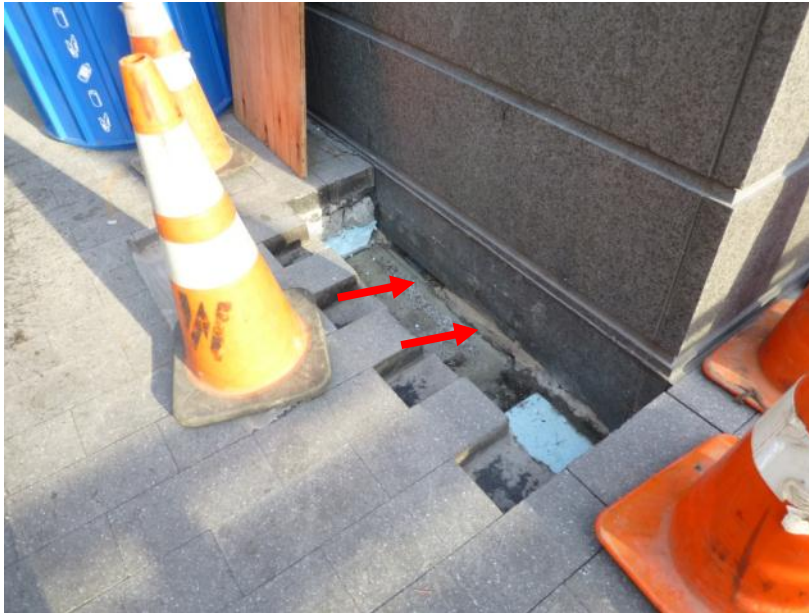
Figure 19. Probe opening performed at building wall and plaza intersection, above expansion joint. General location of EJ noted by arrows.

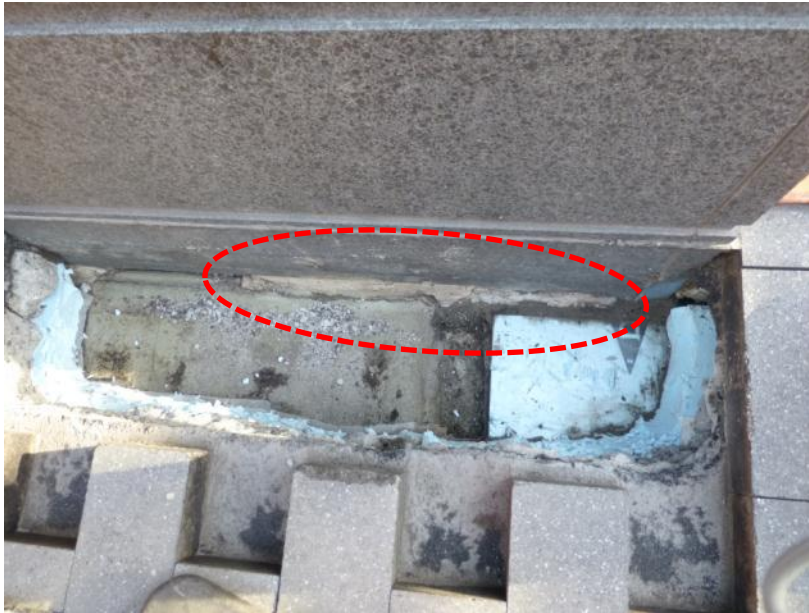
Figure 21. A cementitious parging material was noted to be installed along the joint between the concrete slab and granite panel.

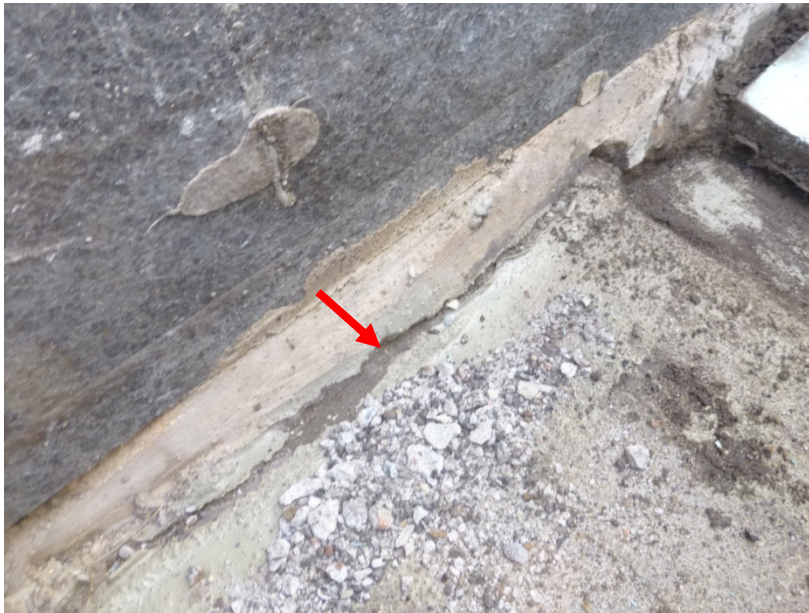
Figure 22. Separation noted at top coat of membrane that overlapped the cementitious parging applied at joint (arrow).

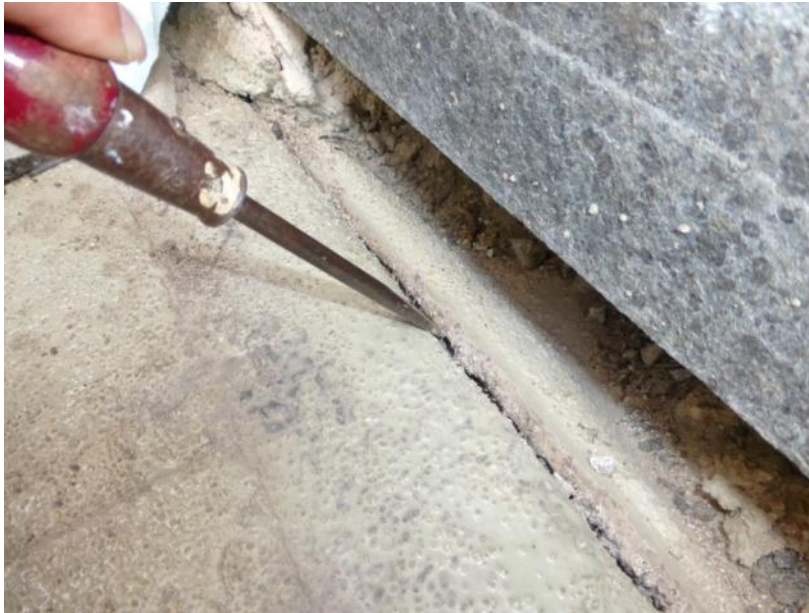
Figure 23. Separation noted in existing Kemper System directly above expansion joint.

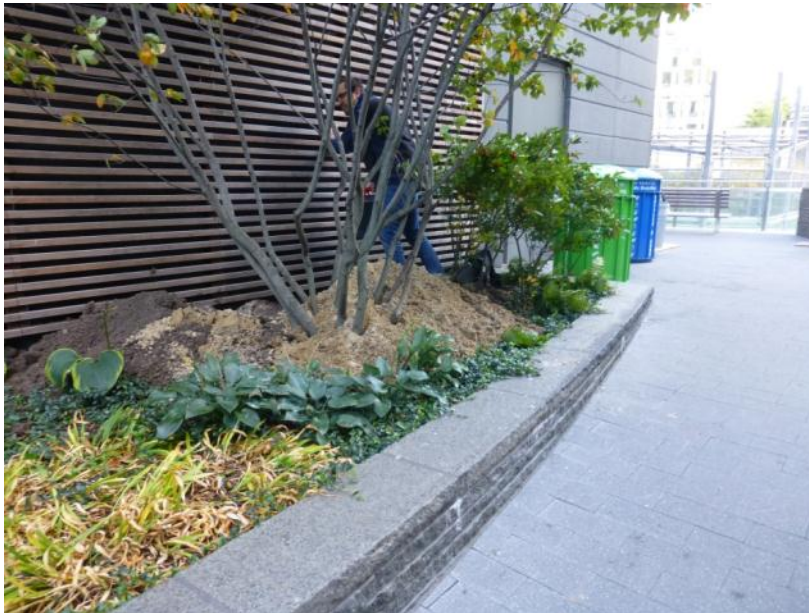
Figure 24. Probe opening performed at planter (10/24).

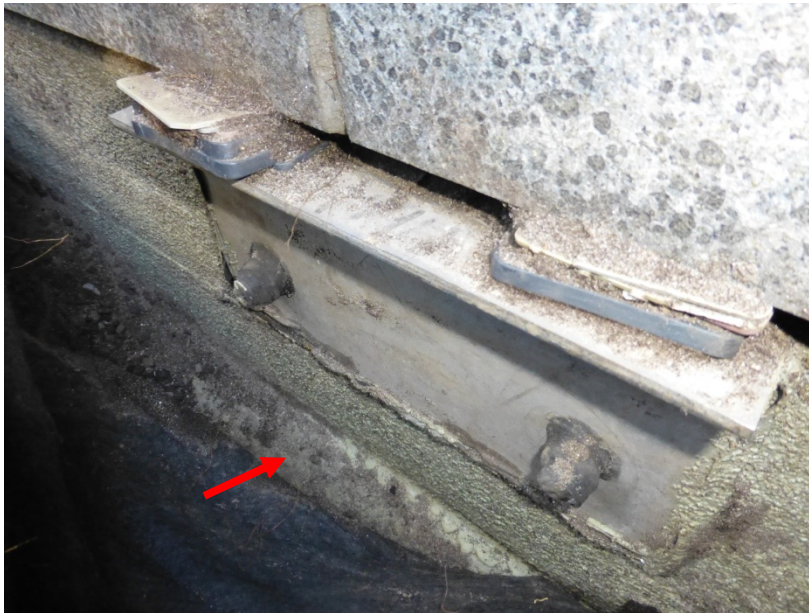
Figure 25. Probe No. 5 taken at planter. Difference in slab elevation exists at this location. Note that the joint configuration varies in that it is a horizontal to vertical transition (arrow).

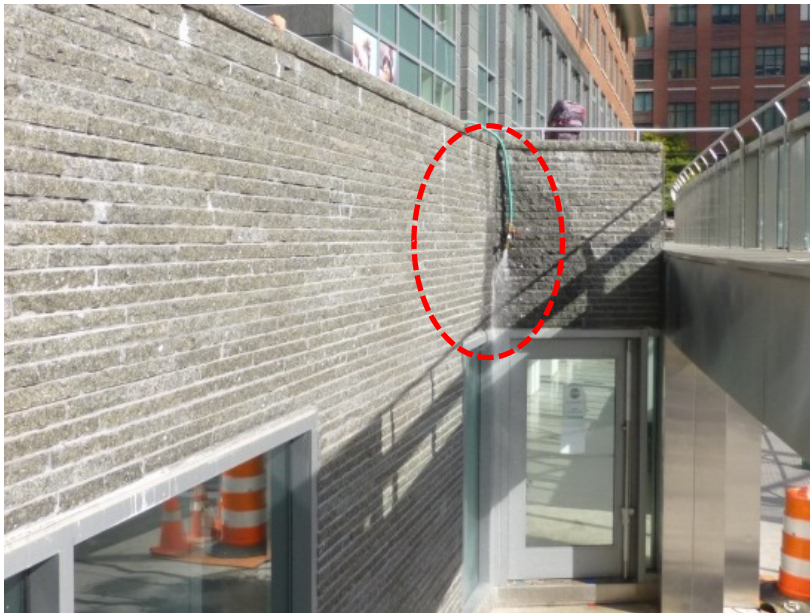
Figure 28. Water test 1 - performed at corner of parapet above north door and storefront window.

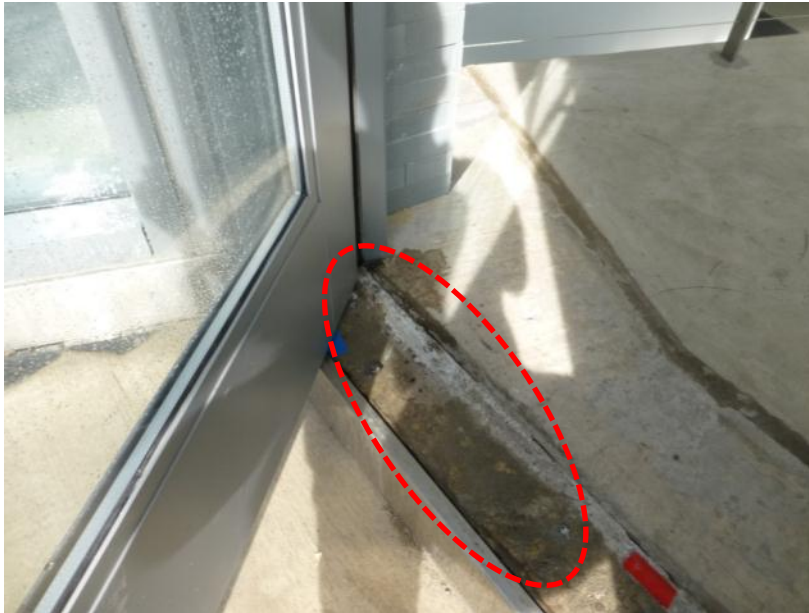
Figure 29. Water penetrated through door threshold two minutes after initiating test.

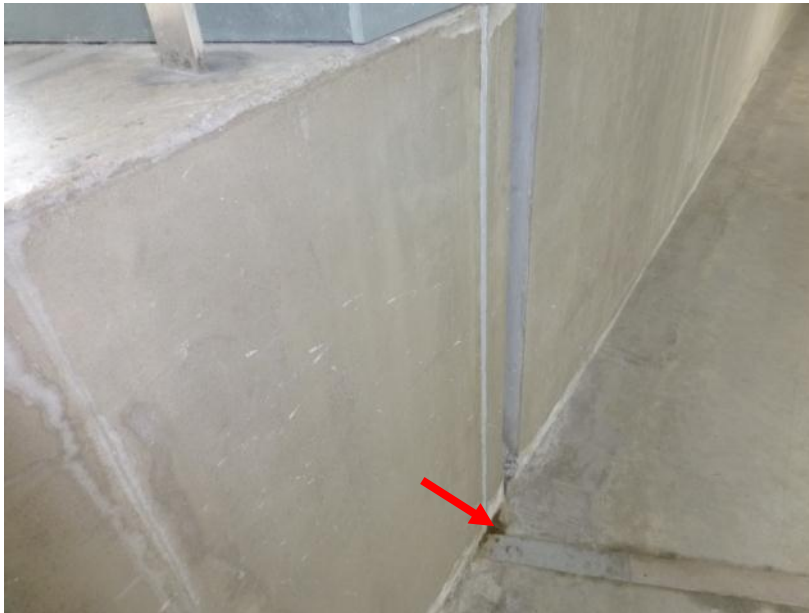
Figure 30. Water observed to be emanating from the bottom of the knee wall 25 minutes after running the testing apparatus.

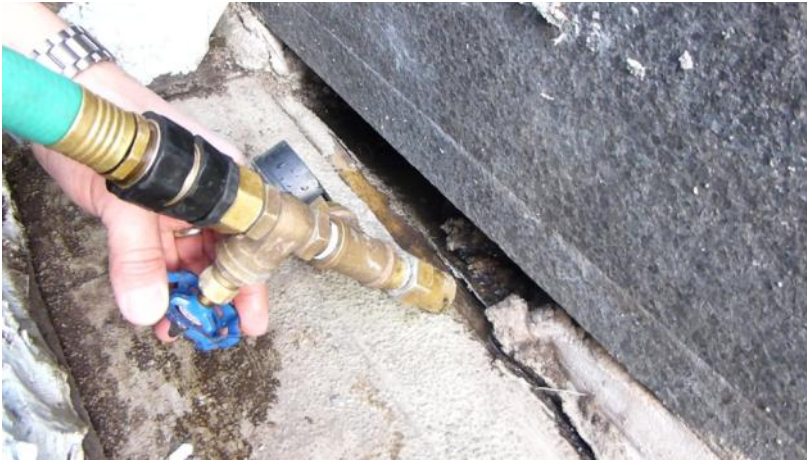
Figure 31. Water test 2 - sprayed AAMA nozzle at a very low pressure at separation noted during probe no. 4.

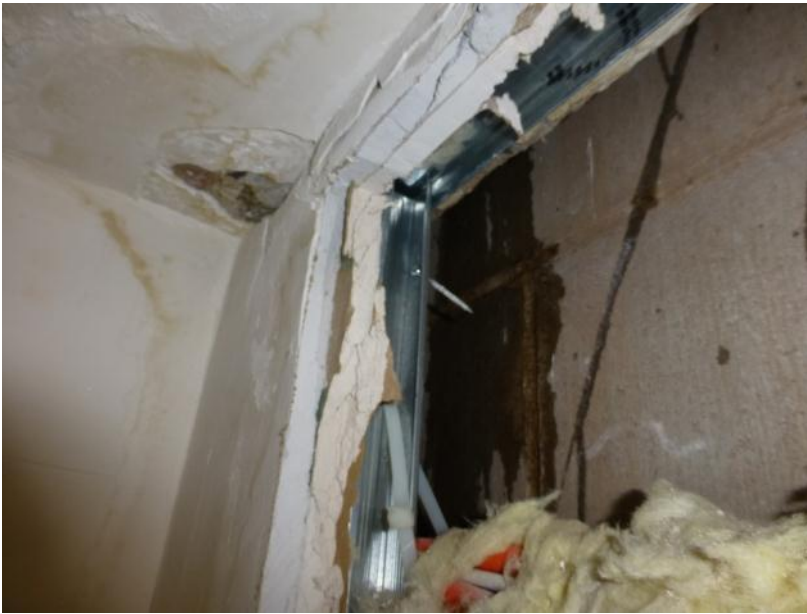
Figure 32. Water infiltration occurred 15 minutes after applying a small amount of water to the expansion joint (approximately 10 feet east of this location).

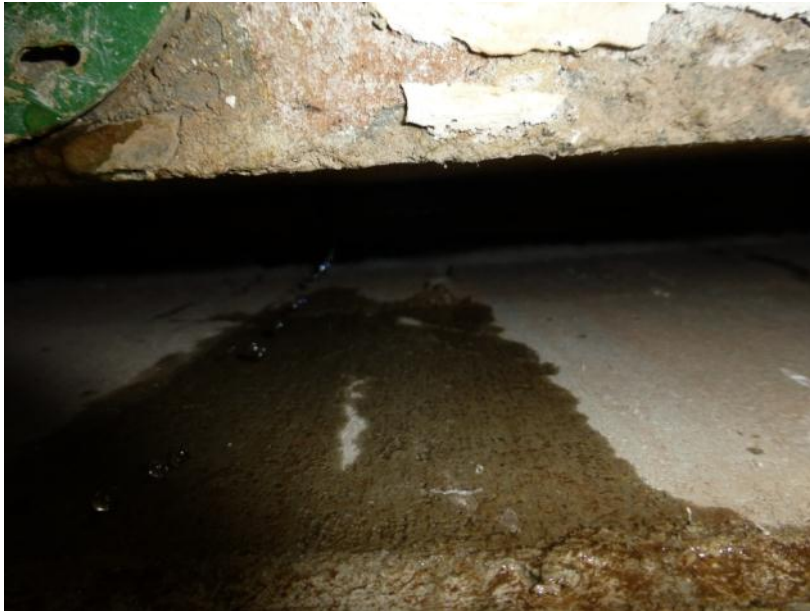
Figure 33. Water continued to pour in for several minutes after shutting off the water source once initial moisture was noted.

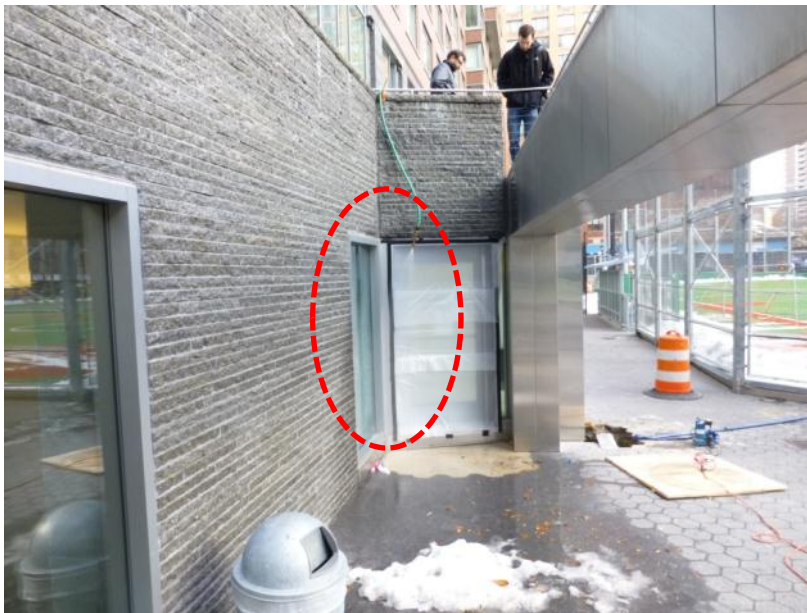
Figure 36. Water test 4 - sprayed AAMA nozzle at jamb of storefront window and door. Note - door is masked off with plastic sheets.

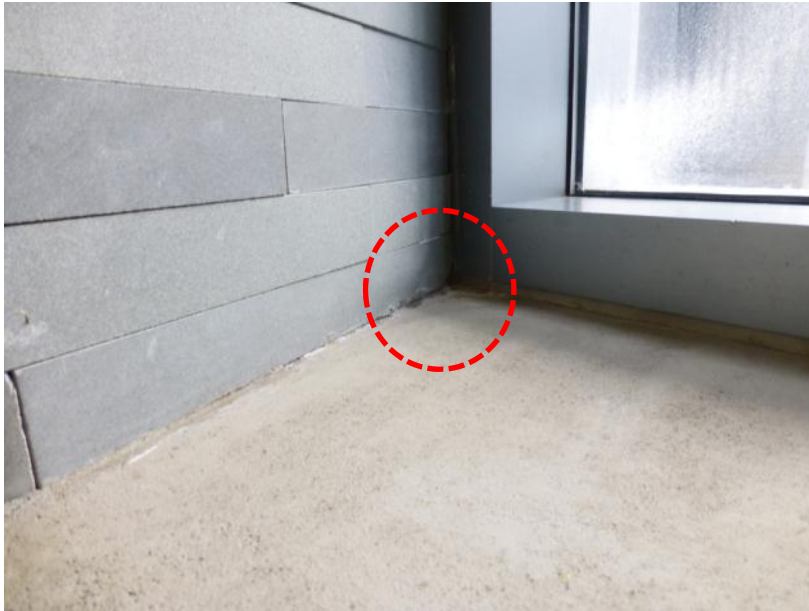
Figure 37. During water test 4, the staining at the north corner of the storefront window appeared to grow.

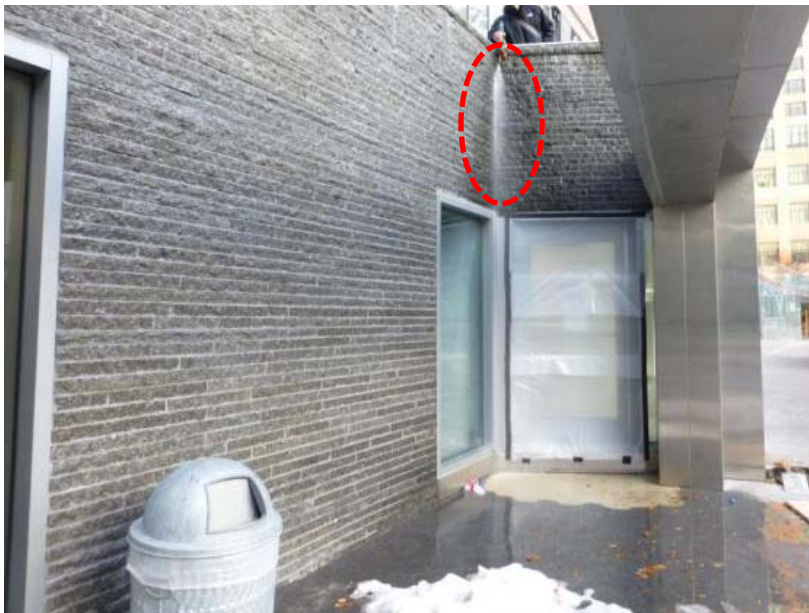
Figure 38. Water test 5 - sprayed AAMA nozzle at jamb of storefront window and door. Note - door is masked off with plastic sheets.

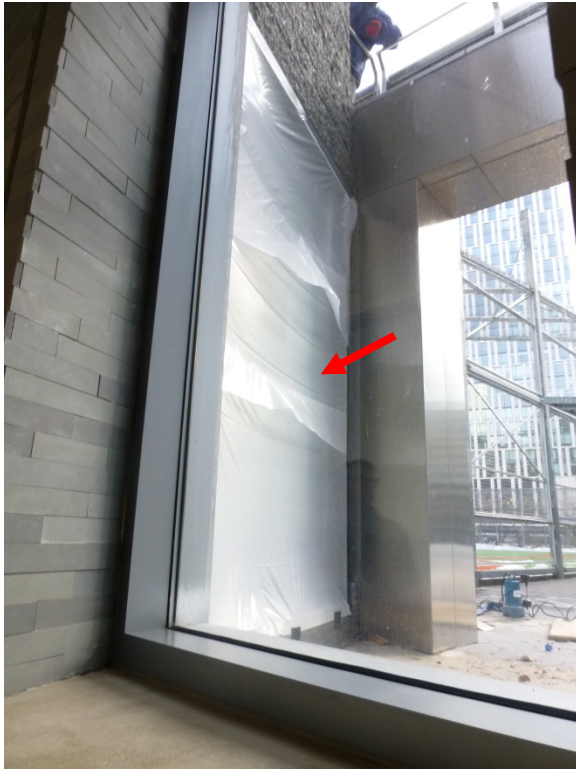
Figure 39. Note plastic sheathing drawn inward towards the interior of the building denoting a likely negative pressure at this location.

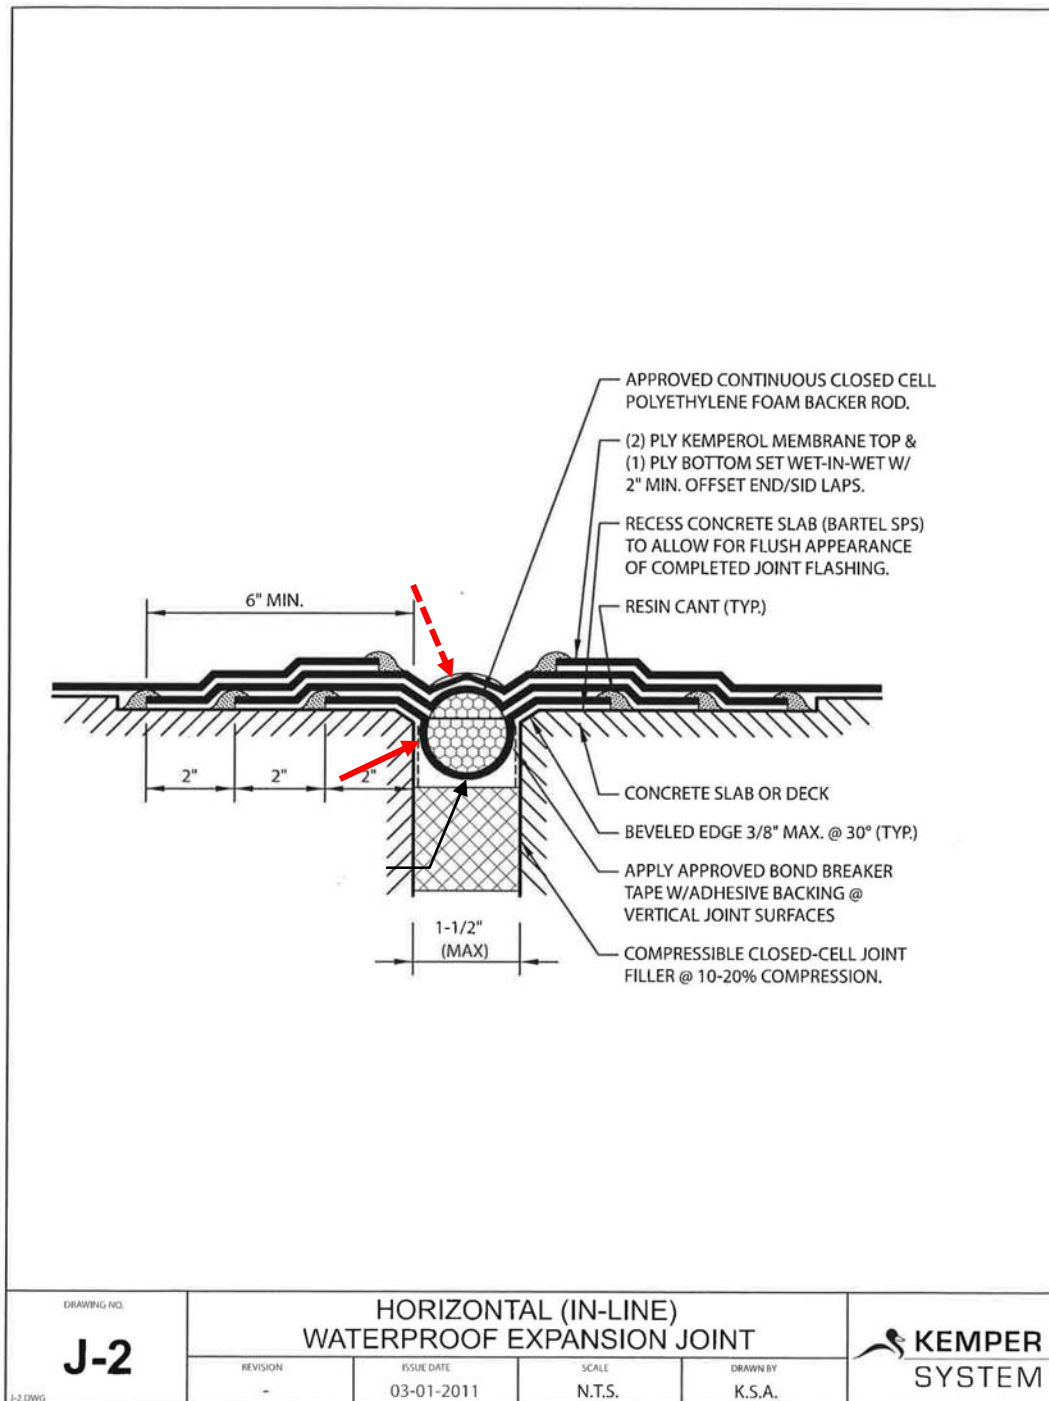
Figure 40. Typical section through an expansion joint as detailed by Kemper. The two-ply top membrane (dashed arrow) and the bottom ply below the backer rod (solid arrow).

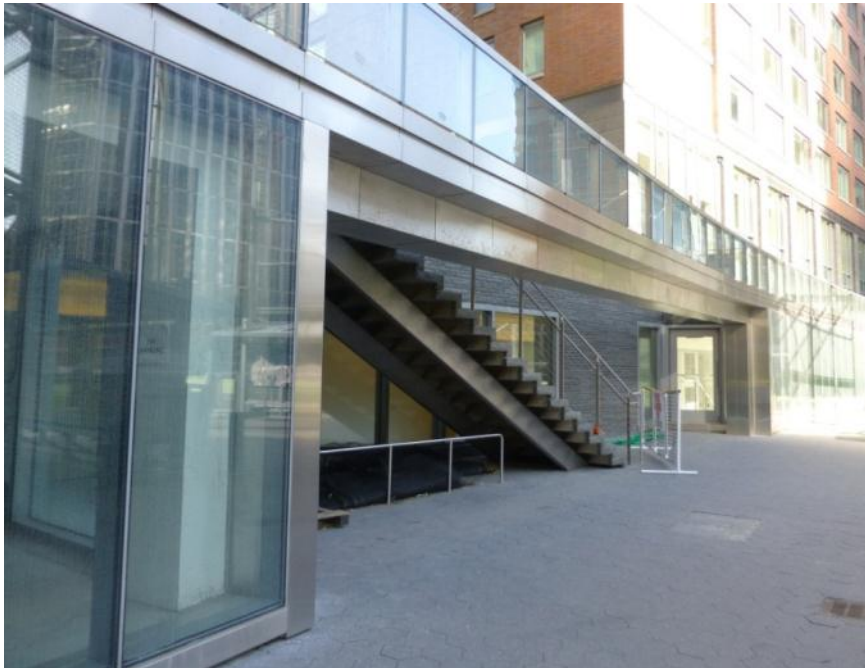
Figure 2. Overall view of subject location under investigation - Center Courtyard.

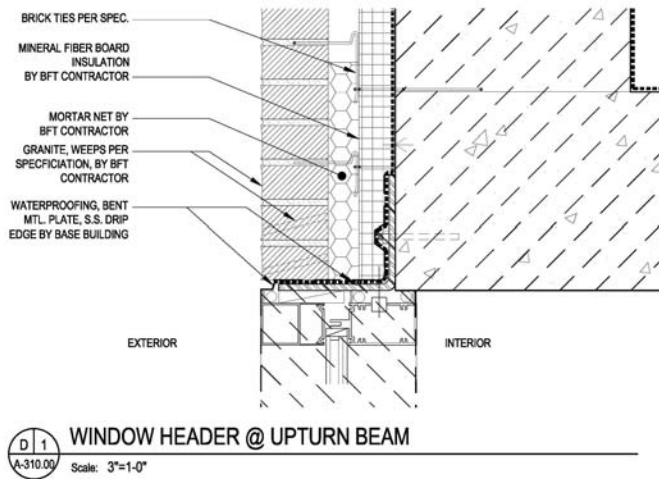
Figure 6. Shown above, detail D1, sheet A-310.00.

- Per sheet A-713, detail D1, *Section Center Courtyard @ Window Assembly* [Figure 5], the continuous layer of waterproofing membrane is interrupted by the storefront window. At this location, per detail D1 of sheet A-310 [Figure 6], it is tied in to waterproofing membrane installed at the lintel. Also, at this window sill the waterproofing on the outside of the foundation wall (as indicated by the dark dashed line on the drawing), is shown to terminate at the outside face of the wall without extending into the return surface of the opening and no sill pan flashing is shown [Figure 7].

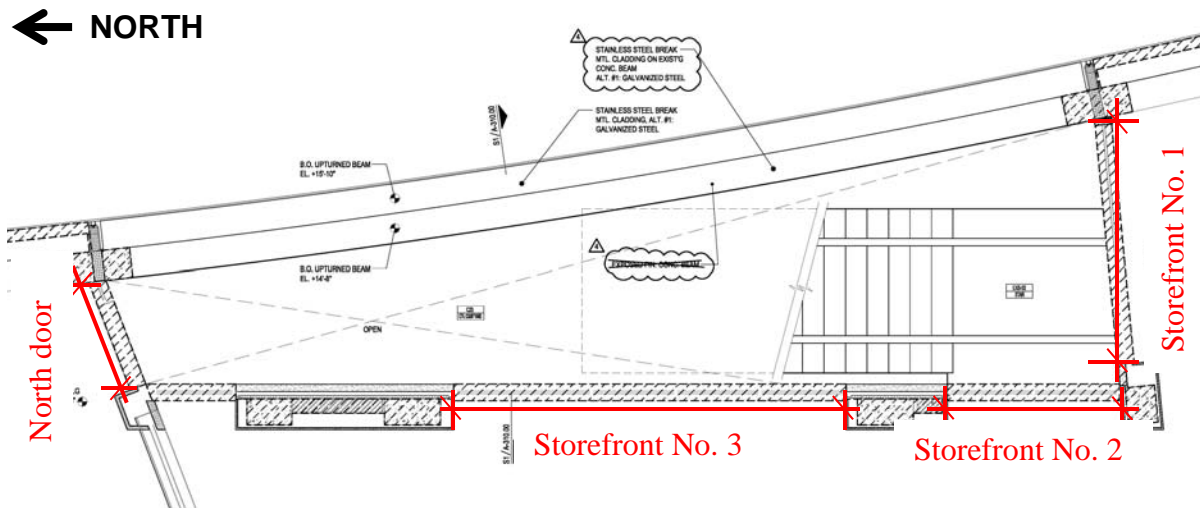
Figure 10. Water tested fenestrations located at the Center Courtyard.

The investigation was completed by Matthew Haberling, Kenrick Hartman, and Jessica Alzate of WJE between May 1 and June 4, 2013. Our investigation included a visual assessment of the building interior and exterior at the reported leak locations, water testing at multiple locations, observation of exterior probe openings. A total of fourteen (14) water tests were performed at the Center Courtyard. Testing included the parapets at the upper plaza, and the fenestrations below, which will be referred to as Storefront No. 1, Storefront No. 2, Storefront No. 3, and the north door [Figure 10], and the foundation wall at the lower plaza. Contractor support for the probes was provided by LiRo.

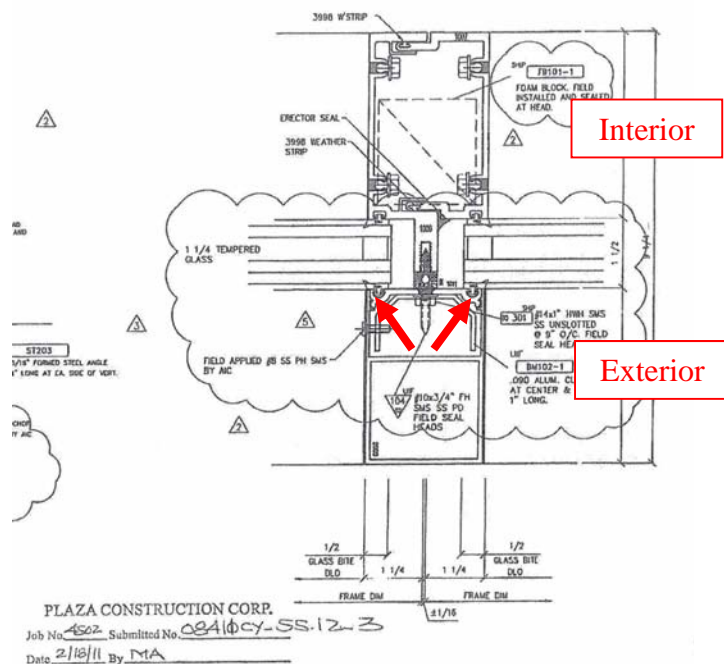
- There are large gaps between the horizontal and vertical window frame members [Figure 16]. Upon review of the shop drawings, it appears that these are glazing stops [Figure 17]. Water stains were observed emanating from these storefront framing joints at the window head and extended down the vertical mullions at multiple locations [Figure 18]. In addition, evidence of water intrusion was observed at the framing joints [Figure 19].

Figure 17. Shown above, detail P, sheet D-09 of window shop drawings.
Note glazing stops (arrows).

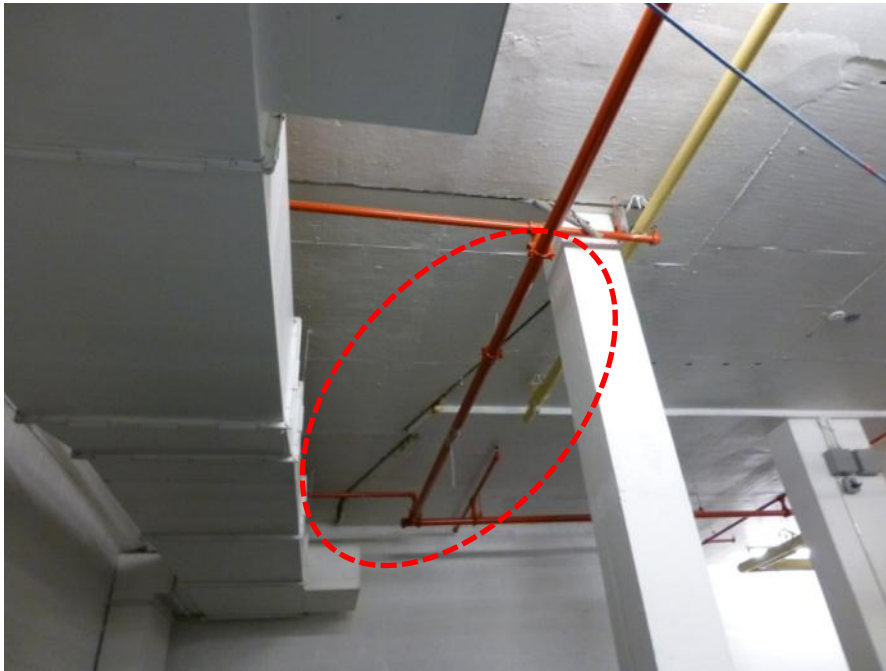
Figure 21. Expansion joint as viewed from parking garage below.

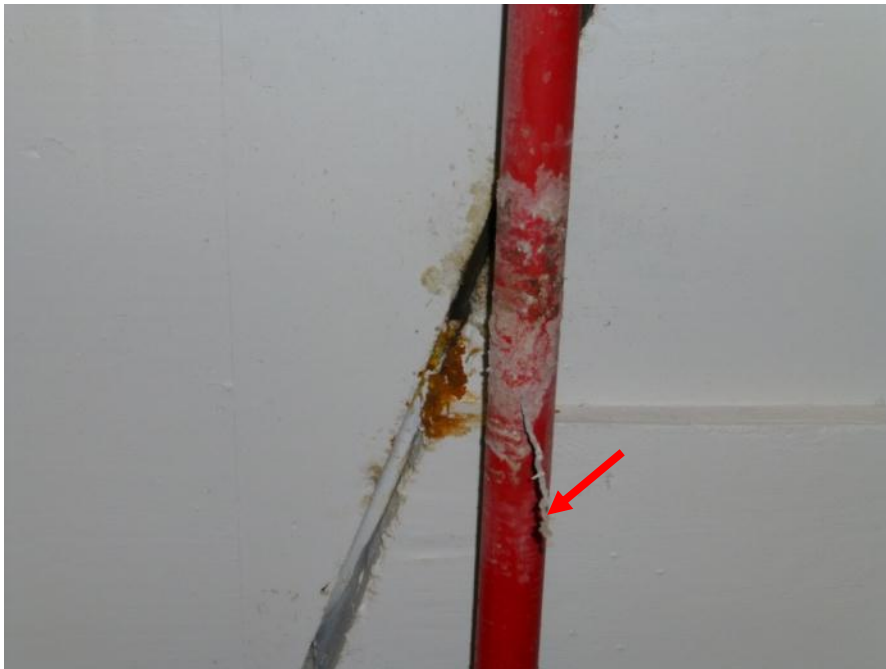
Figure 22. Note stalactite at pipes directly below expansion joint (arrow).

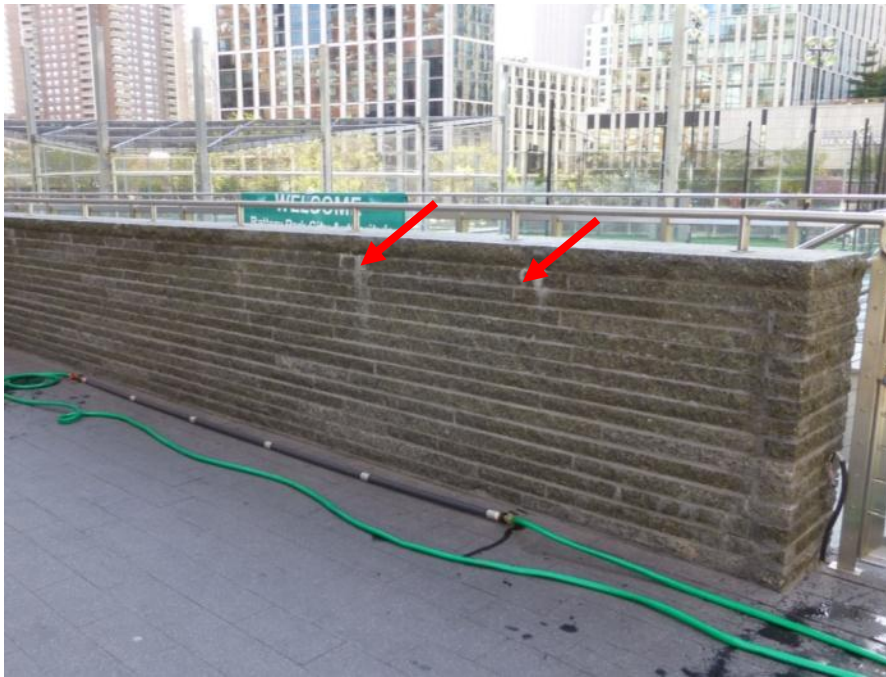
Figure 23. Note evidence of efflorescence at parapet walls, directly below coping stone above center parapet wall (arrows).

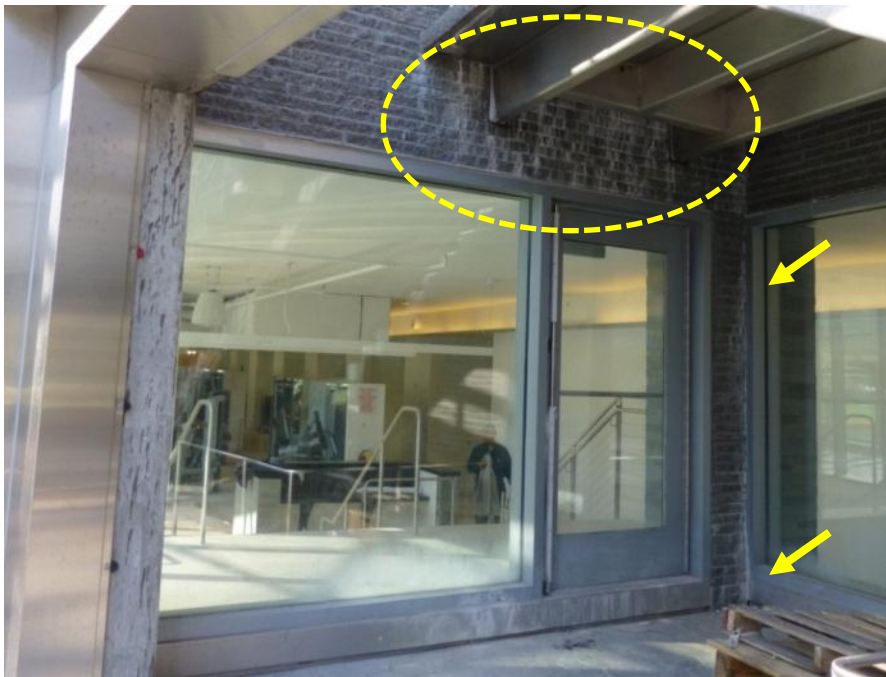
Figure 24. Shown above, Storefront No. 1. Note efflorescence at stair landing above and at window-wall location (arrows).

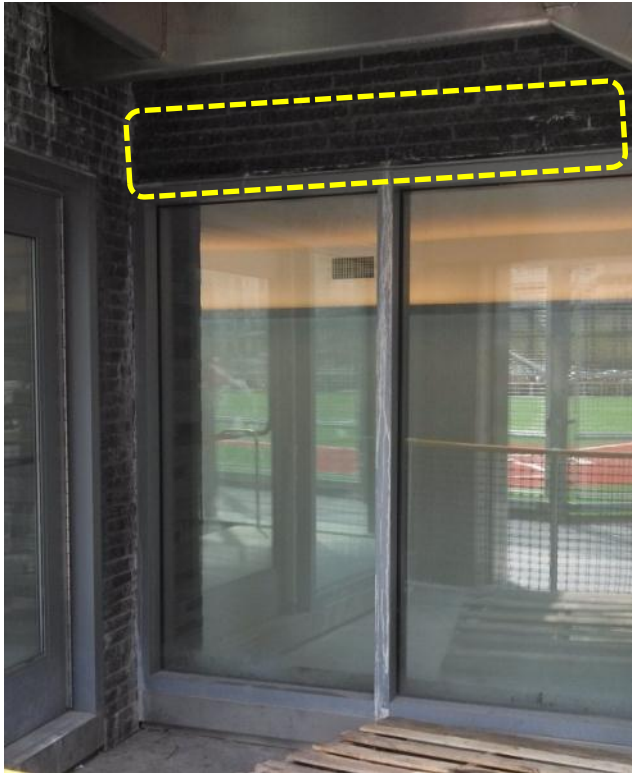
Figure 25. Storefront No. 2 (east facing) shown above. Note efflorescence above window.

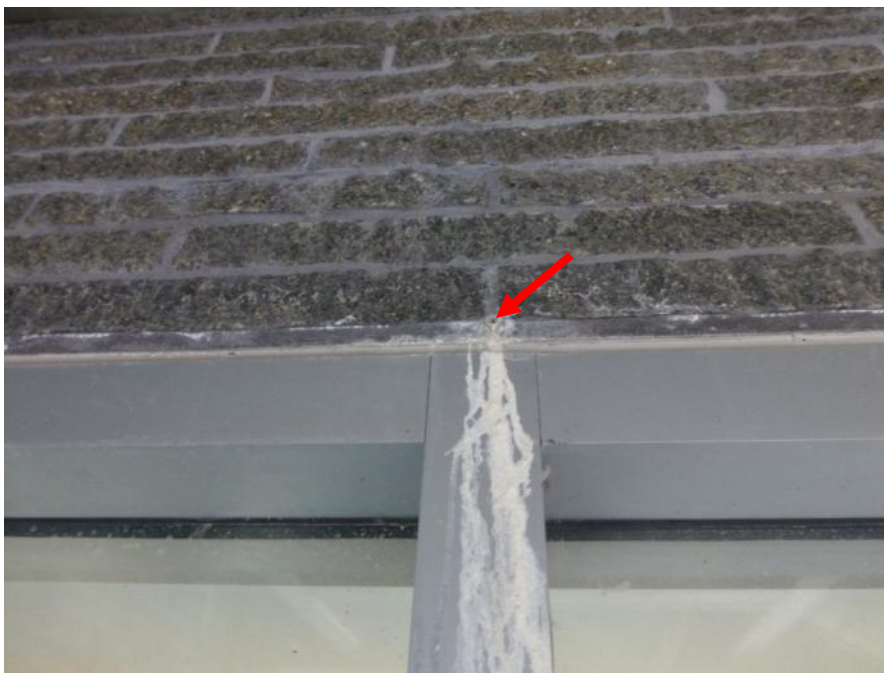
Figure 26. Note significant efflorescence leeching out of weep hole above window head (arrow).

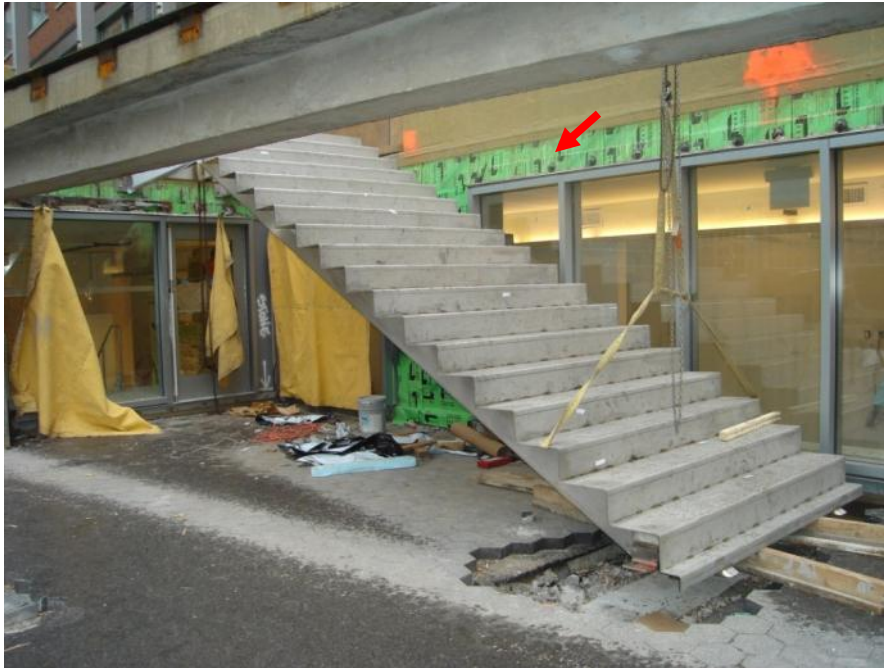
Figure 31. Photo provided by LiRo, dated 12/19/2011. Installation of stairway armature in progress. Note flashing membrane installed at wall (arrow).
