Project: **200-300 N.E. Leak Remediation
Design**

RE: **Addenda #1**
93 **(# of pages)**
Pages:

Re: 212 North End Avenue
Expansion Joint Investigation
WJE No.PC13.1965

Re: 212 North End Avenue
Leak and Probe Investigation
WJE No.PC13.1965

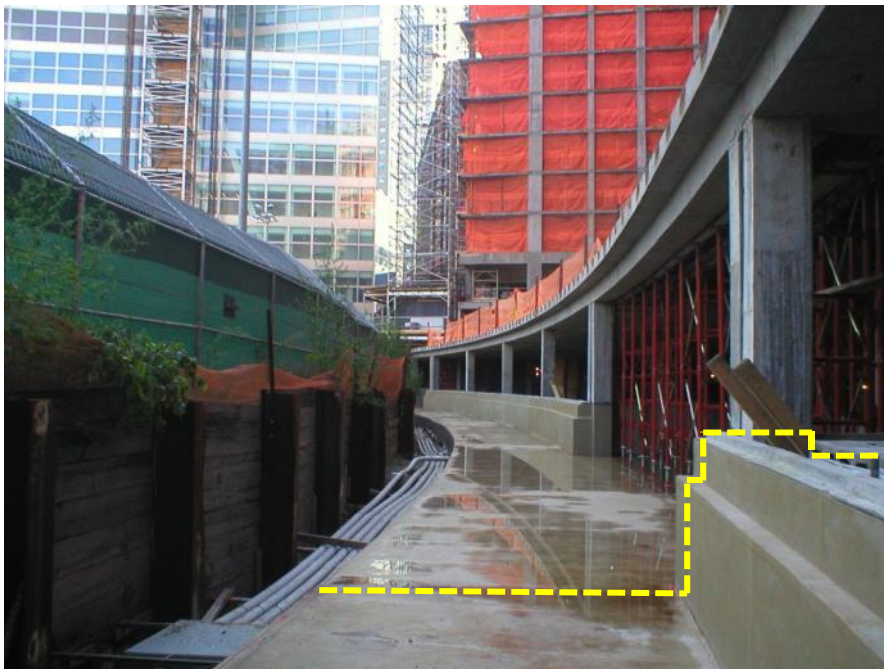
Figure 32. No evident provision in the Kemper waterproofing for the expansion joint between the two buildings. Approximate location depicted by yellow dashed line (photo provided by LiRo dated 9/20/2011).

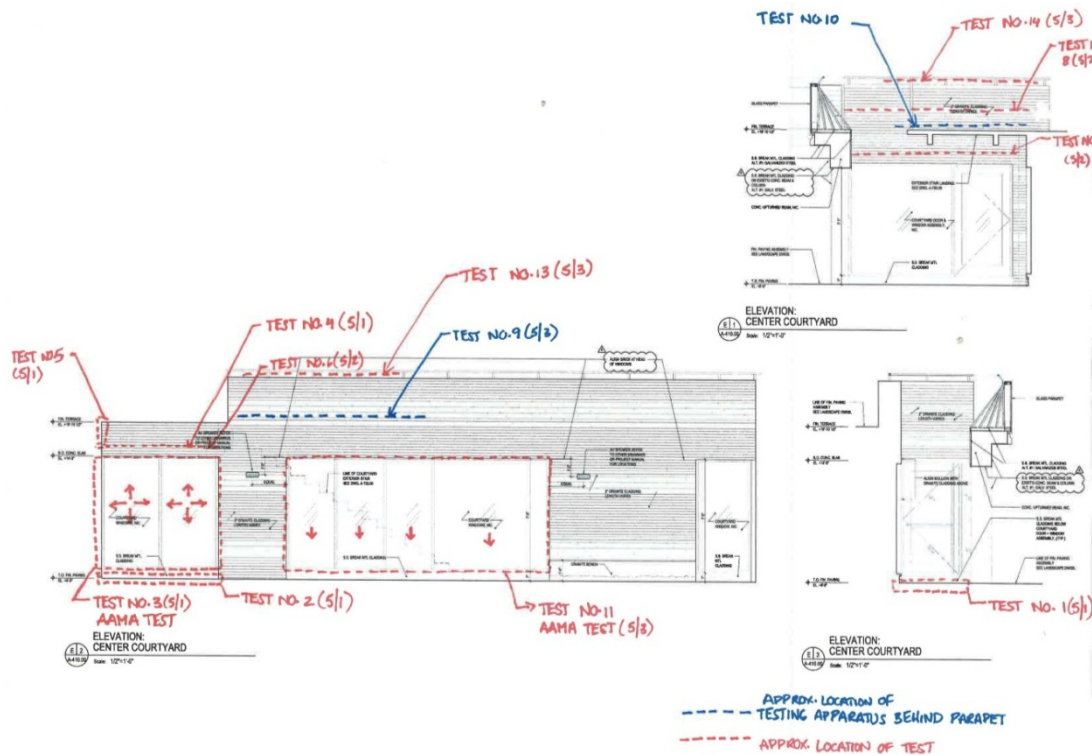
Figure 33. Locations of water tests performed.

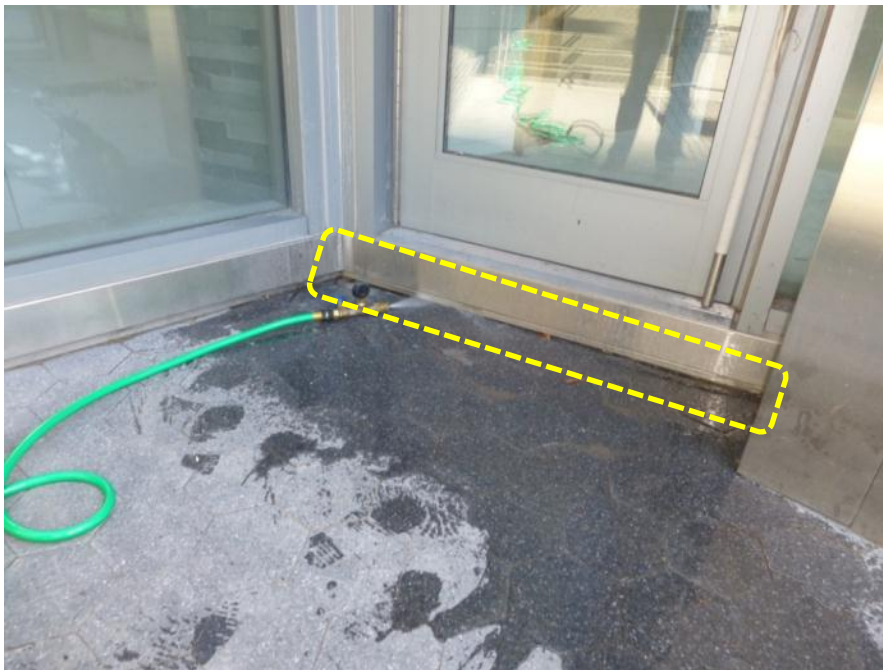
Figure 34. AAMA nozzle sprayed below north door threshold.

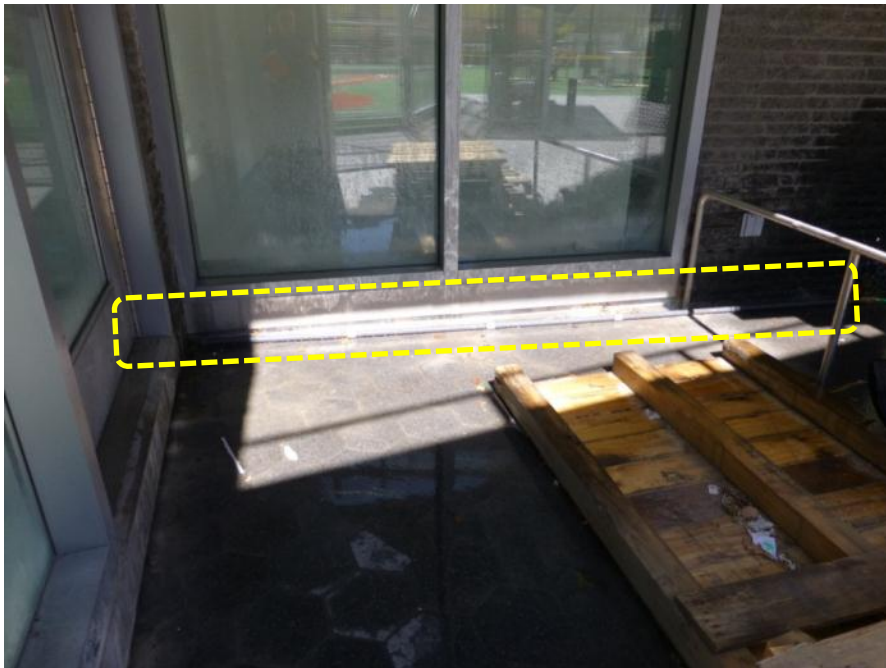
Figure 36. Spray rack positioned below Storefront No.2.

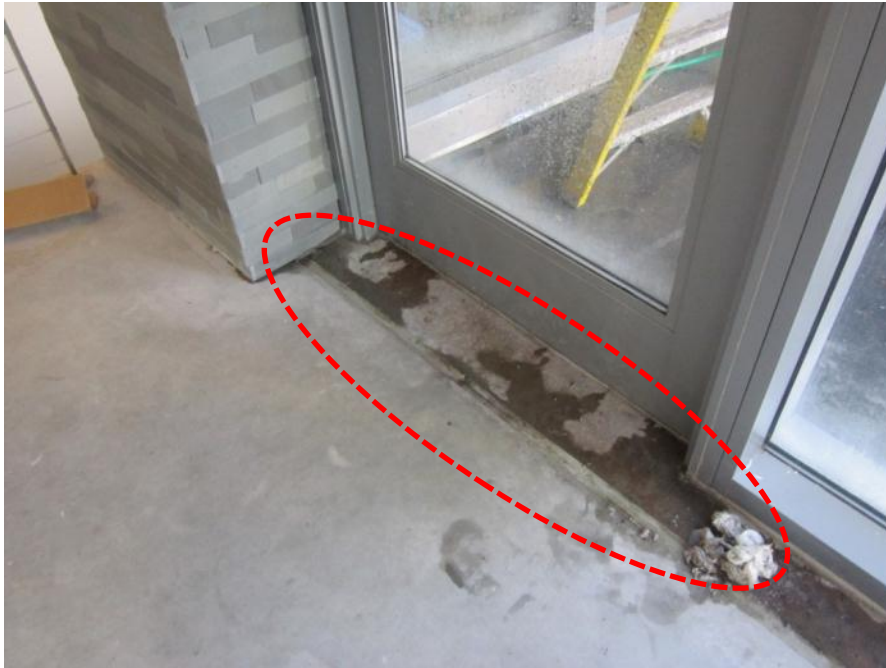
Figure 41. Water intrusion continued to occur through the door threshold while running test no. 5.

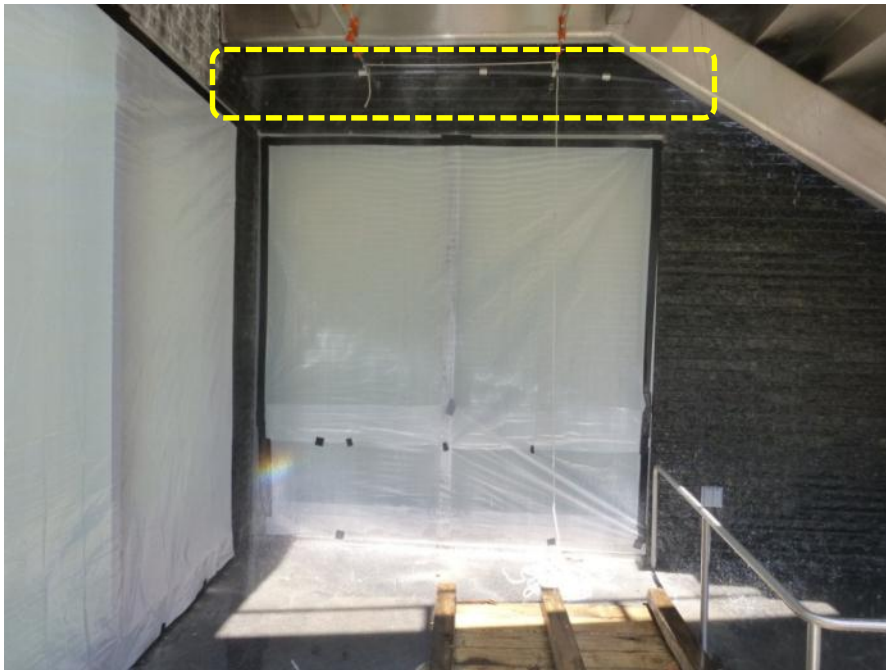
Figure 42. Spray rack positioned approx. 6-inches above the window head of Storefront no. 2. Note plastic sheathing installed at fenestrations.

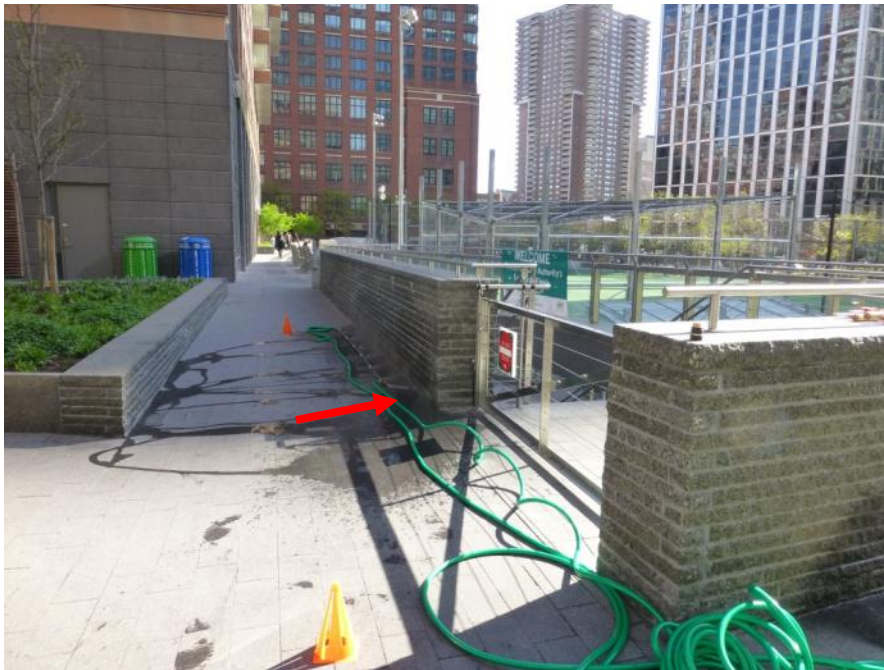
Figure 49. Directed spray rack behind center parapet for test. No. 9 (arrow).

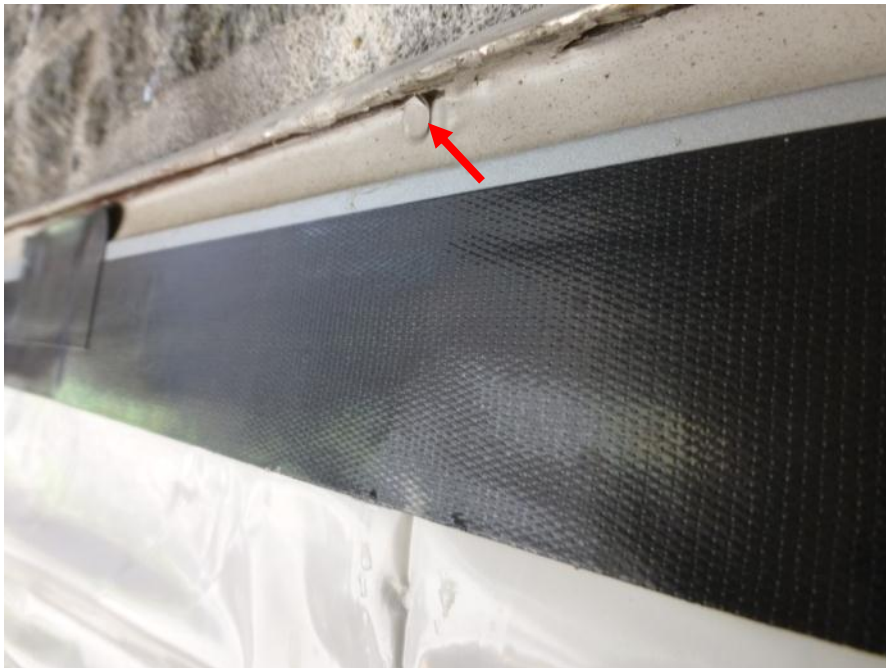
During our investigation, we observed water exfiltration at the exterior joint between the glass and the aluminum framing. This occurred while we were water testing the window head with the window masked off with plastic sheeting. This indicates that the water observed during the test breached the waterproofing above the window and potentially the thermal break in the window frame. We also observed exfiltration of water at the interior aluminum framing components. Once again, this indicates that water is somehow getting into the window frame. In both cases, water is also likely traveling inside the window jambs, which are hollow aluminum tubes, and contributes to the leaks observed at the sills [Figure 88].

Figure 54. Note water exfiltrating via window-wall sealant joint during test no. 10.

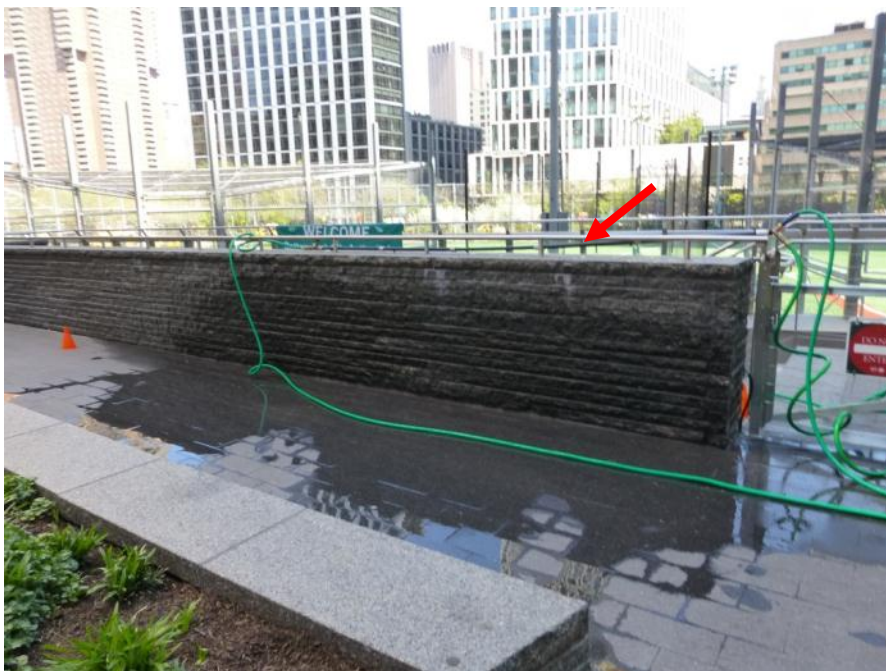
Figure 56. Note spray rack positioned over parapet during test no. 12 (arrow)

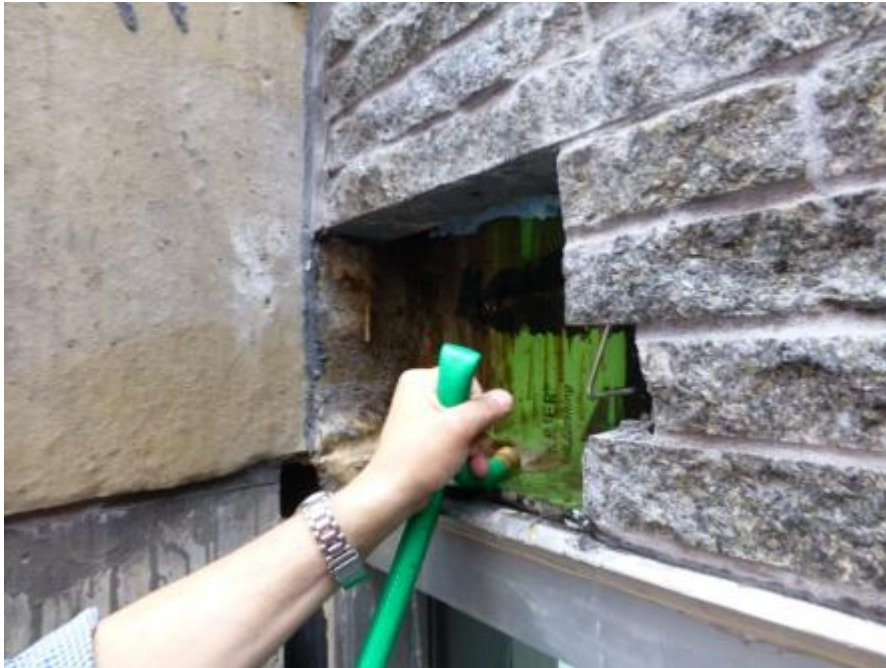
Figure 59. Ran hose at probe opening no. 1 with the intent to re-create leak at interior.

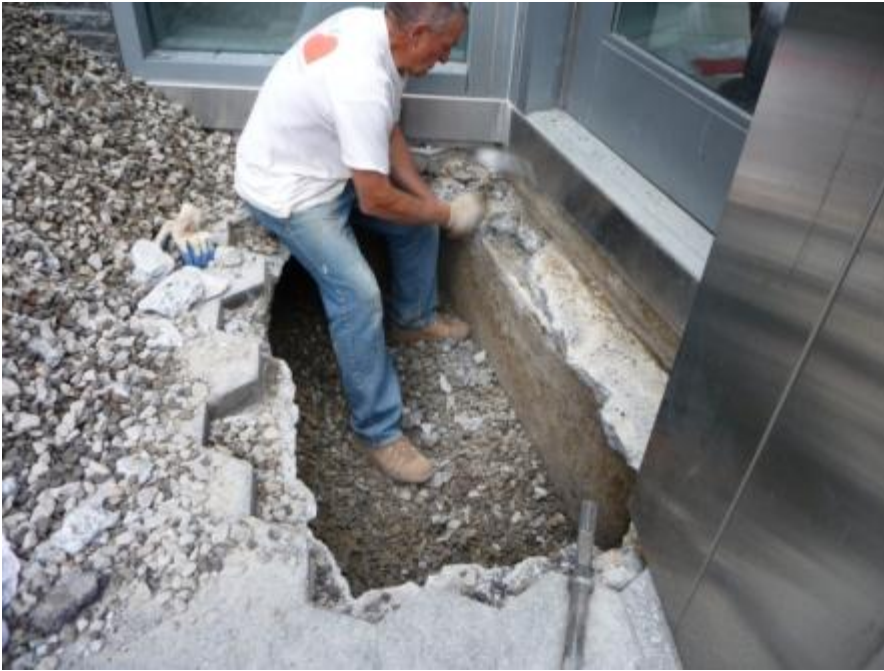
Figure 64. Probe #1 was taken at north door threshold (5/13/2013).

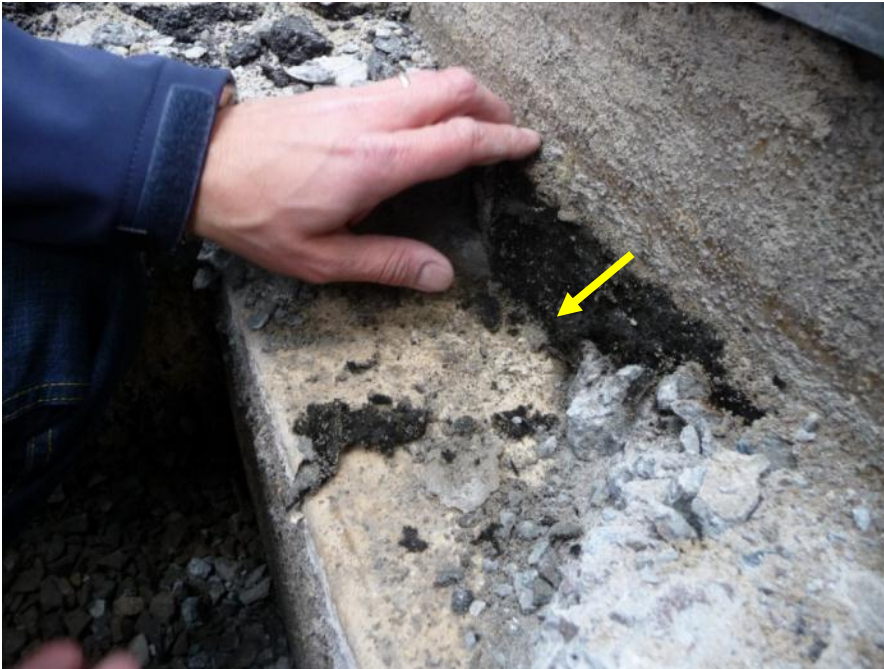
Adjacent to the door step is a concrete ledge. In order to review the joint at this location, additional removal of the topping slab was requested. The joint between the wall and the ledge appeared to be in good condition with no discernible defects [Figure 65].

Figure 65. Further concrete topping slab removed to reveal the joint (arrow).

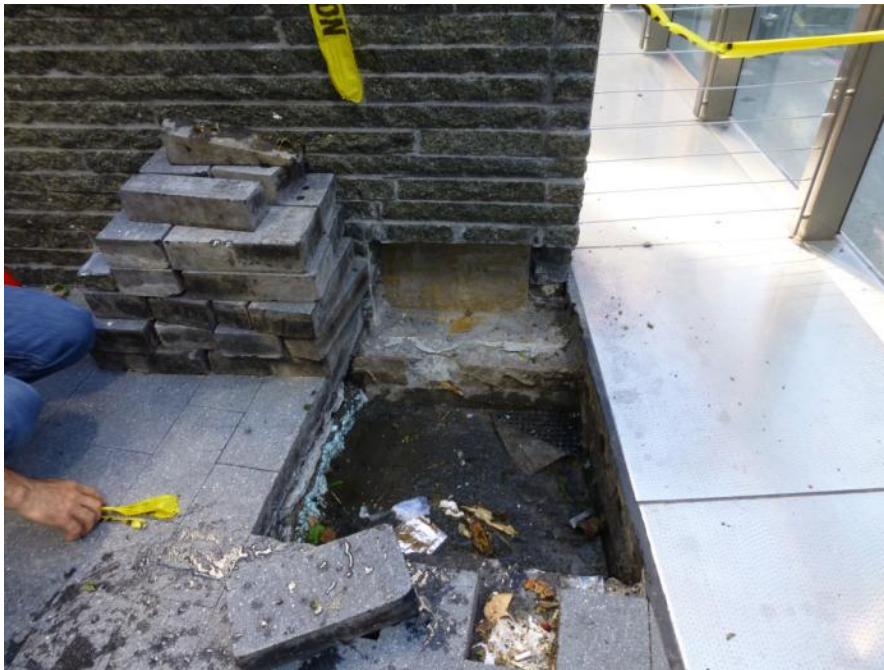
Per test no. 12, water was directed at the opposite side of the parapet wall and water infiltration occurred at the bottom of Storefront No. 1 (east corner). Therefore, probe #2 was opened at the south parapet wall adjacent to the horizontal metal panels [Figure 68].

Figure 68. Probe #2 taken at Upper Plaza south parapet level adjacent to metal panel.

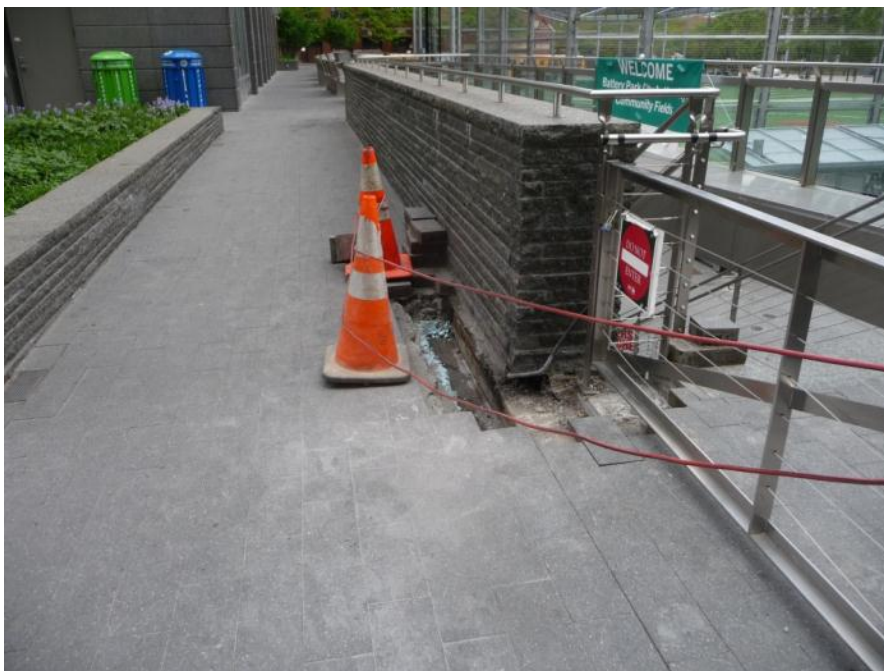
Per various tests performed at the parapet, water infiltration was noted at the base of the column located directly below the end of the parapet wall. Therefore, a probe opening was performed at this location, specifically at the corner, to understand how the stair landing intersected the plaza [Figure 71].

Figure 71. Location of Probe #3 at center parapet.

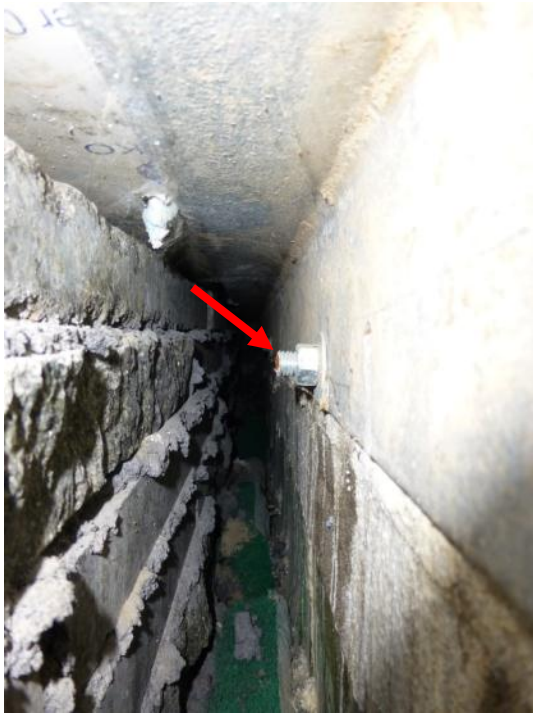
The area of removal consisted of an area of approximately 3'x 1' of asphalt pavers, asphaltic bed, and insulation. Drainage board and waterproofing were left in place. Two courses of granite were removed at the parapet exposing the Kemper installation. The waterproofing exhibited similar characteristics as in Probe #2, where it was observed to be brittle and delaminating from the substrate at the tie-in location. The slurry coat, also present, was noted to be delaminated from the base Kemper installation [Figure 72]. Additionally, it was observed that the stair landing sits atop the stone veneer and is fastened into the cast-in-place concrete wall. Minor corrosion was observed at the angle [Figures 73 and 74].

Figure 74. View of inside of cavity wall with stair landing directly above. Note corrosion at fastener (arrow).

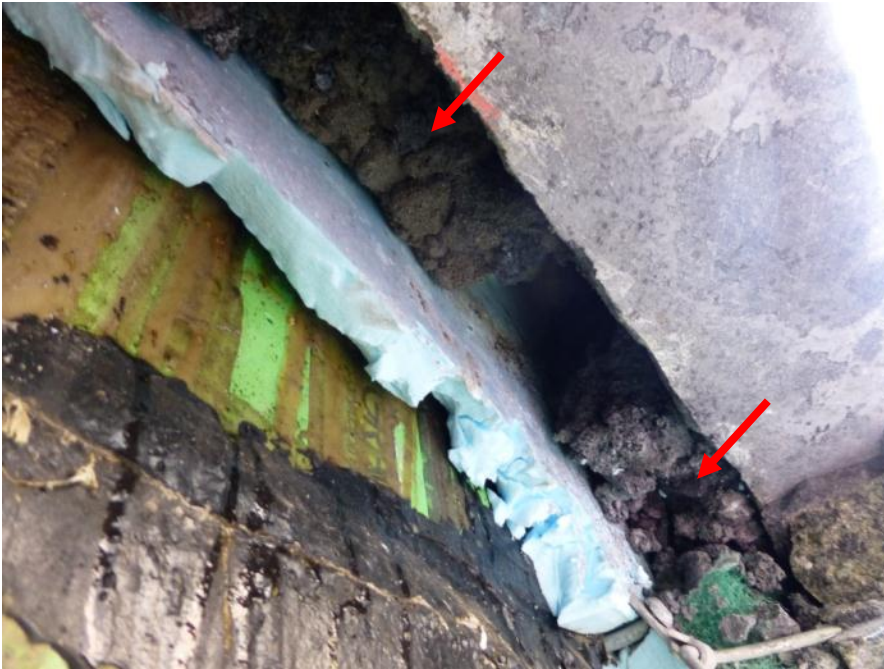
- Hole noted in the Grace Perm-A-Barrier membrane which also appeared to be through the lintel [Figure 76].
- Delaminated Kemper at tie-in location [Figure 77].
- Moisture noted to be present under the Kemper [Figure 78].
- Cavity largely filled with mortar droppings [Figure 79].

Figure 79. Largely filled membrane with mortar droppings.

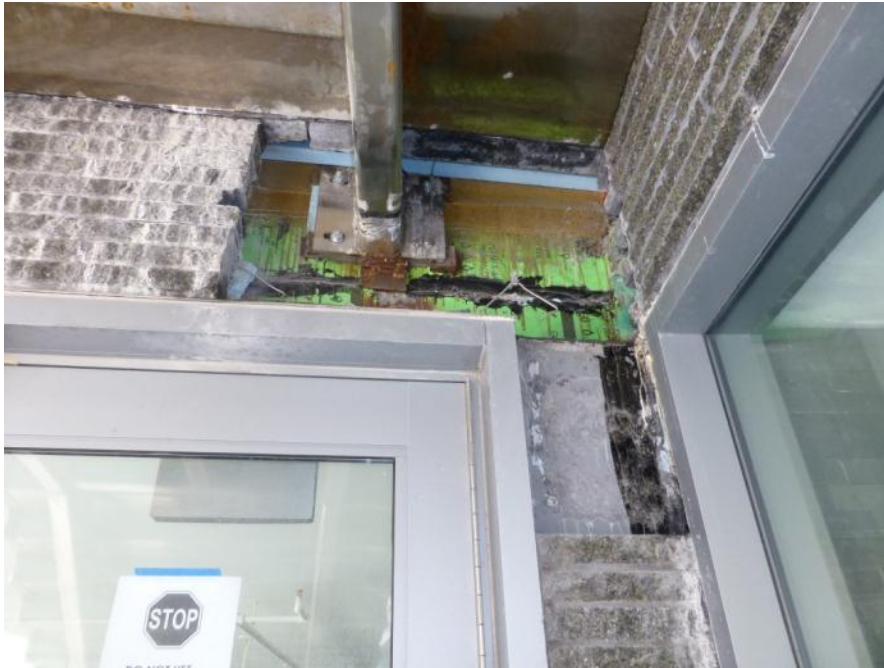
At WJE's request, the size of the probe opening was increased to allow for more exposure including the tie in condition where the stair beam intersects the wall [Figure 80]. The following conditions were noted at this location:

Figure 80. Probe opening adjacent to south door.

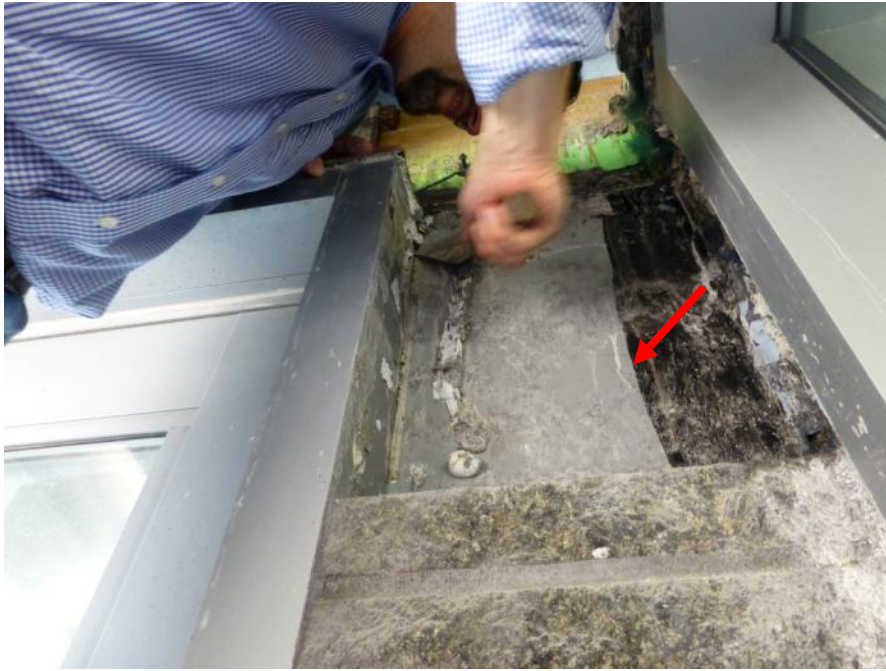
- Breach in the waterproofing and corroded shims at the stair beam / wall intersection [Figure 81].
- Metal panel at wall spans the height of the door [Figure 82]. The metal panel is installed behind the door frame and sealed with a bead of sealant. During our investigation, the sealant observed to be defective and was easily removed showing little to no adhesion to the substrates.
- Openings in the flashing membrane at various locations that exhibited signs of moisture underneath [Figure 83].
- The metal flashing at the head did not have any end dams [Figure 84].

Figure 82. Metal panel spanning the length of the door observed at this probe location.

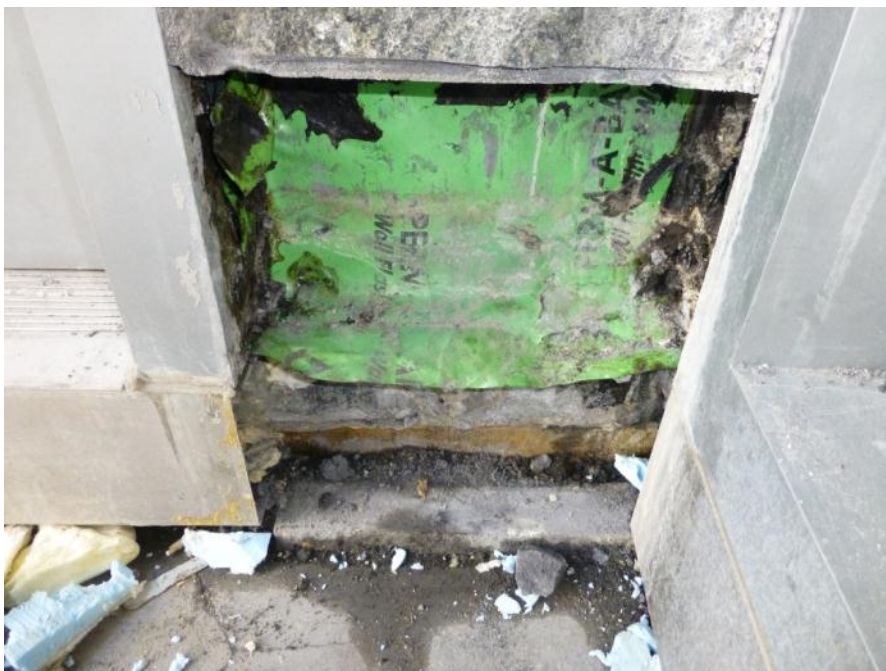
At WJE's request, probe location #6 was opened in order to verify and understand the flashing condition at the base of the wall [Figure 85]. The metal panel noted in Probe #5 was observed to extend to the base of the wall. Perma-A-Barrier flashing, installed above the metal panel, extends approximately 10-inches above the wall. The waterproofing at this location was observed to be delaminated from the door jamb and at the base of wall [Figure 86]. Corrosion was also noted at the angle where the door and storefront window partially sit on. Additionally, at the base of the storefront window, where the break metal panel was installed in lieu of plywood as per the design documents, the void was observed to be filled with spray foam insulation [Figure 87].

Figure 85. Probe #6 adjacent to south door.

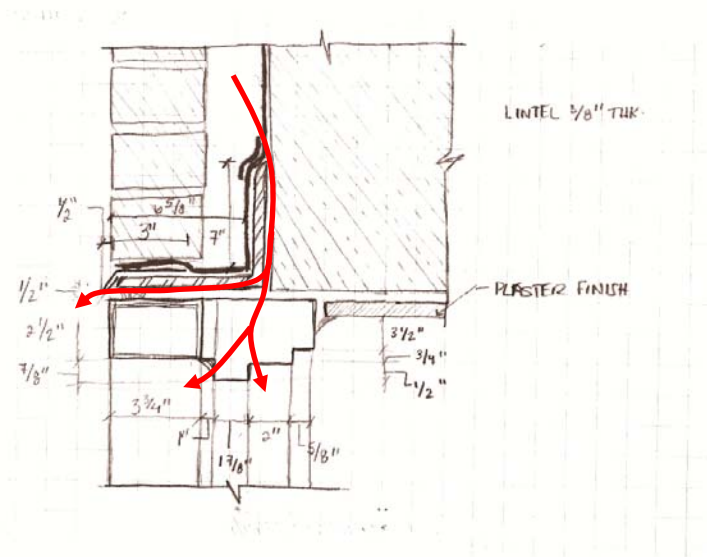
The Grace Perm-A-Barrier was also observed to be separating from a metal flashing installed over the fenestration openings. Again, this condition may be contributing to the infiltration of water into the building as observed during one of our water tests in the vicinity of Probe #4 [Figure 88].

Figure 88. Section through door head showing potential path of water leakage. Directly above, south parapet wall of Center Courtyard
